ROOFING REALITIES NESEA March 2016

IT'S ALL IN THE DETAILS

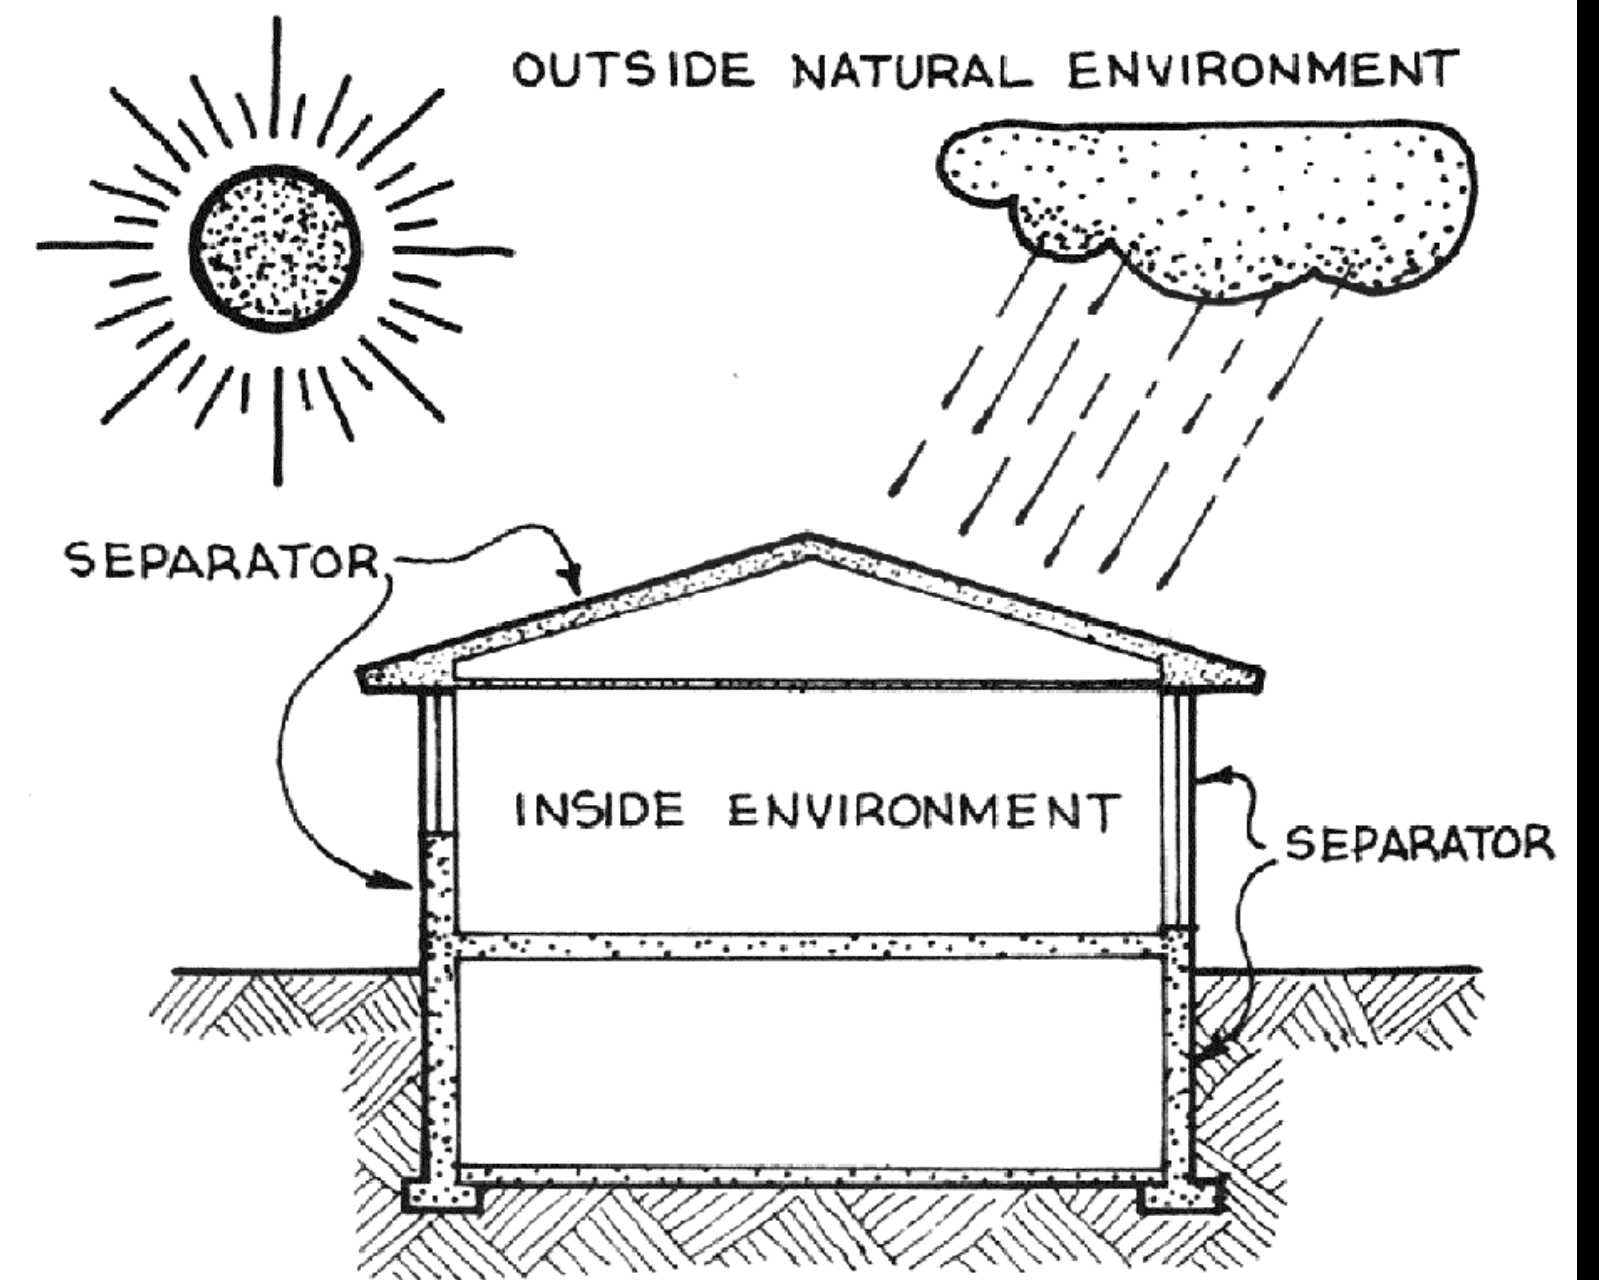
Figure 1-3. Roof with walls are environmental separators.

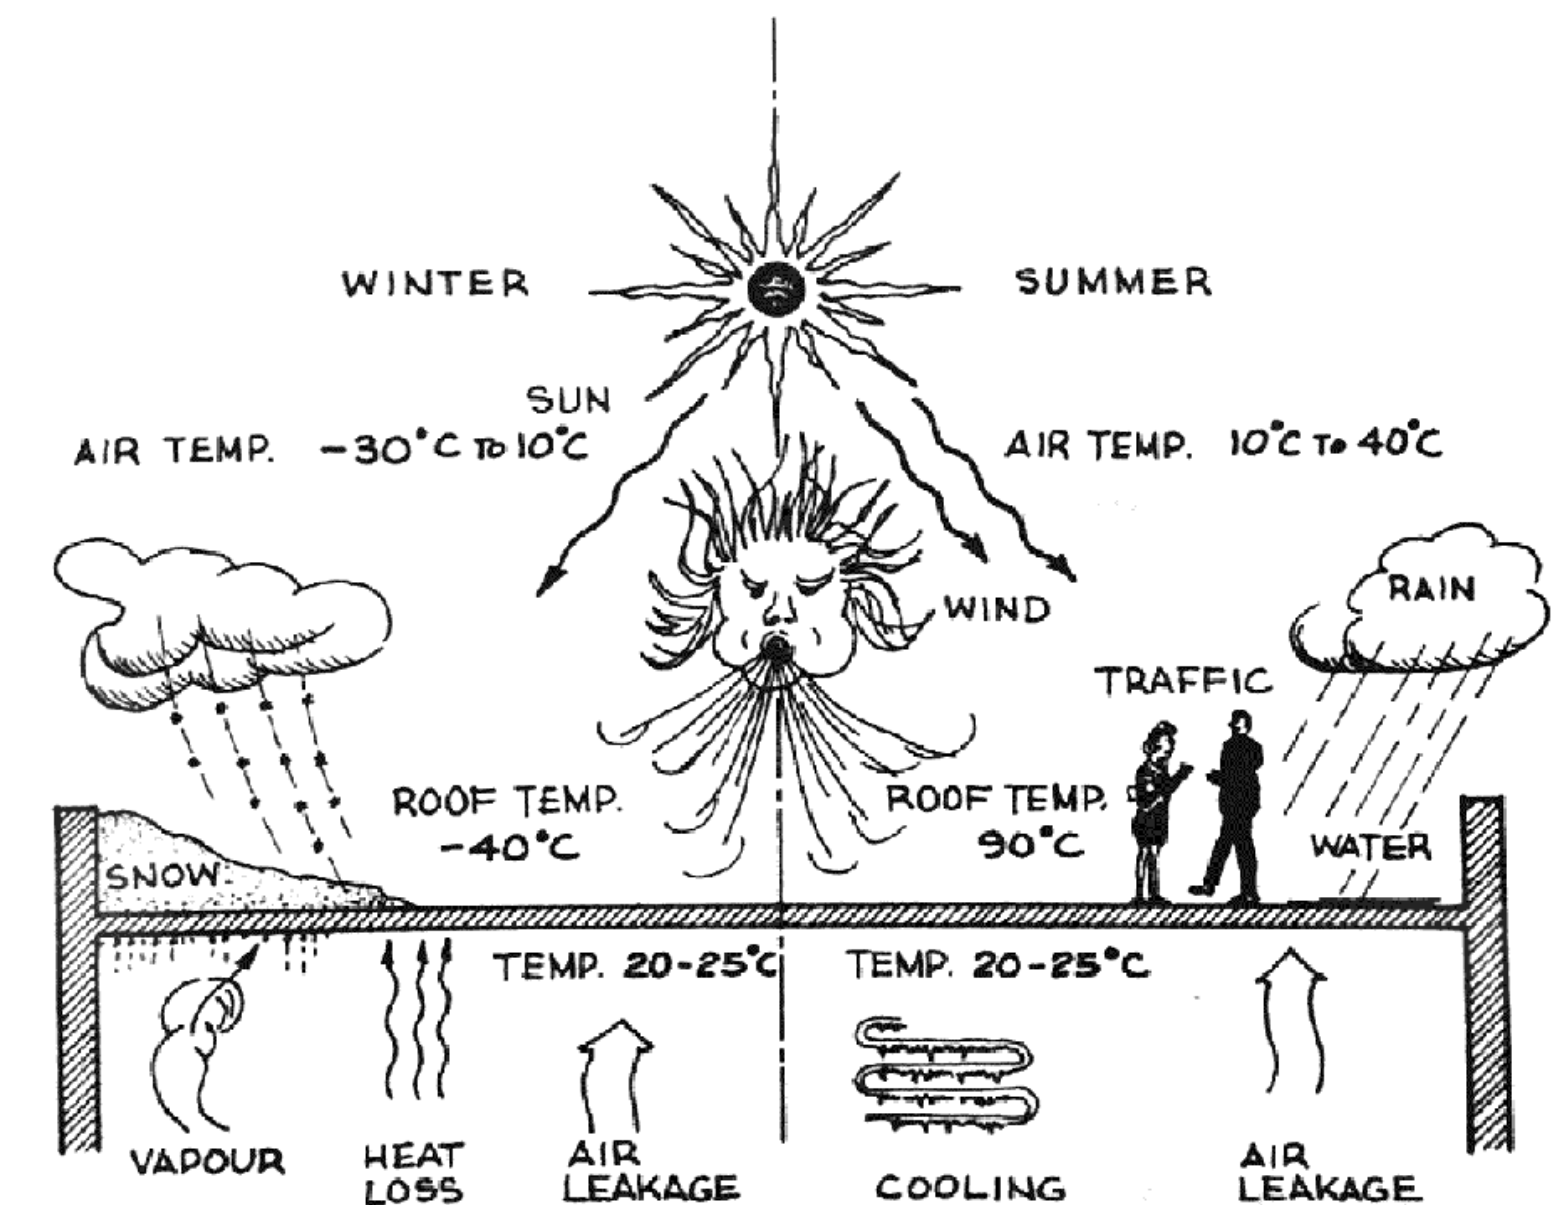
Figure 1-4. Factors of inside and outside environments.

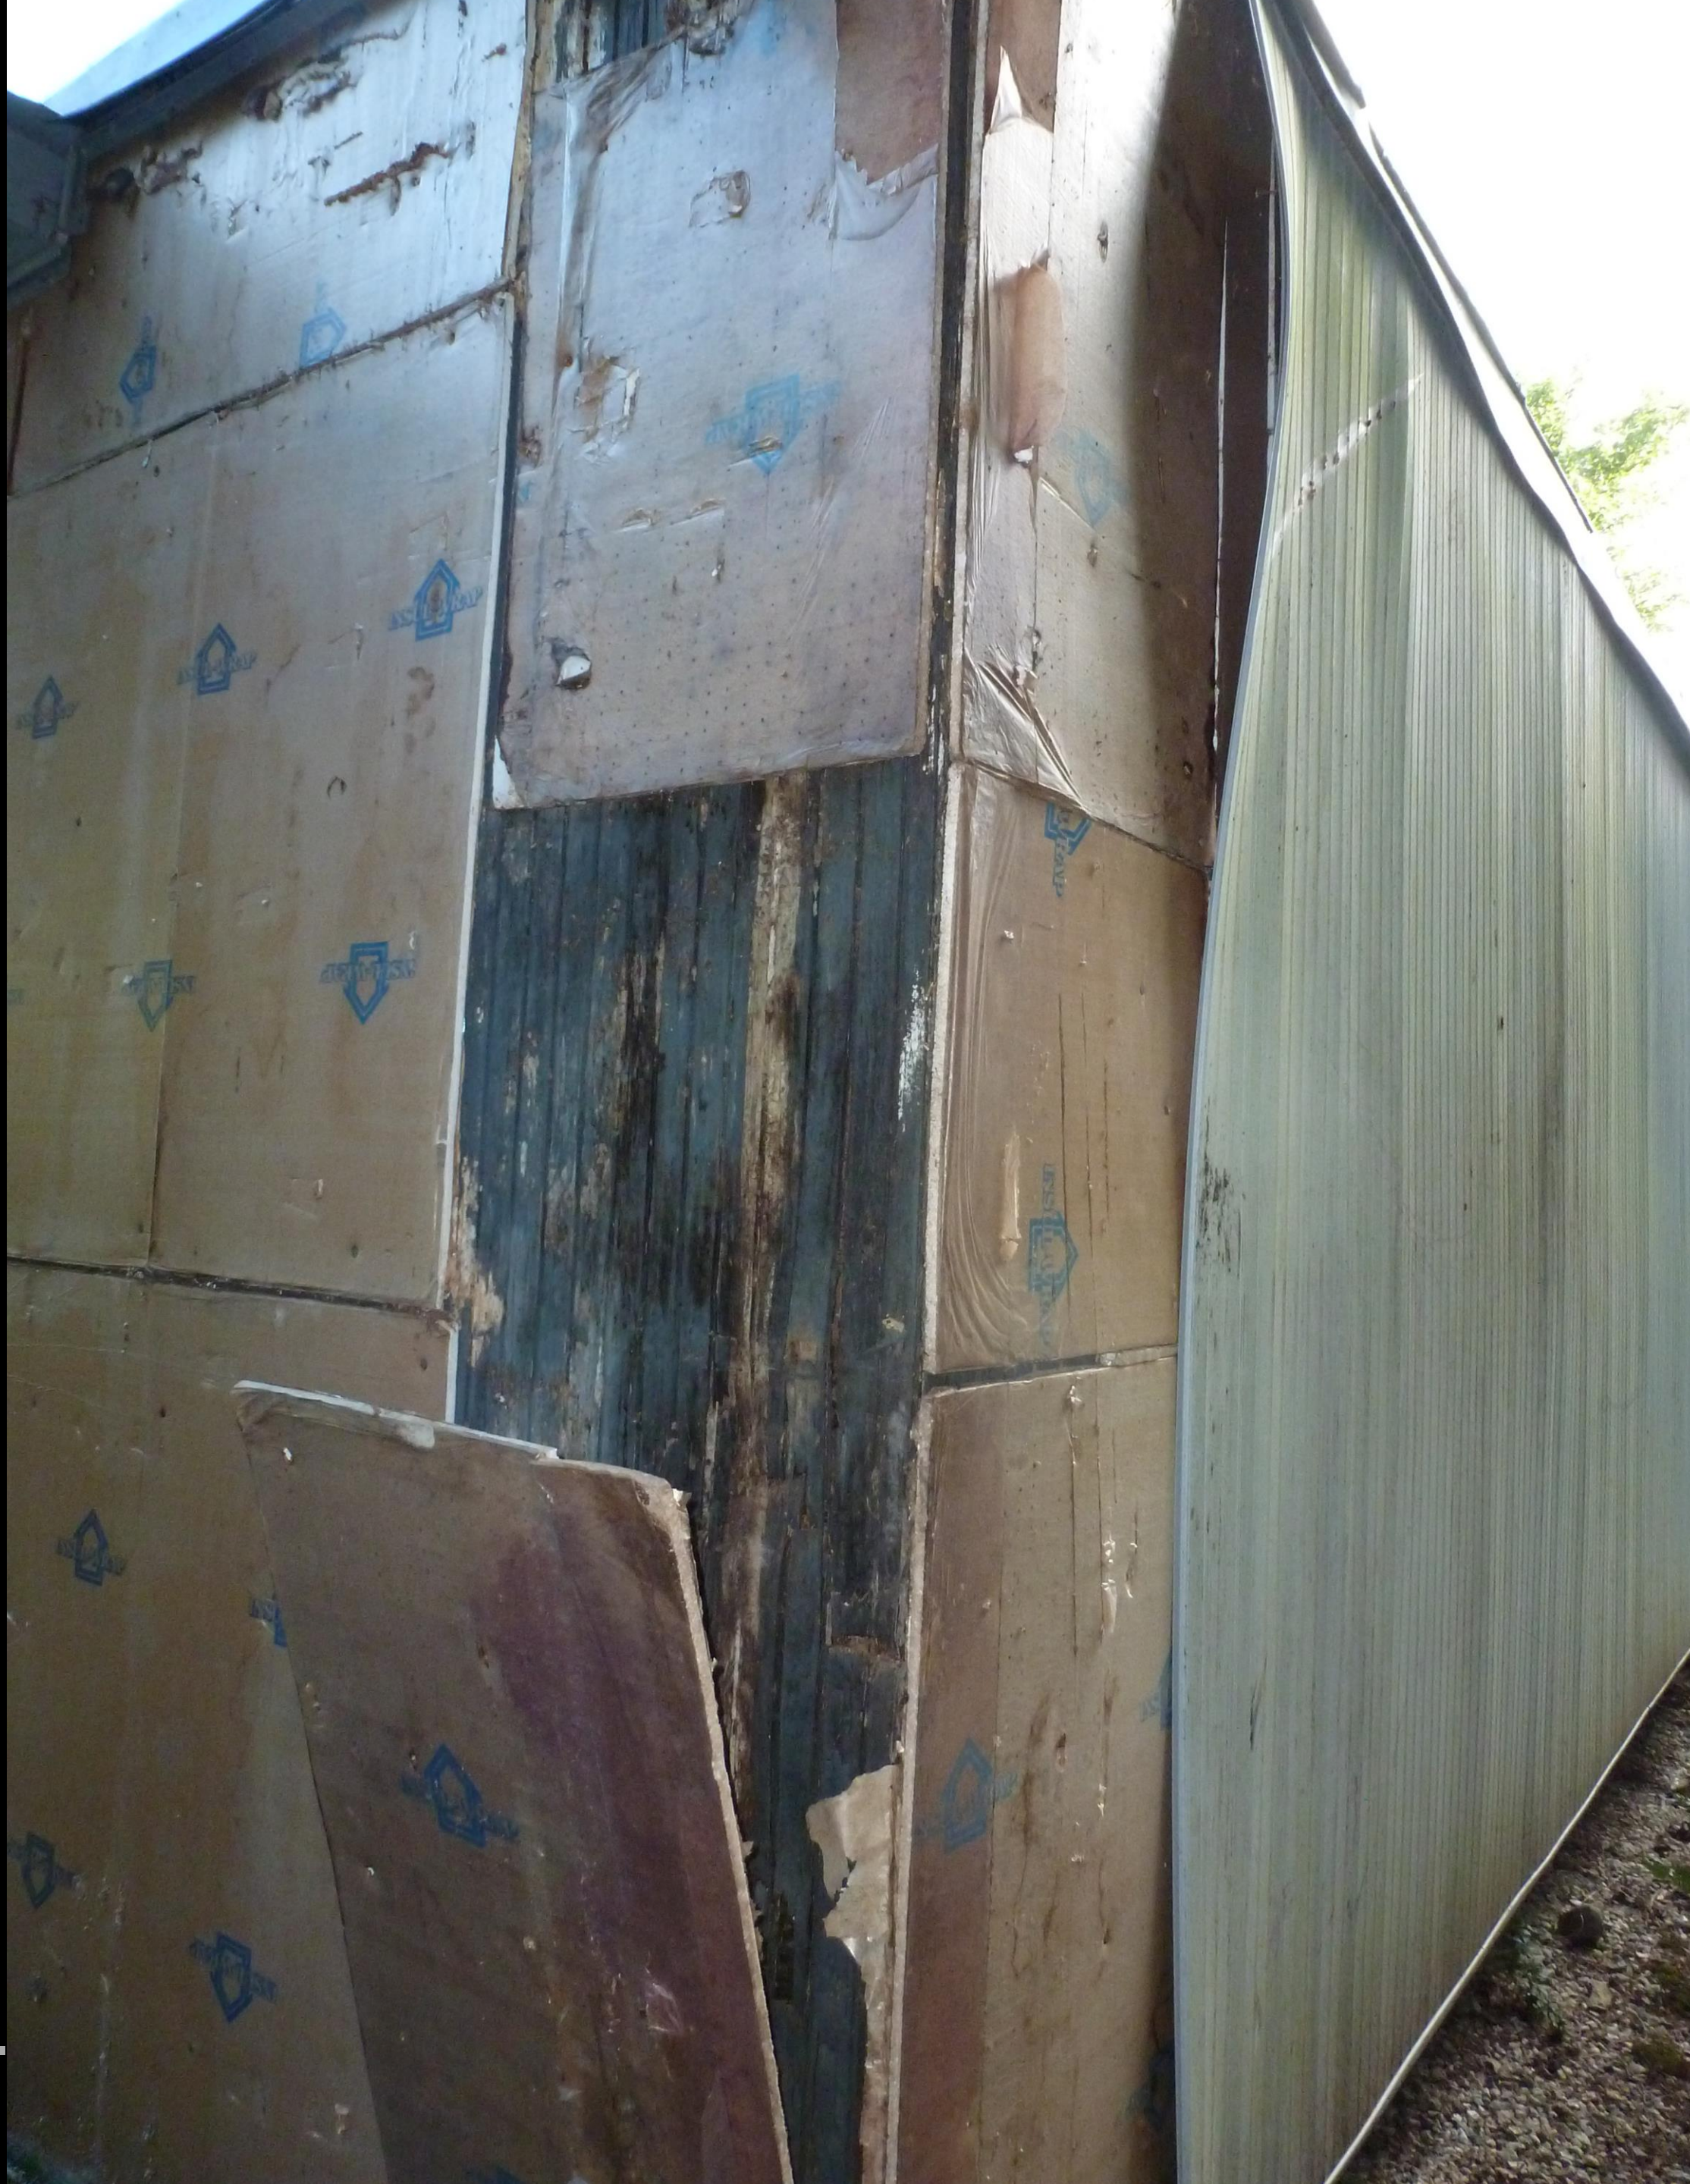
Failure at roof edge caused the wall to rot.

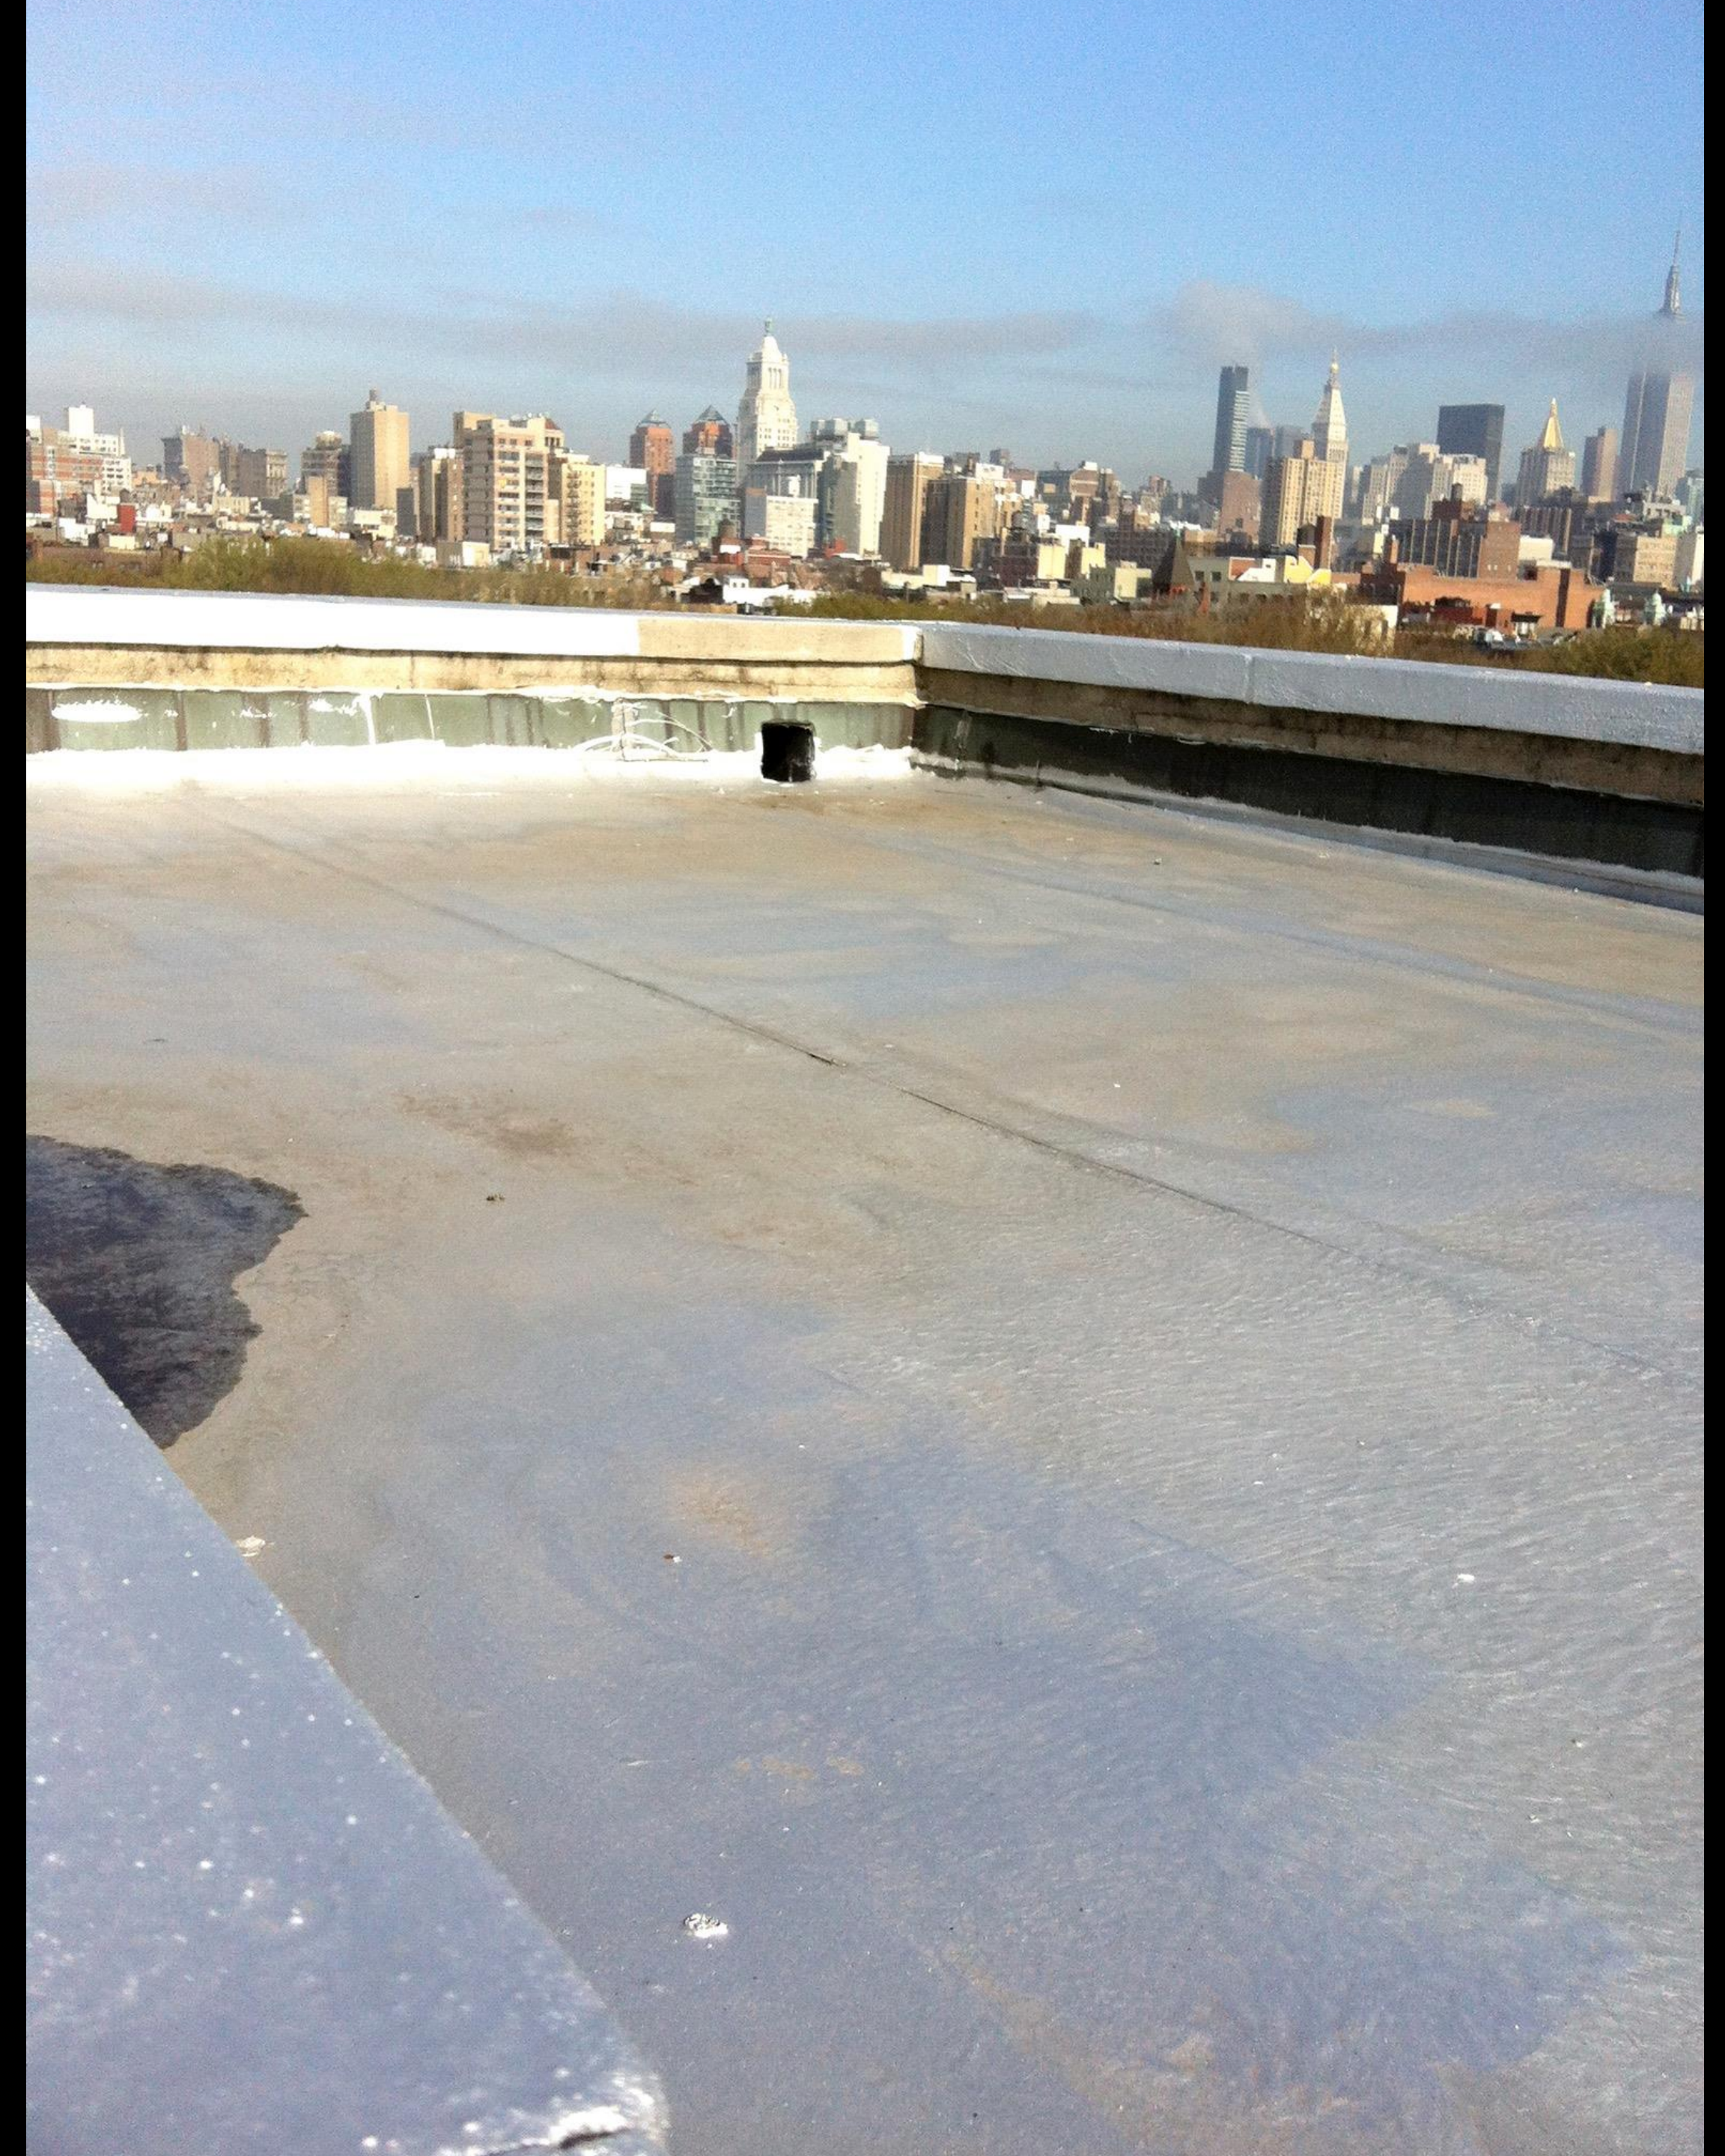
Look OK? It lasted 13 years.....

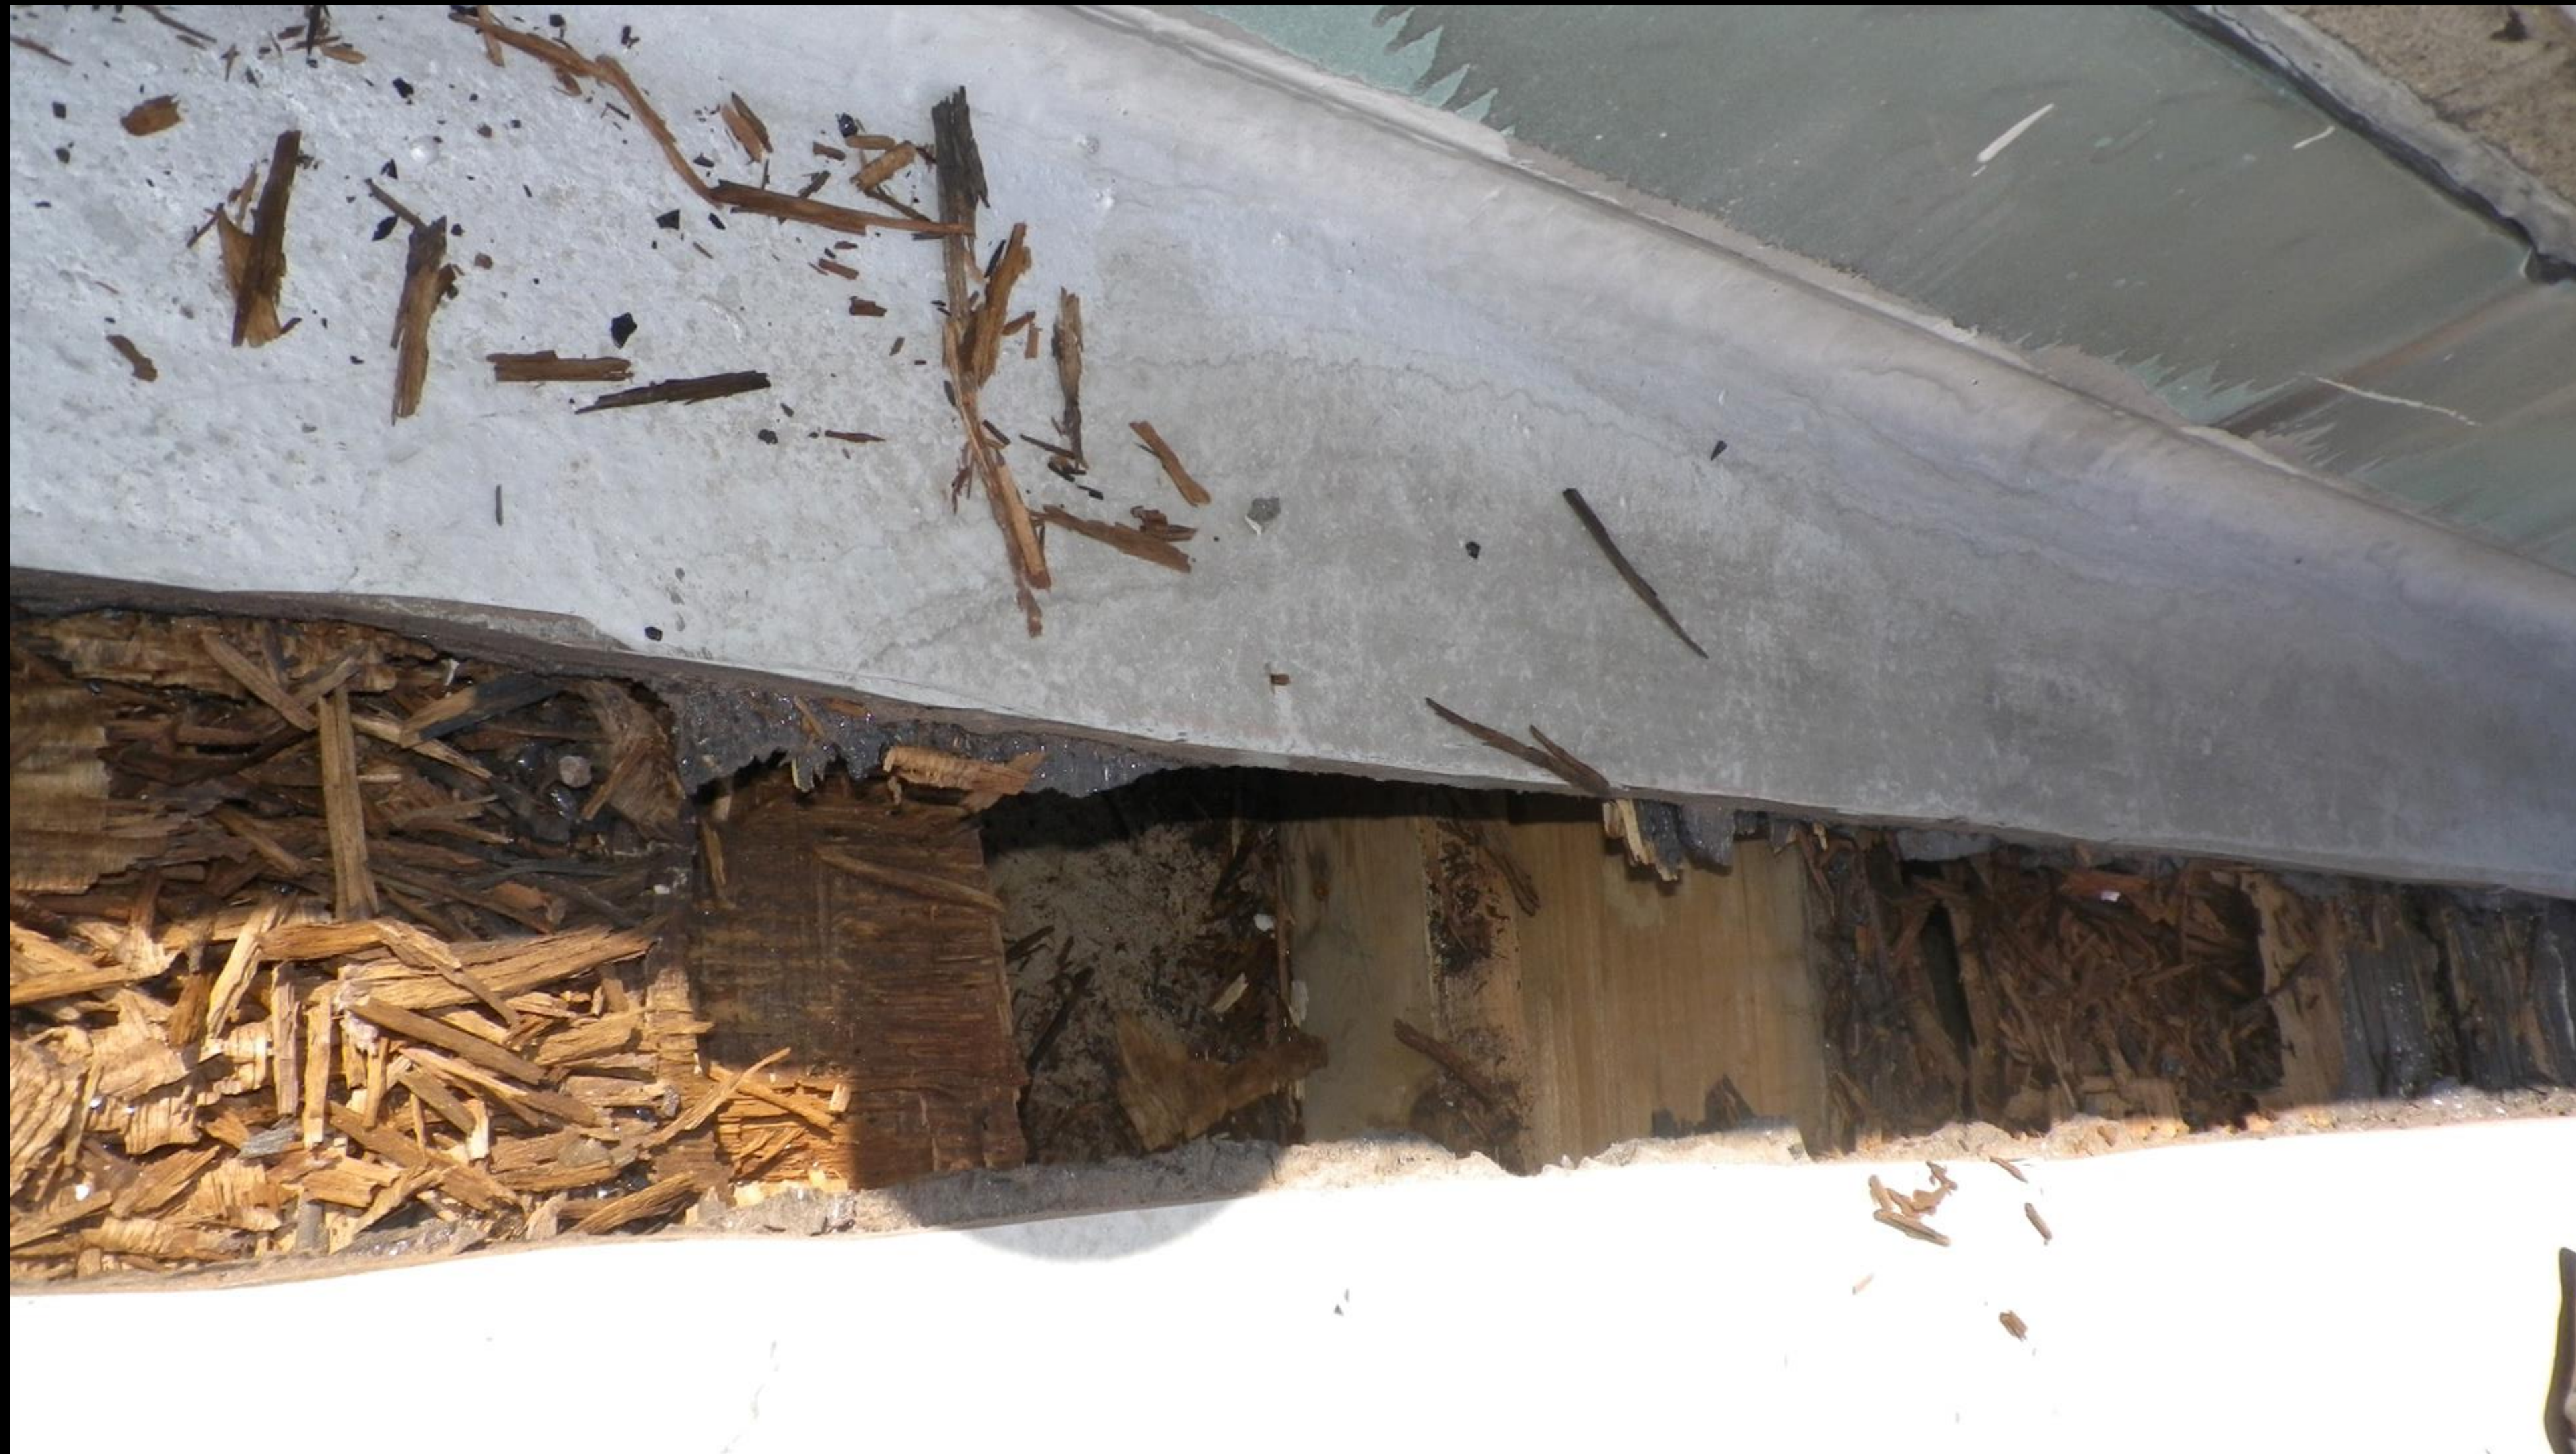
Rotted wood deck due to the improper base flashings.
Leaking parapets *and* unprotected coping stones are to blame.

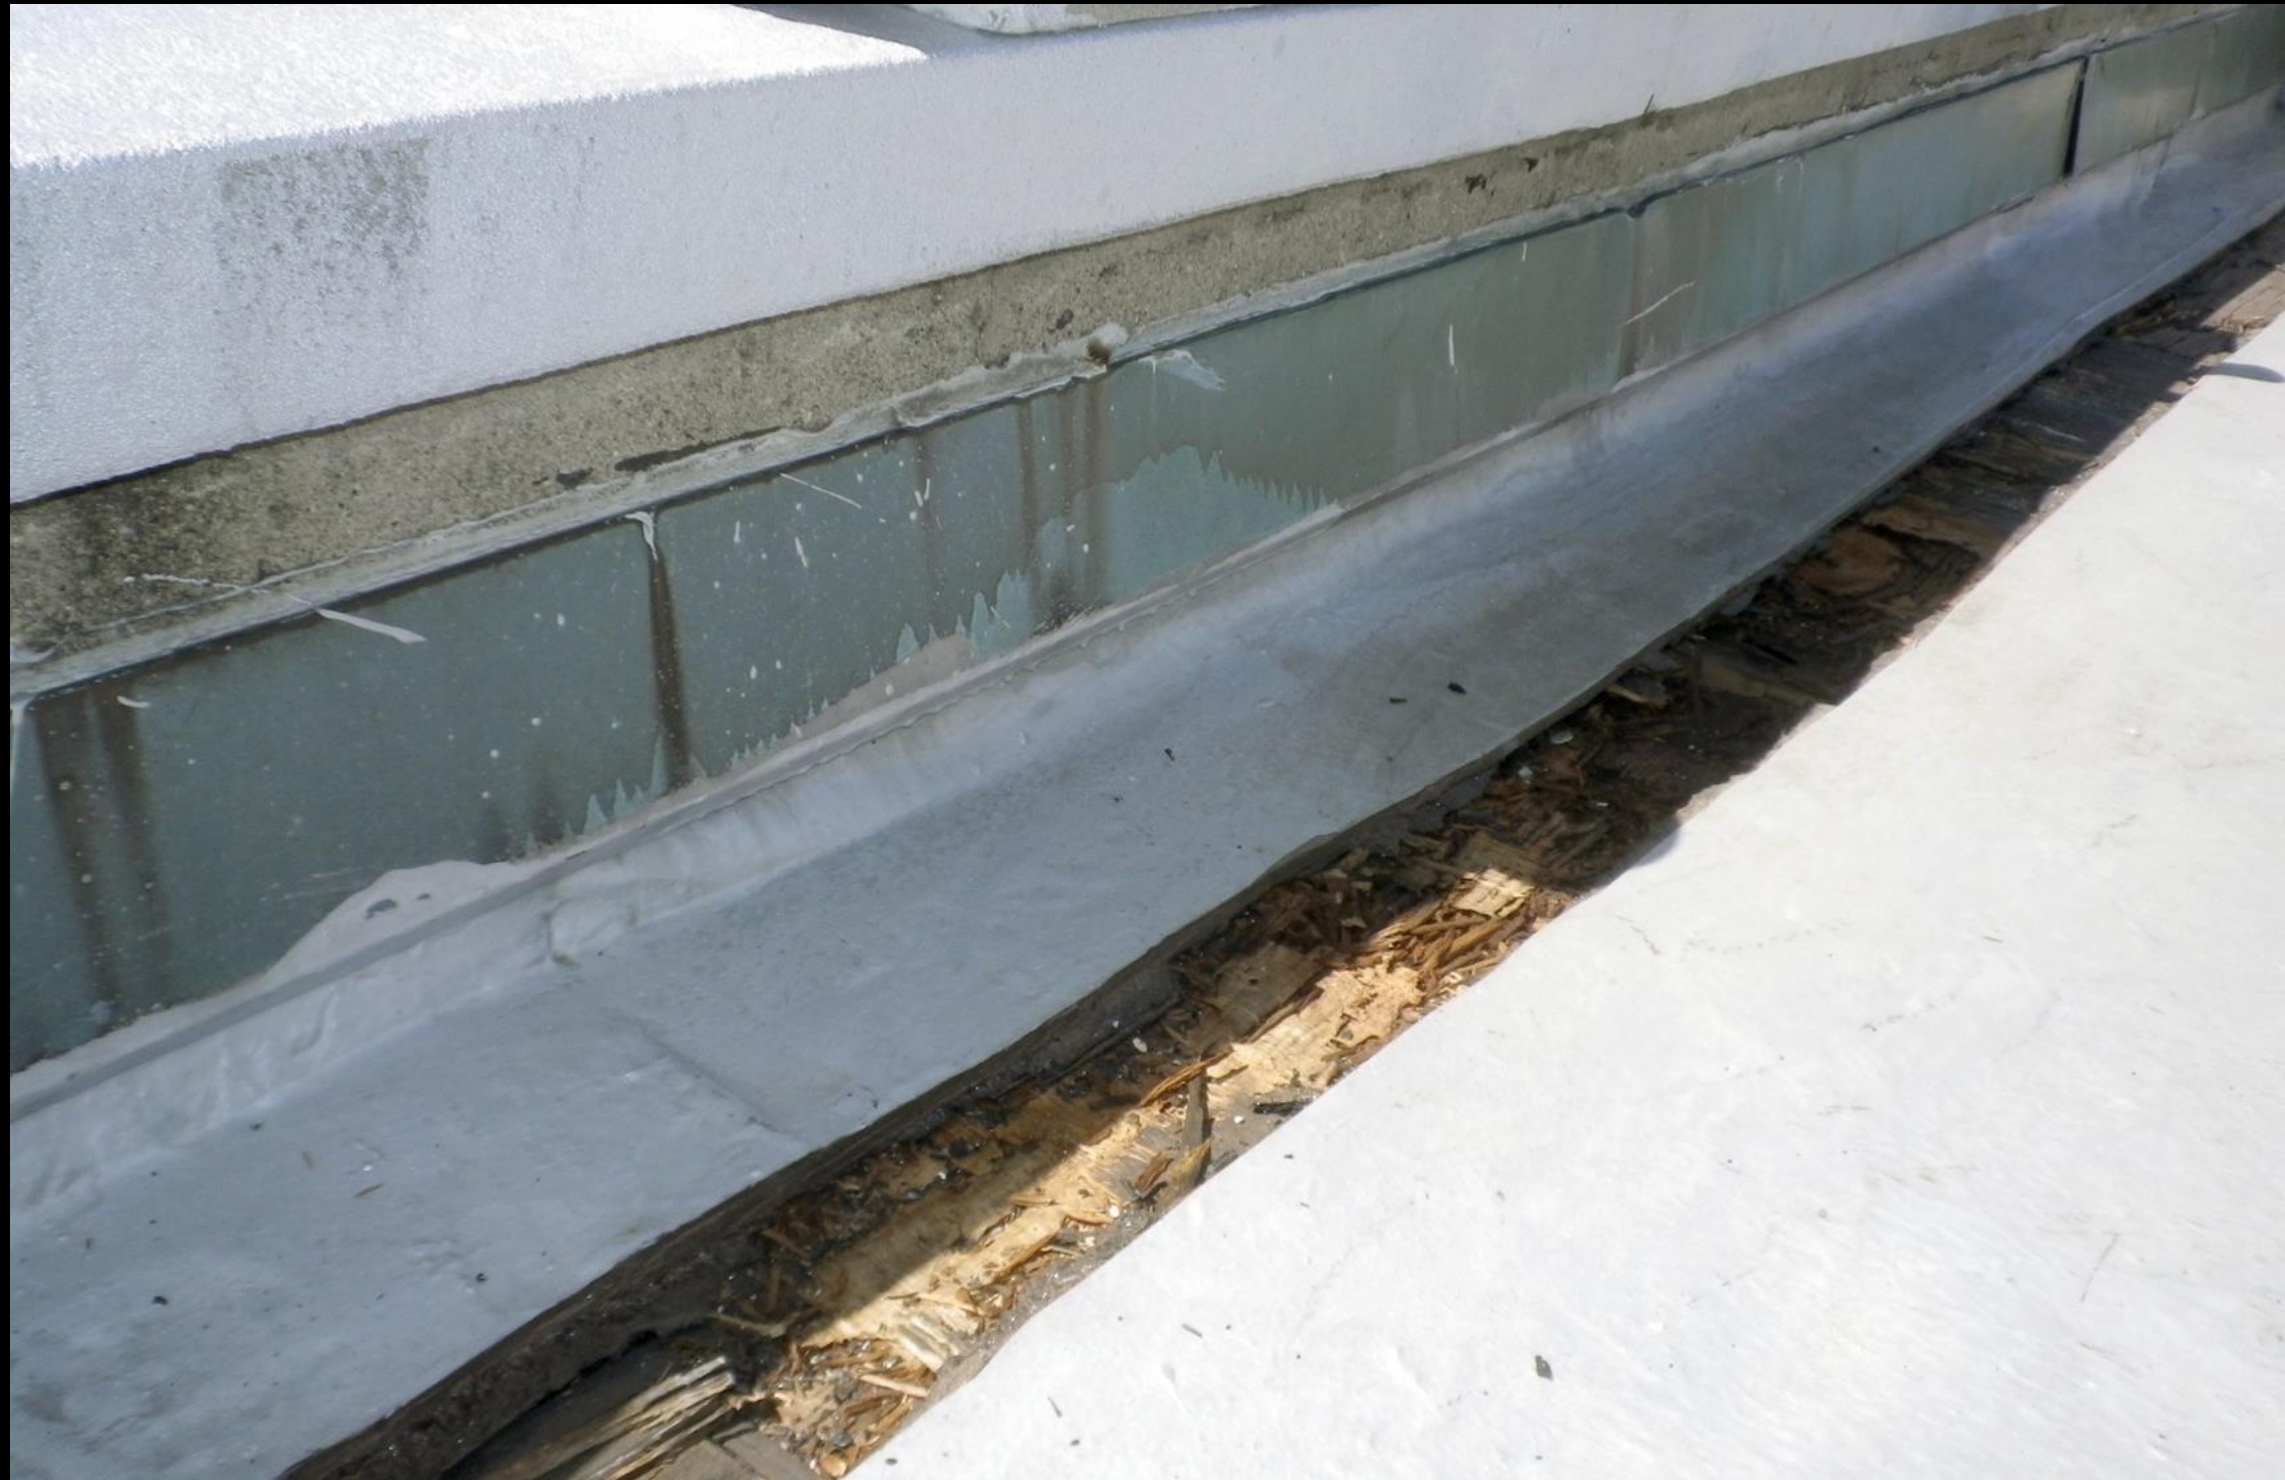
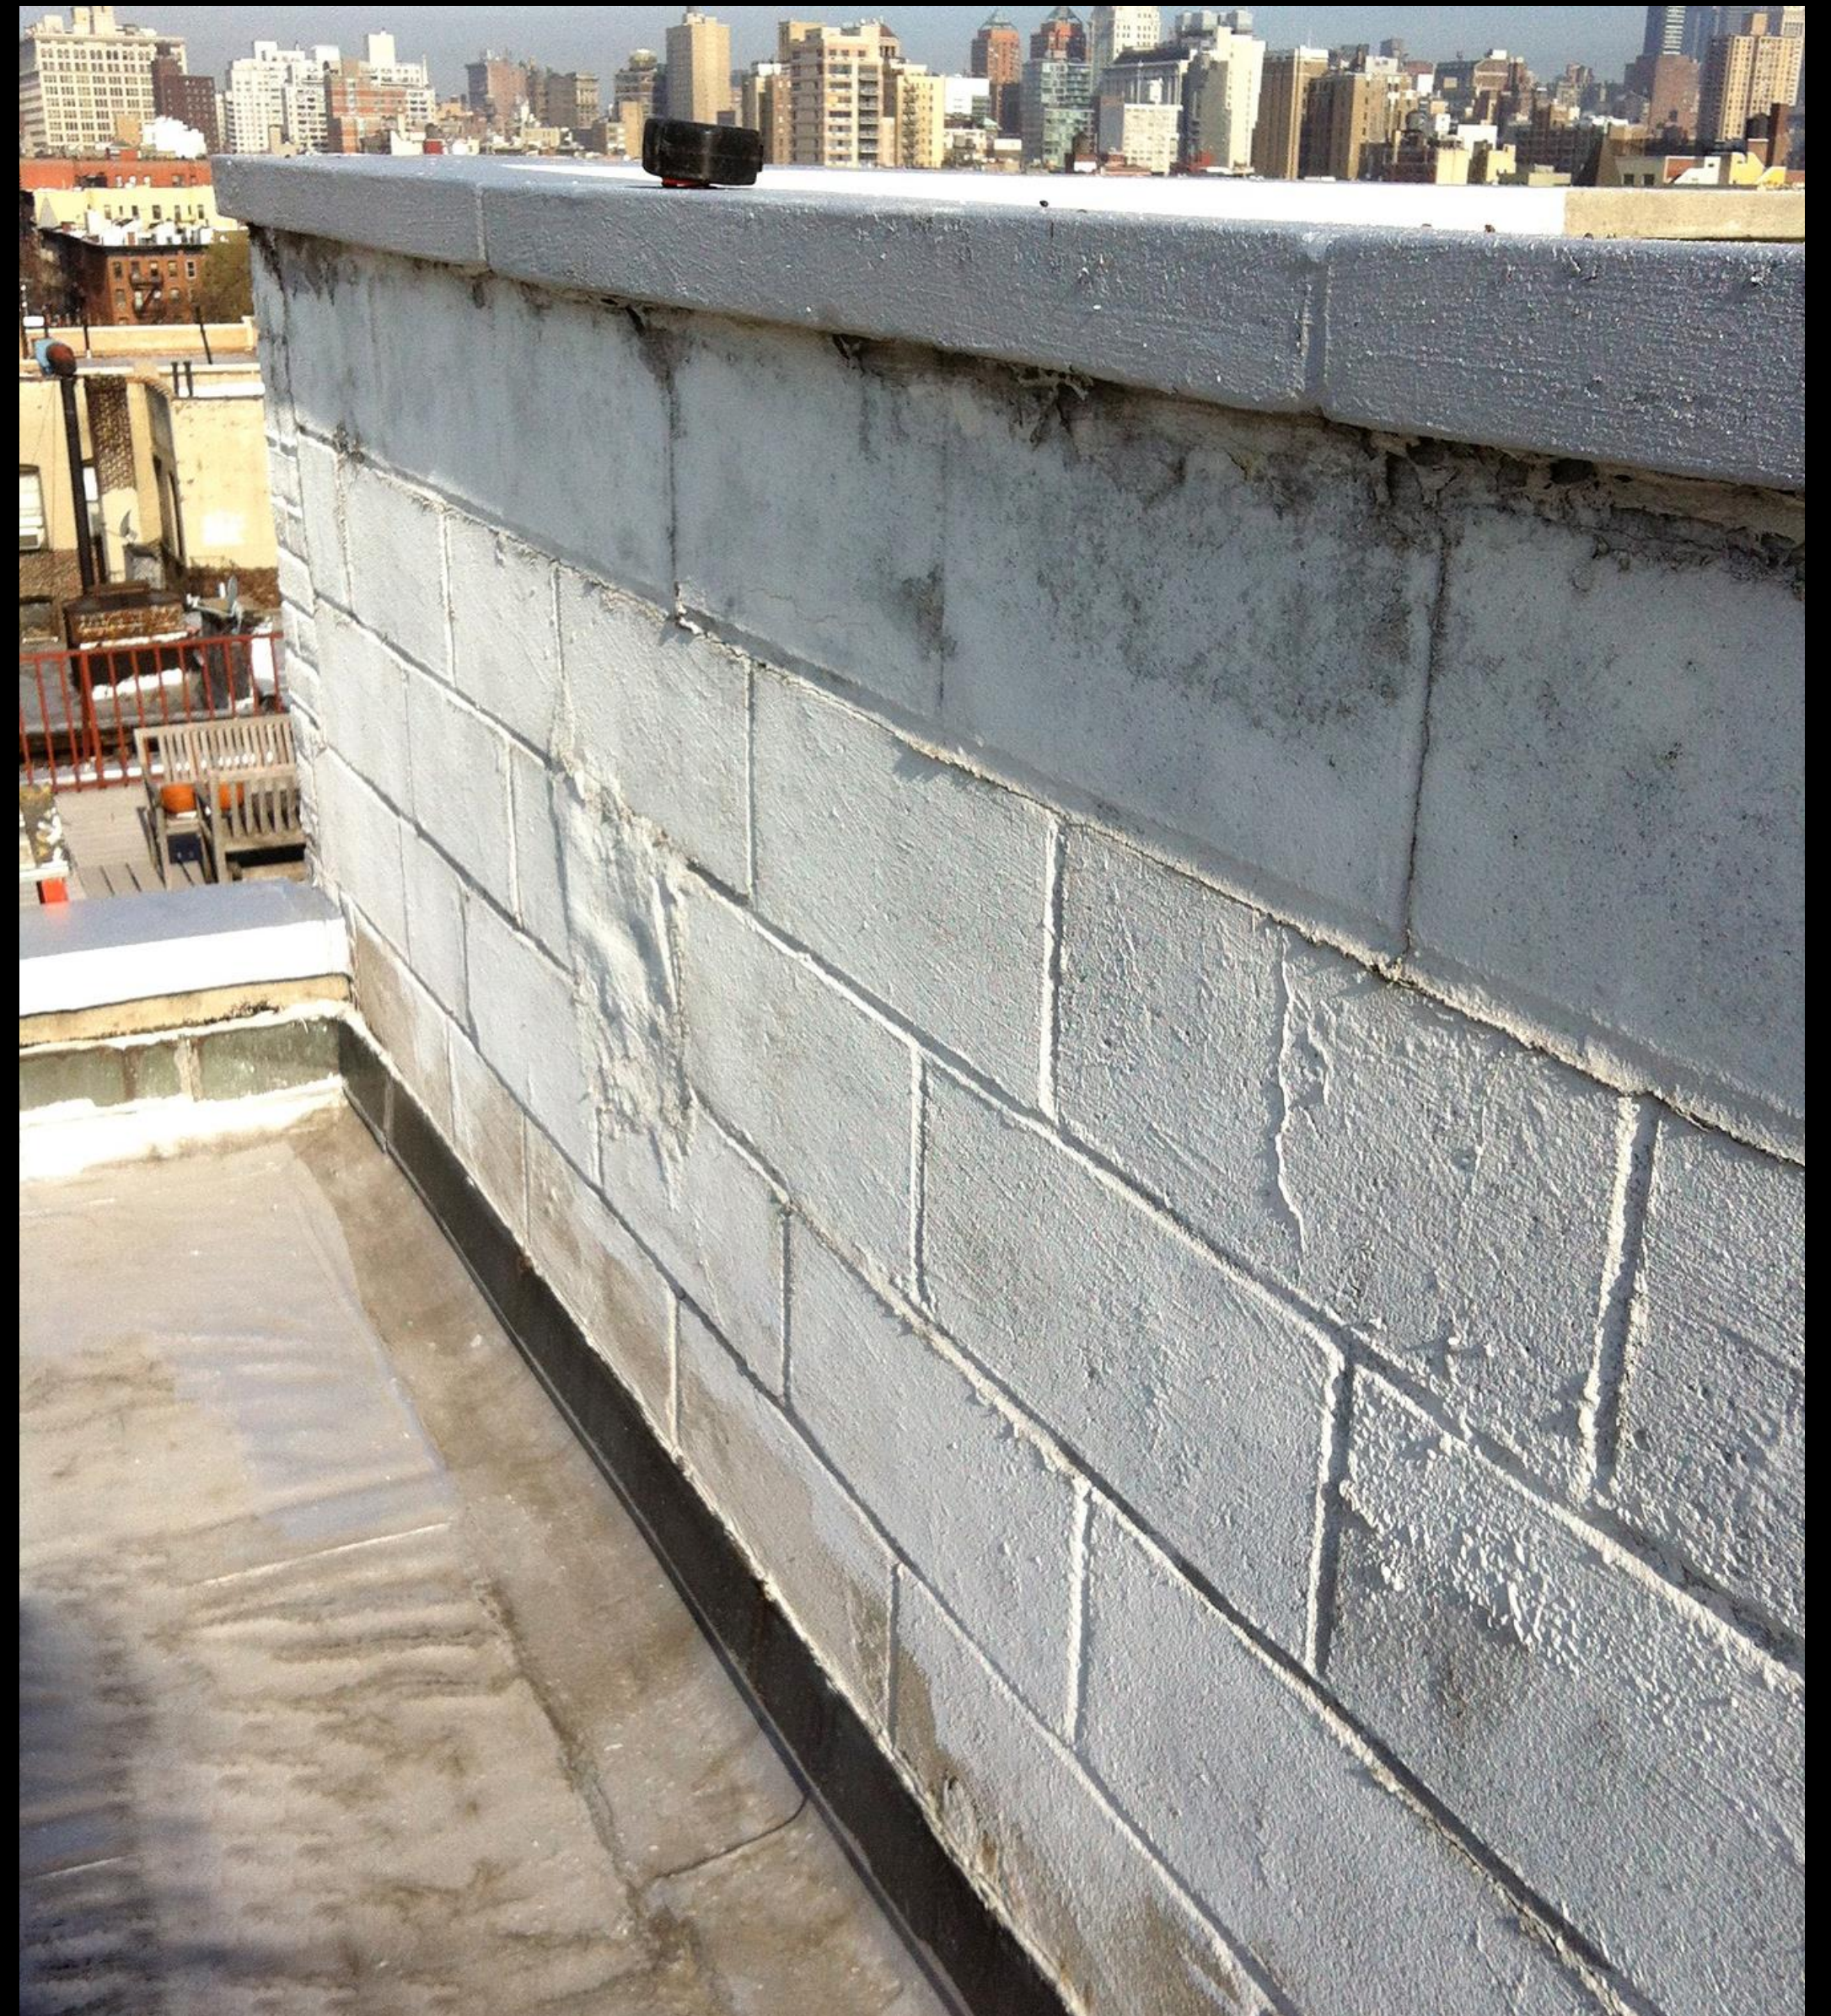
Useless base flashing! No waterproofing at coping. Large amounts of water enter the structure through unprotected wall coping.
