ROOFING REALITIES NESEA March 2016

IT'S ALL IN THE DETAILS

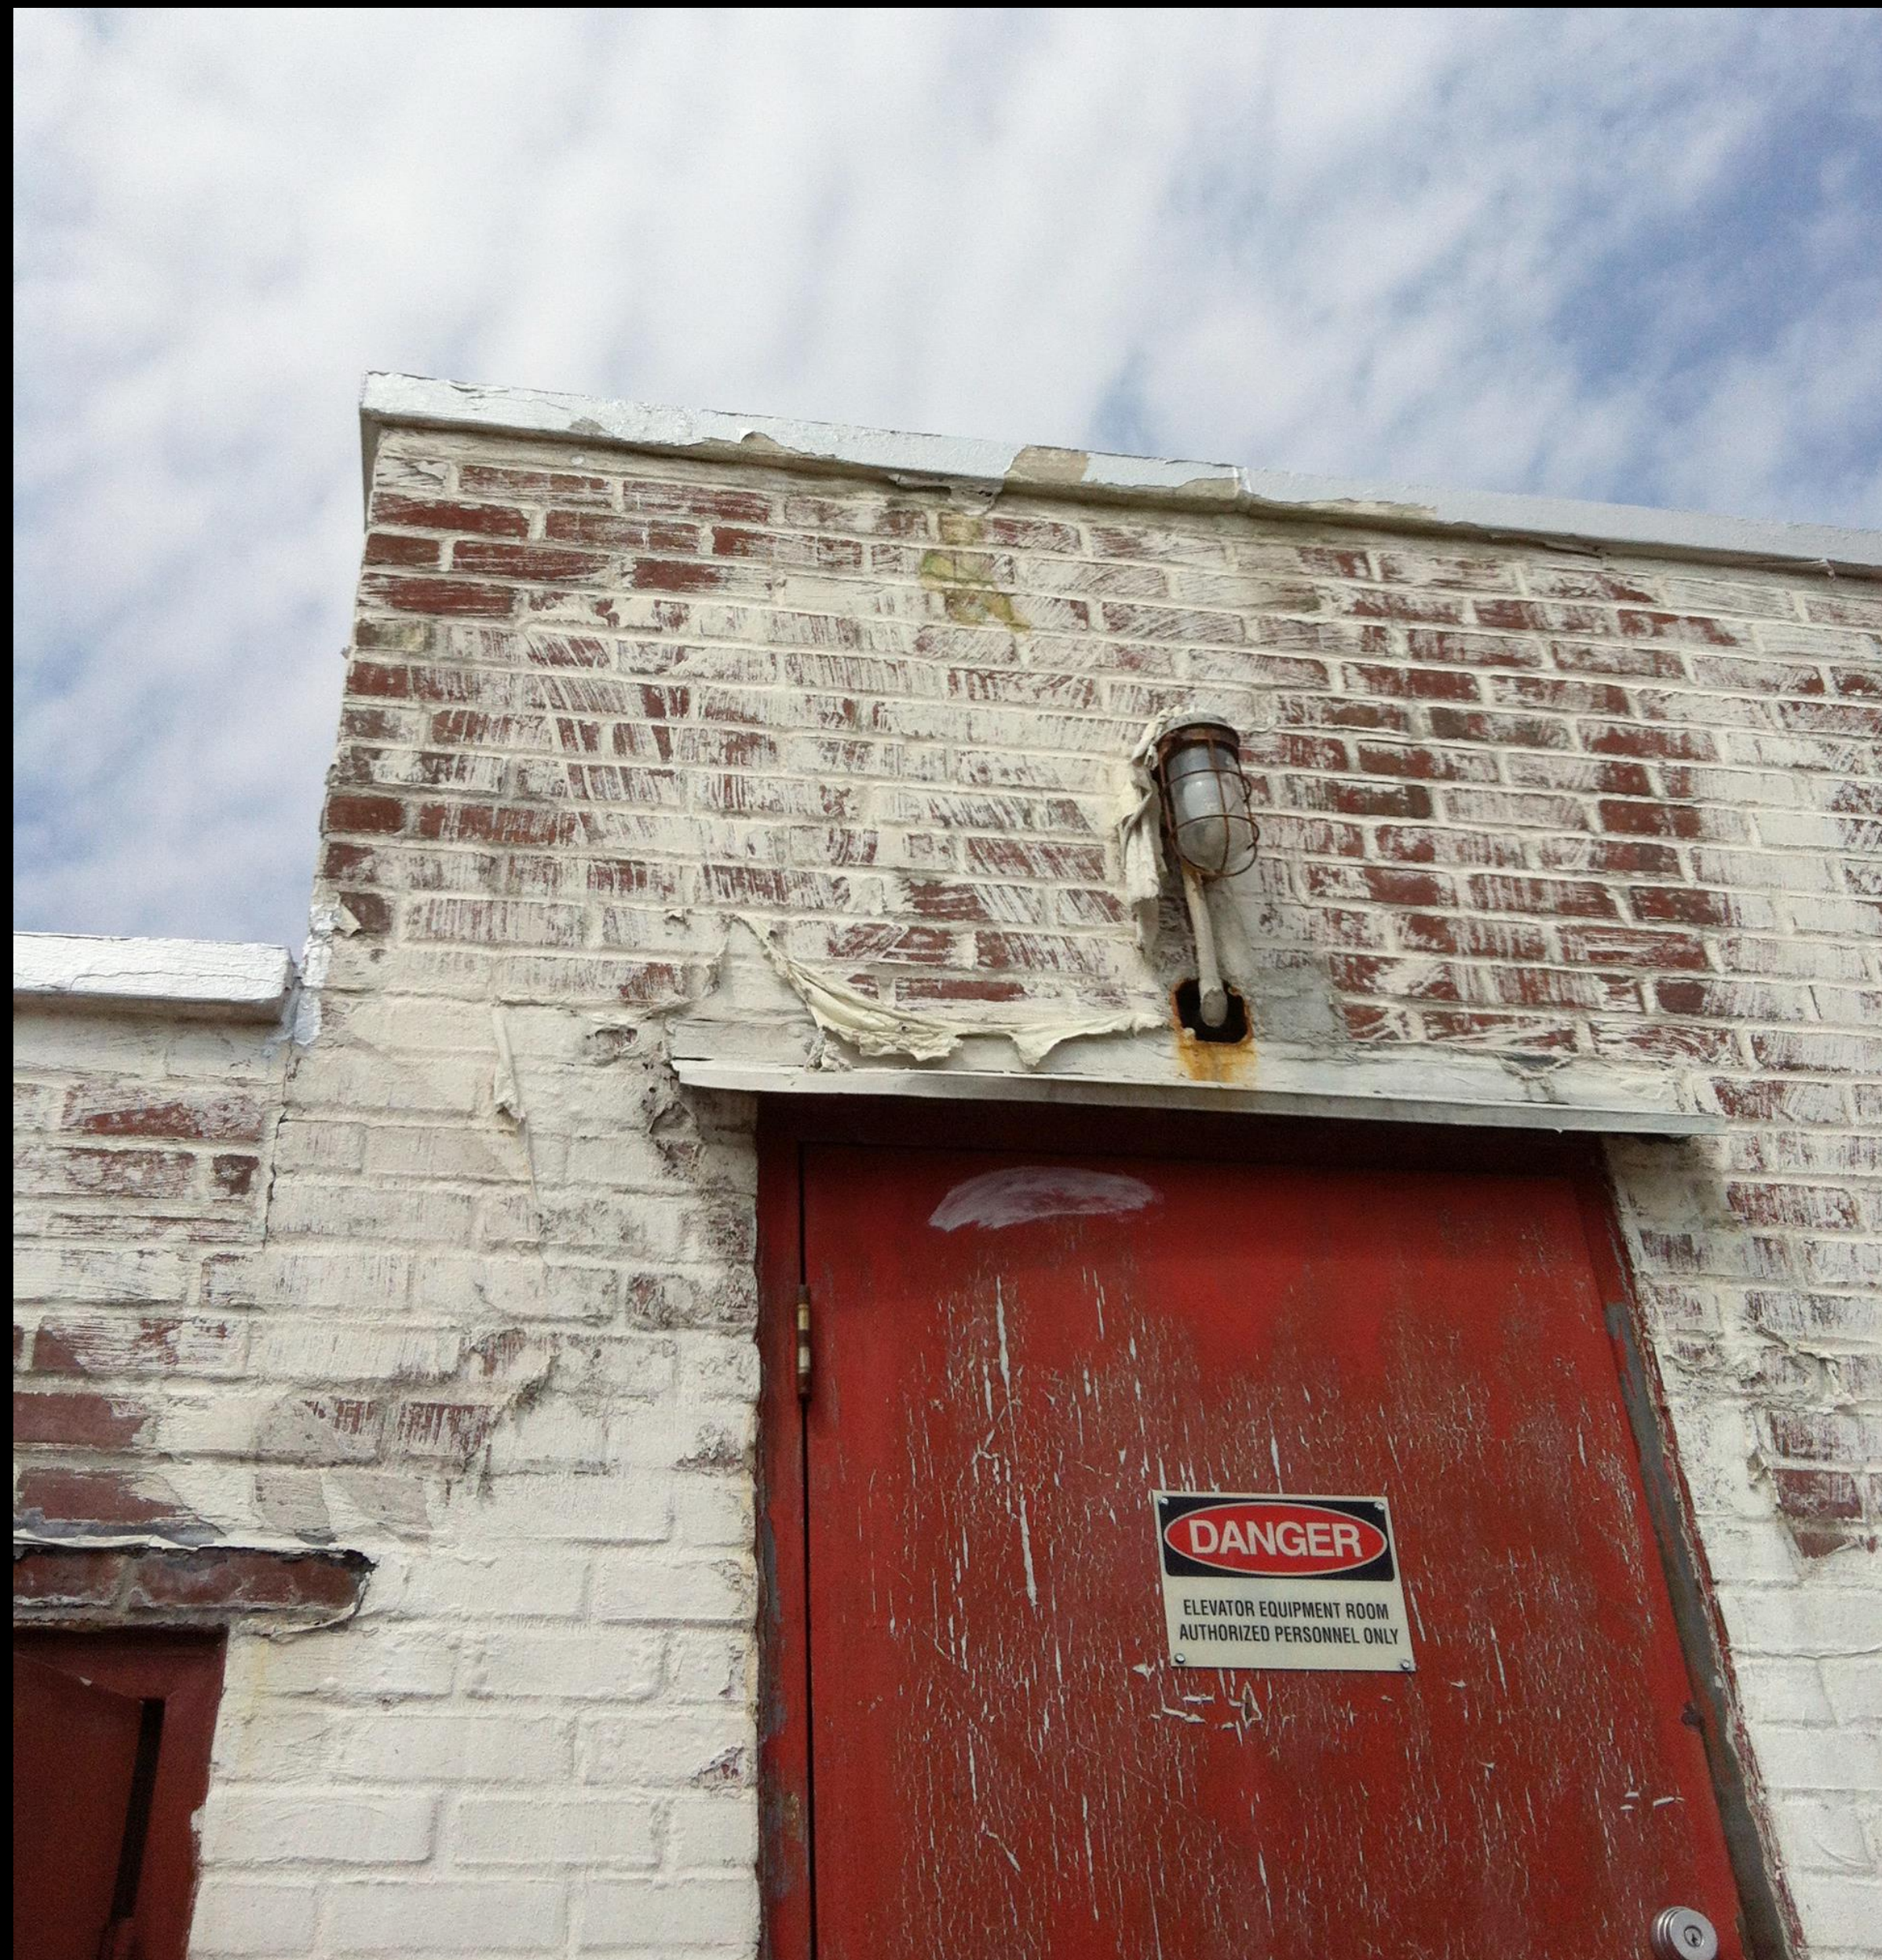
This is a **failure of a roofing component** *not* the masonry wall. An incredible amount of water enters buildings through unprotected parapet caps. Coatings are *not* a solution when something else is wrong in the assembly.

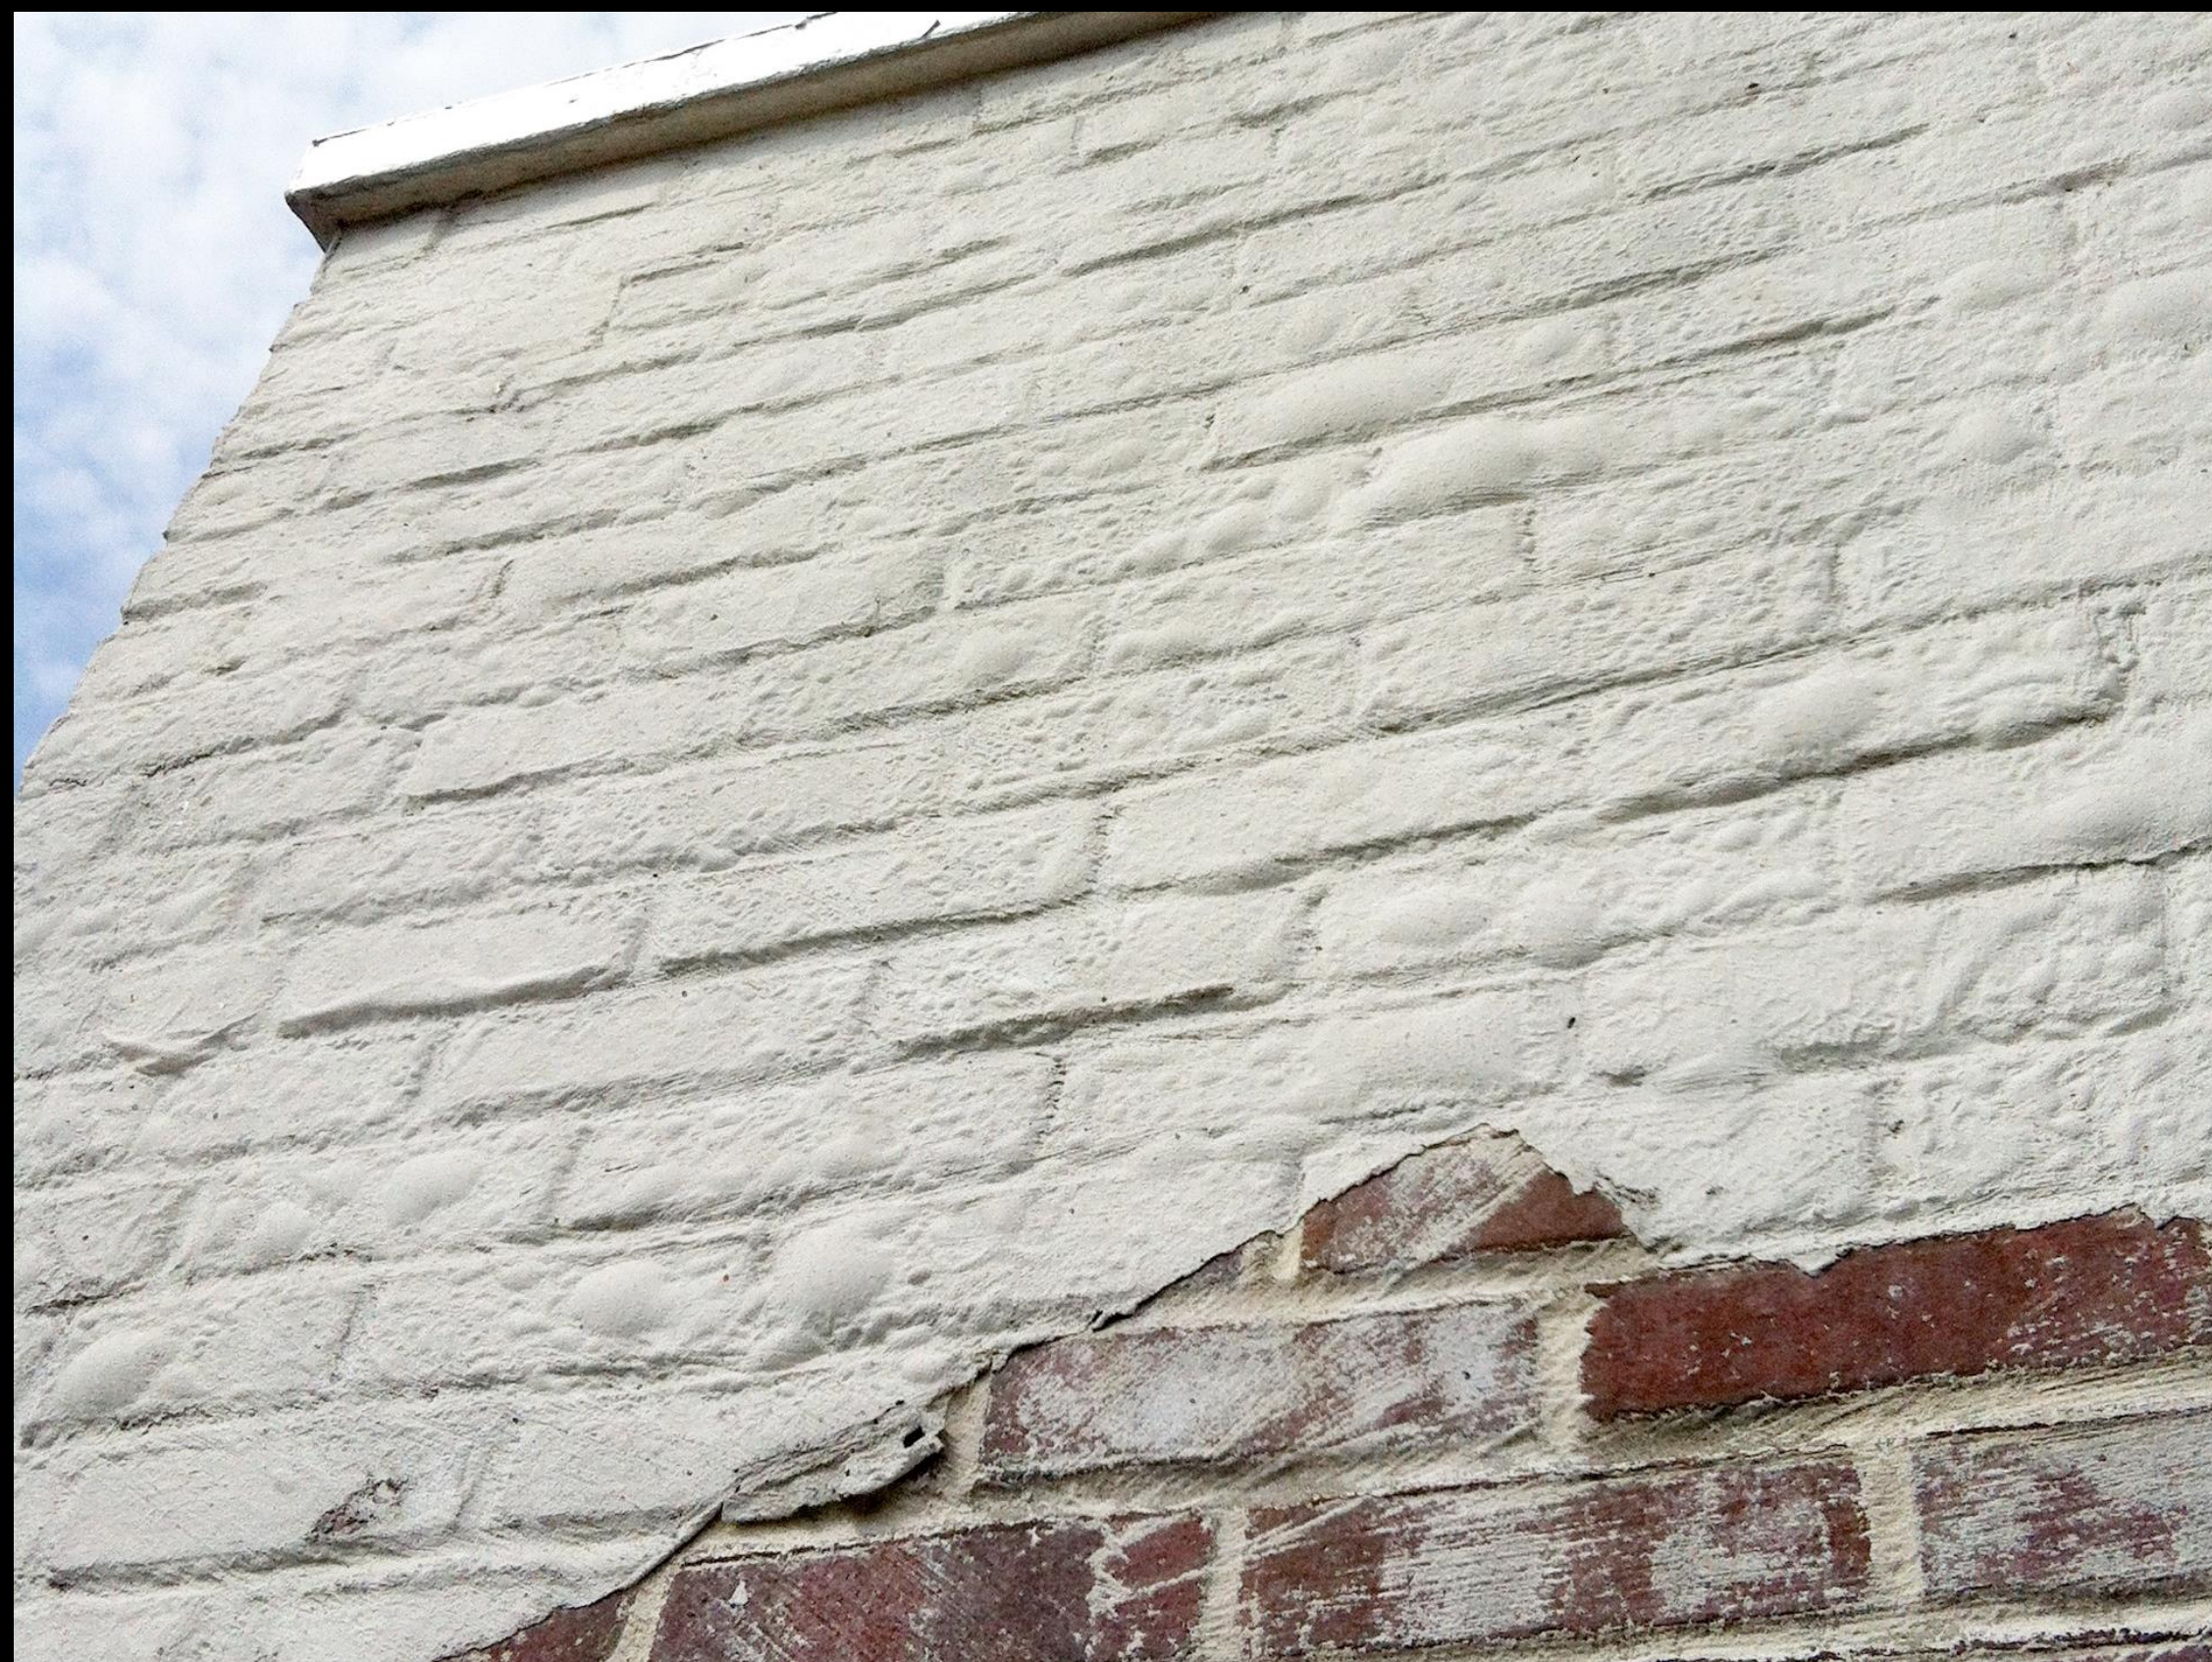
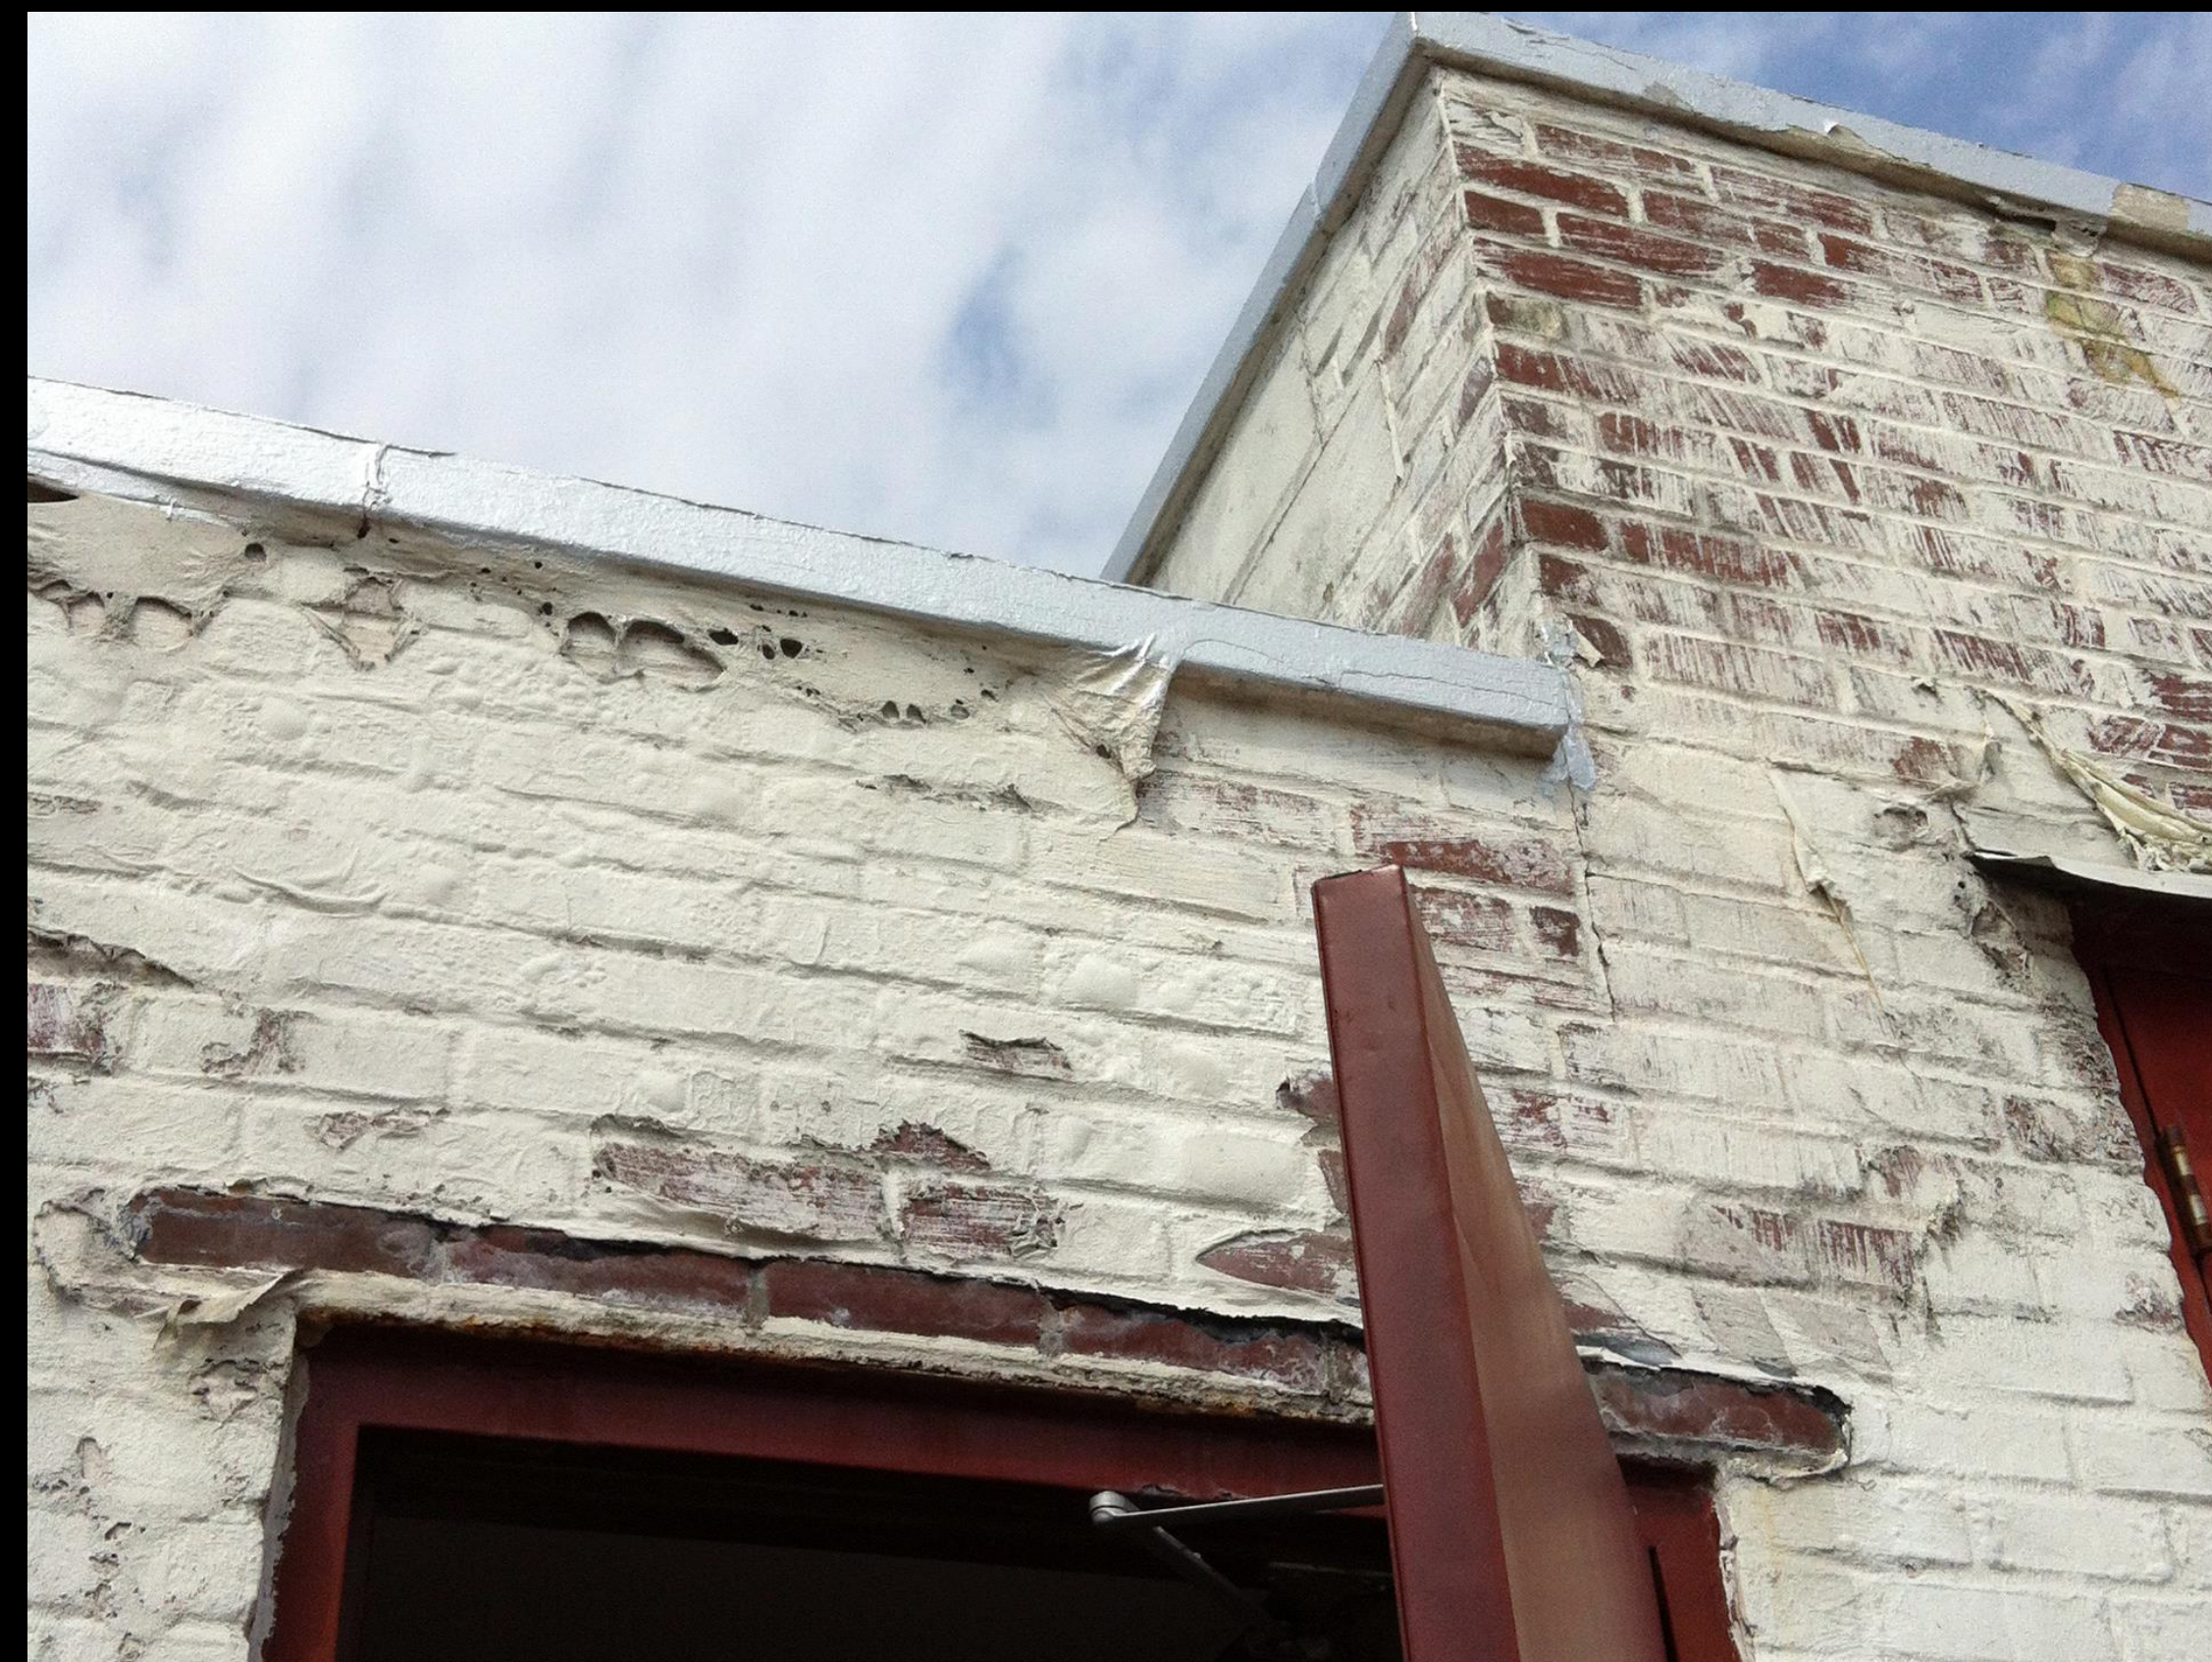
This is elastomeric *vapor open* paint working exactly as it should - it keeps the water out but also **keep it IN!**

This wall has been **in failure** since it was built in 1994.

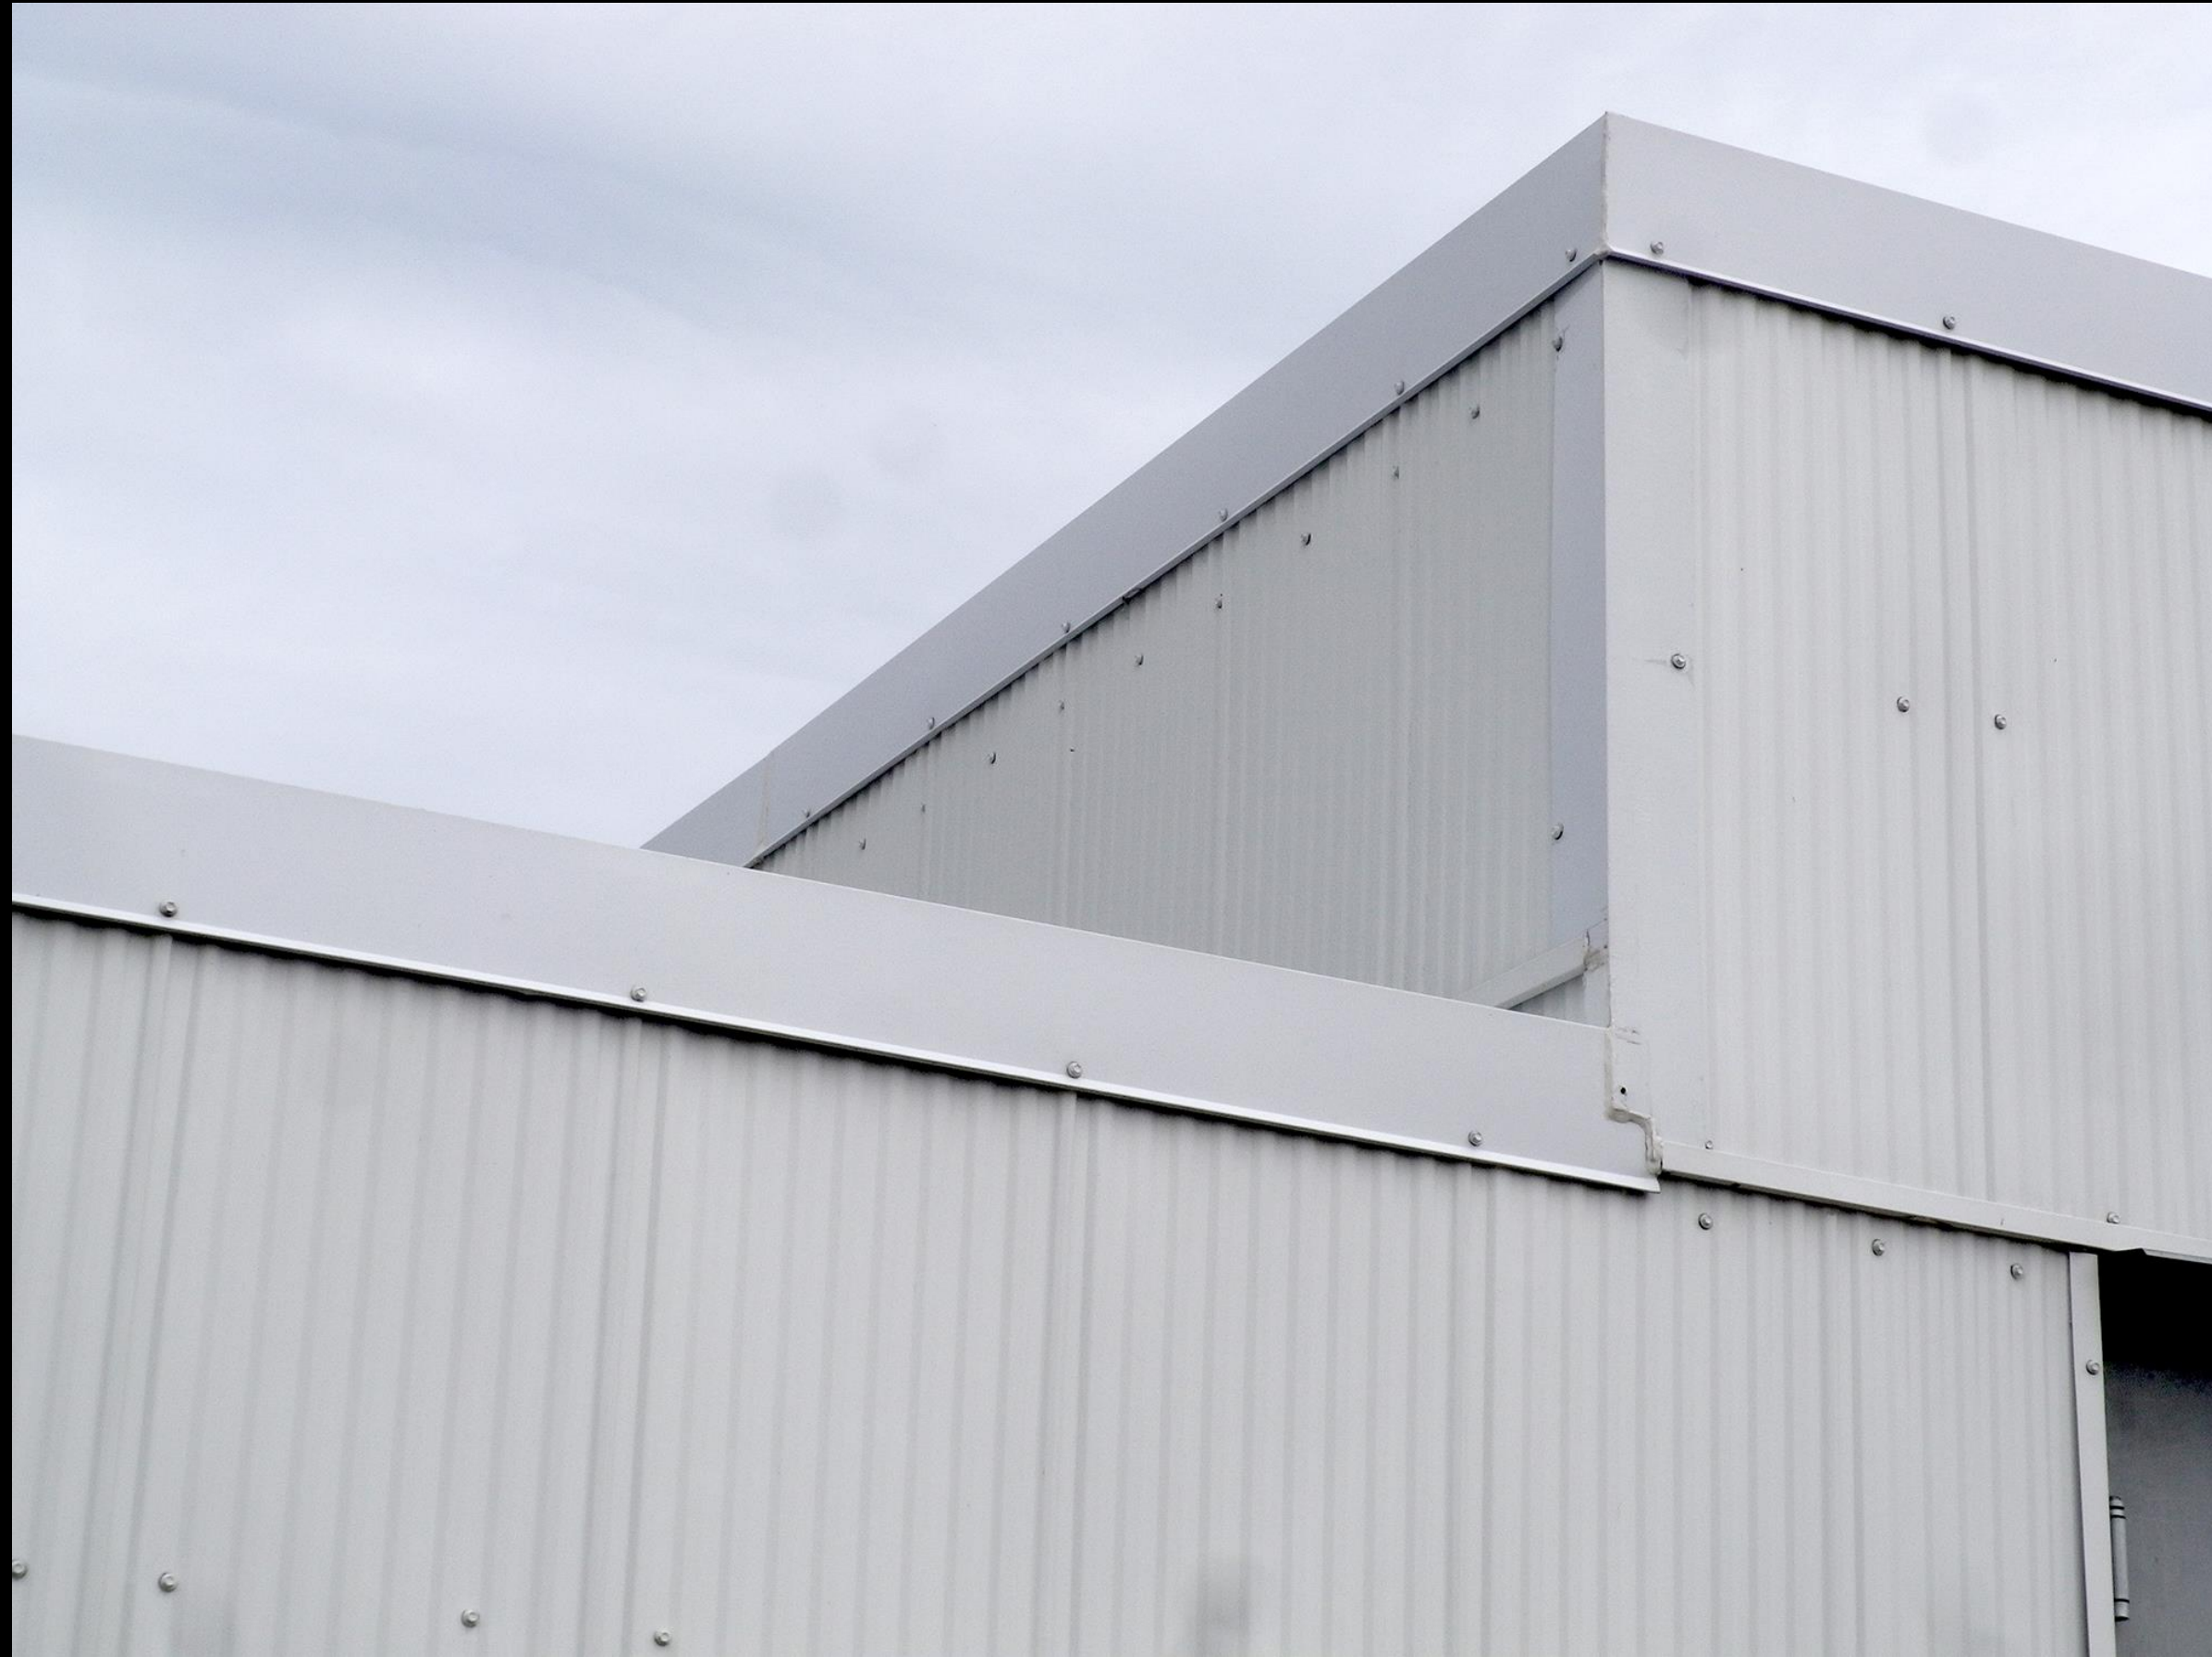
Cladding solves the problem. Maybe not too attractive but the wall is insulated and dry.

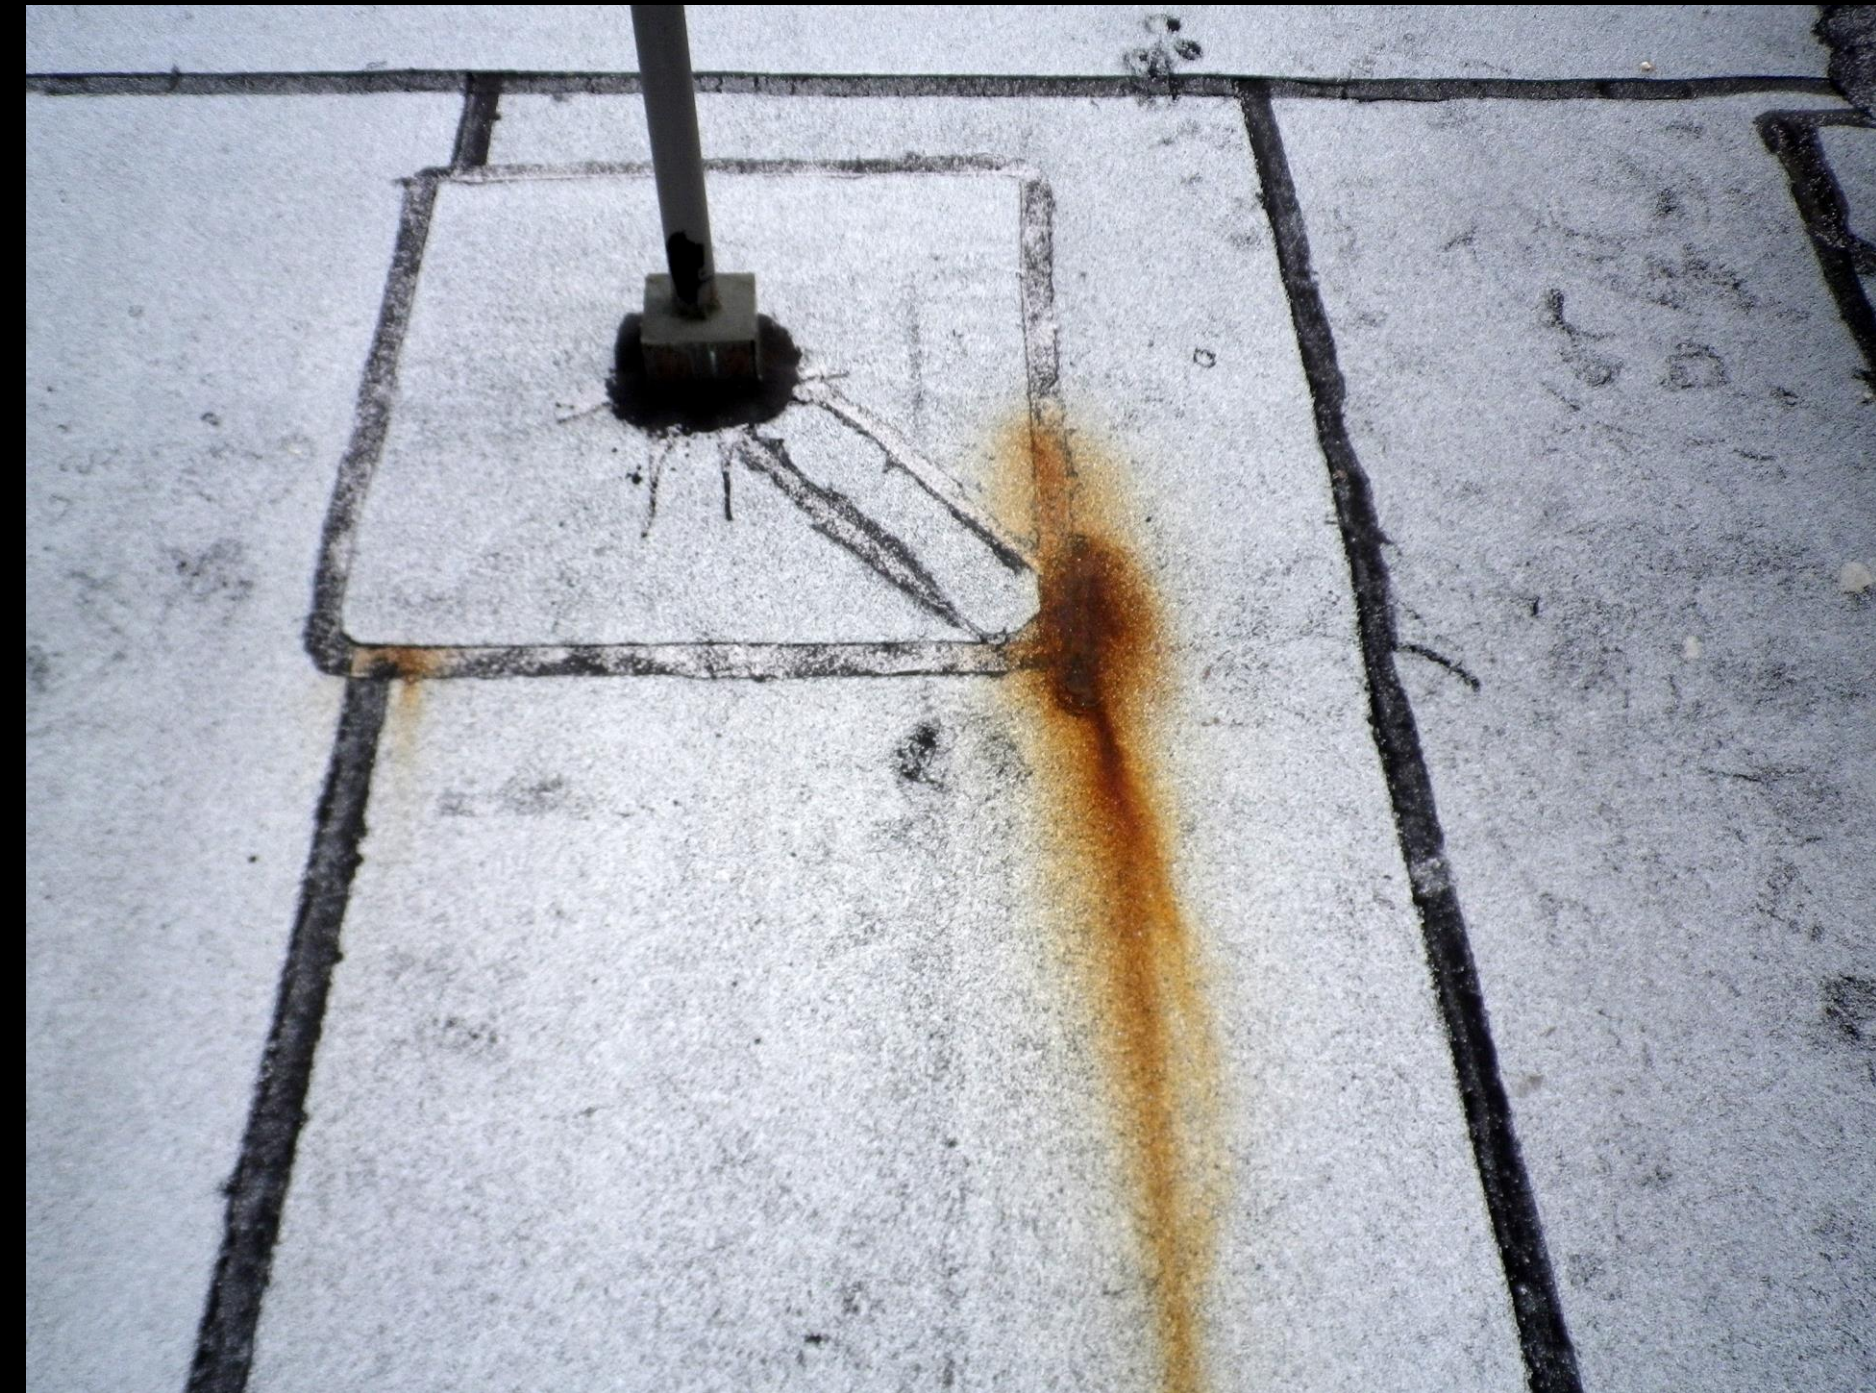
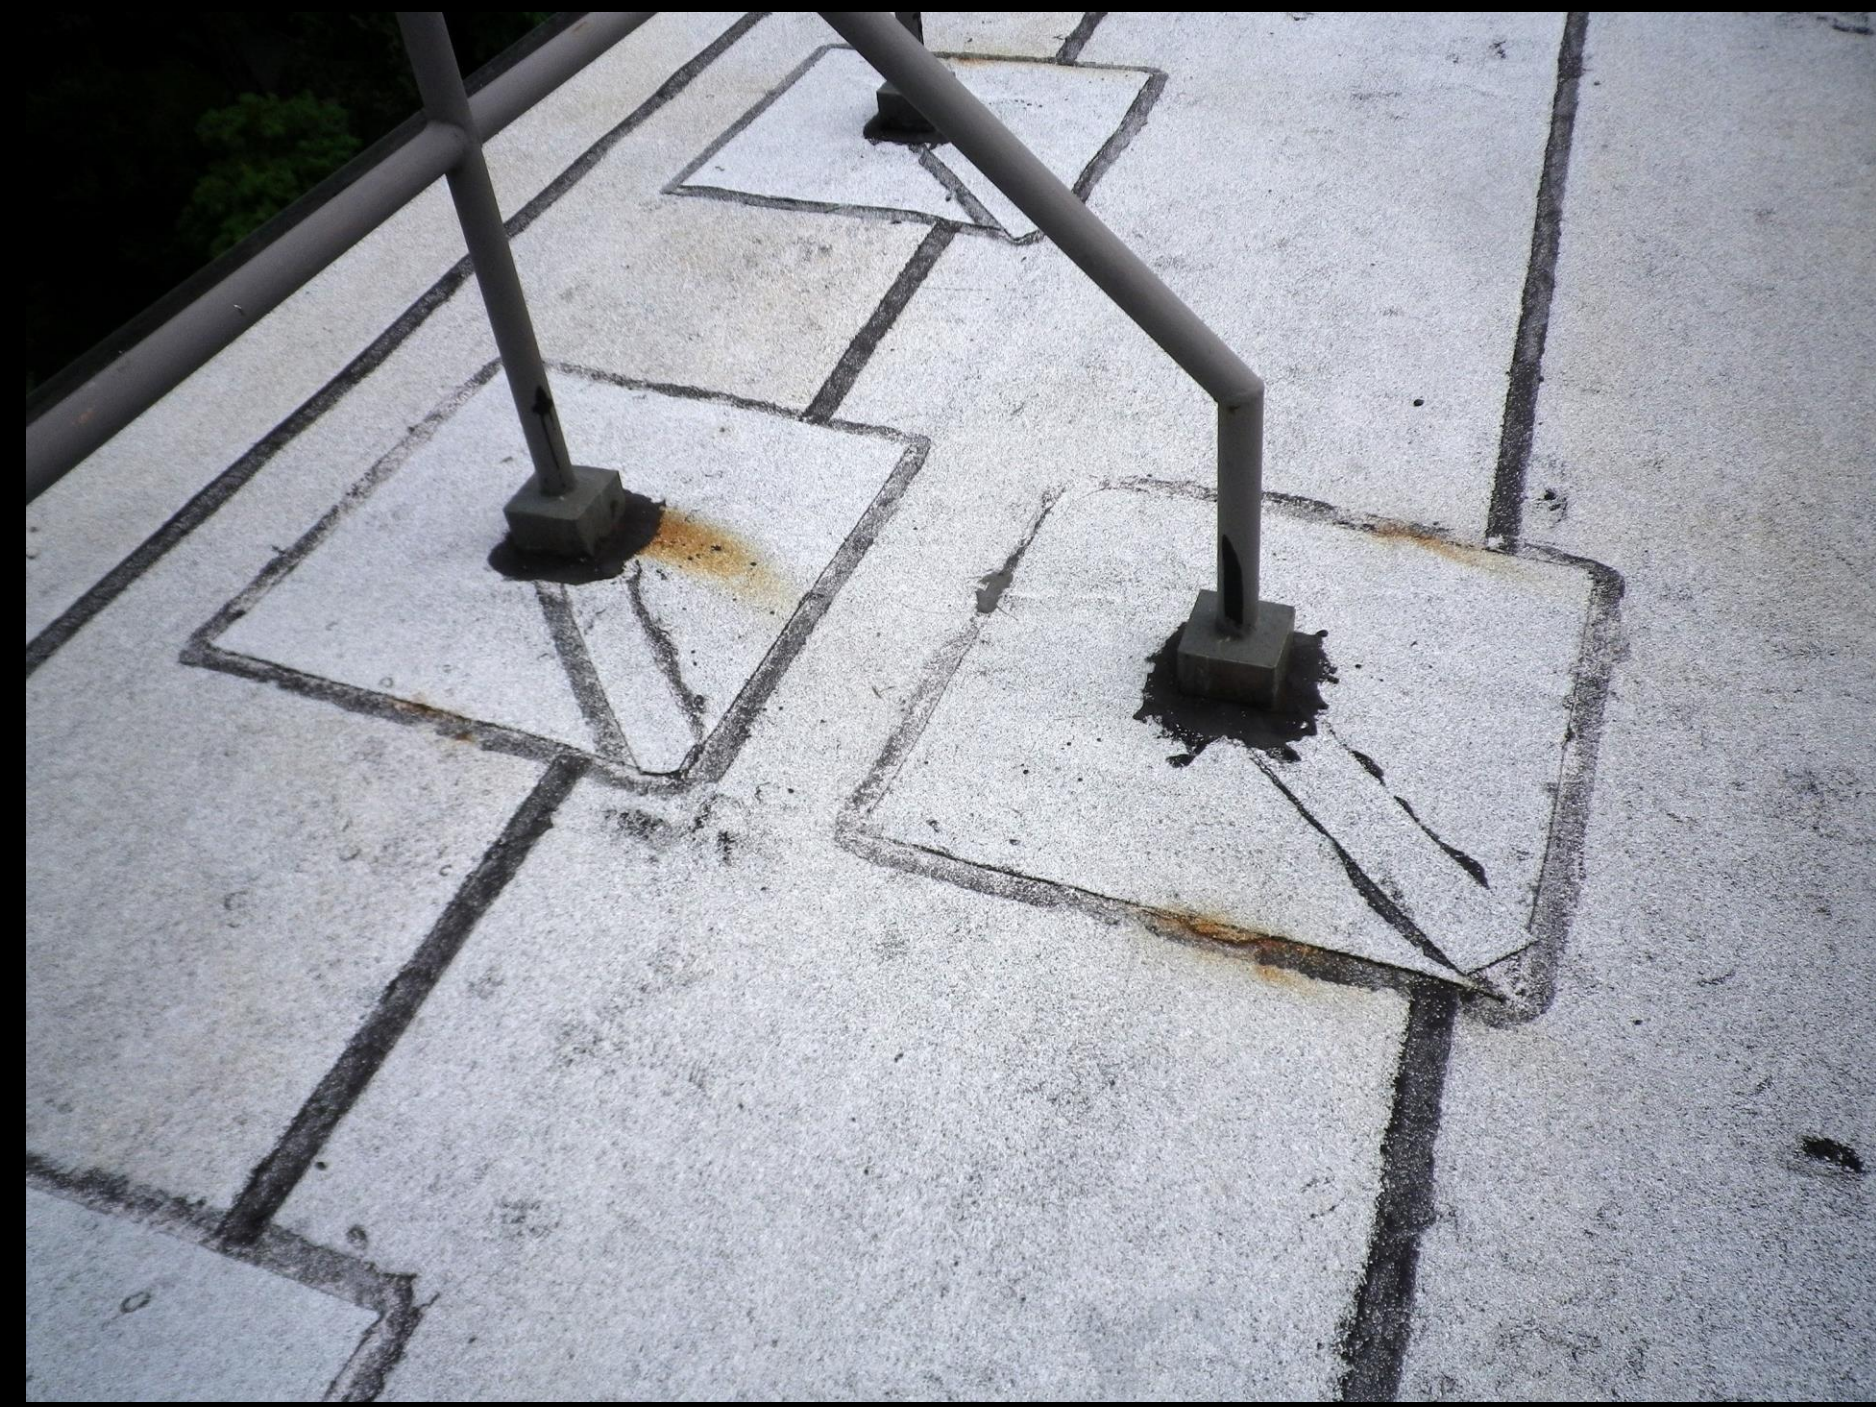
Typical Railing Details. Poor design. Poor execution. Lack of maintenance.
