ROOFING REALITIES NESEA March 2016

IT'S ALL IN THE DETAILS

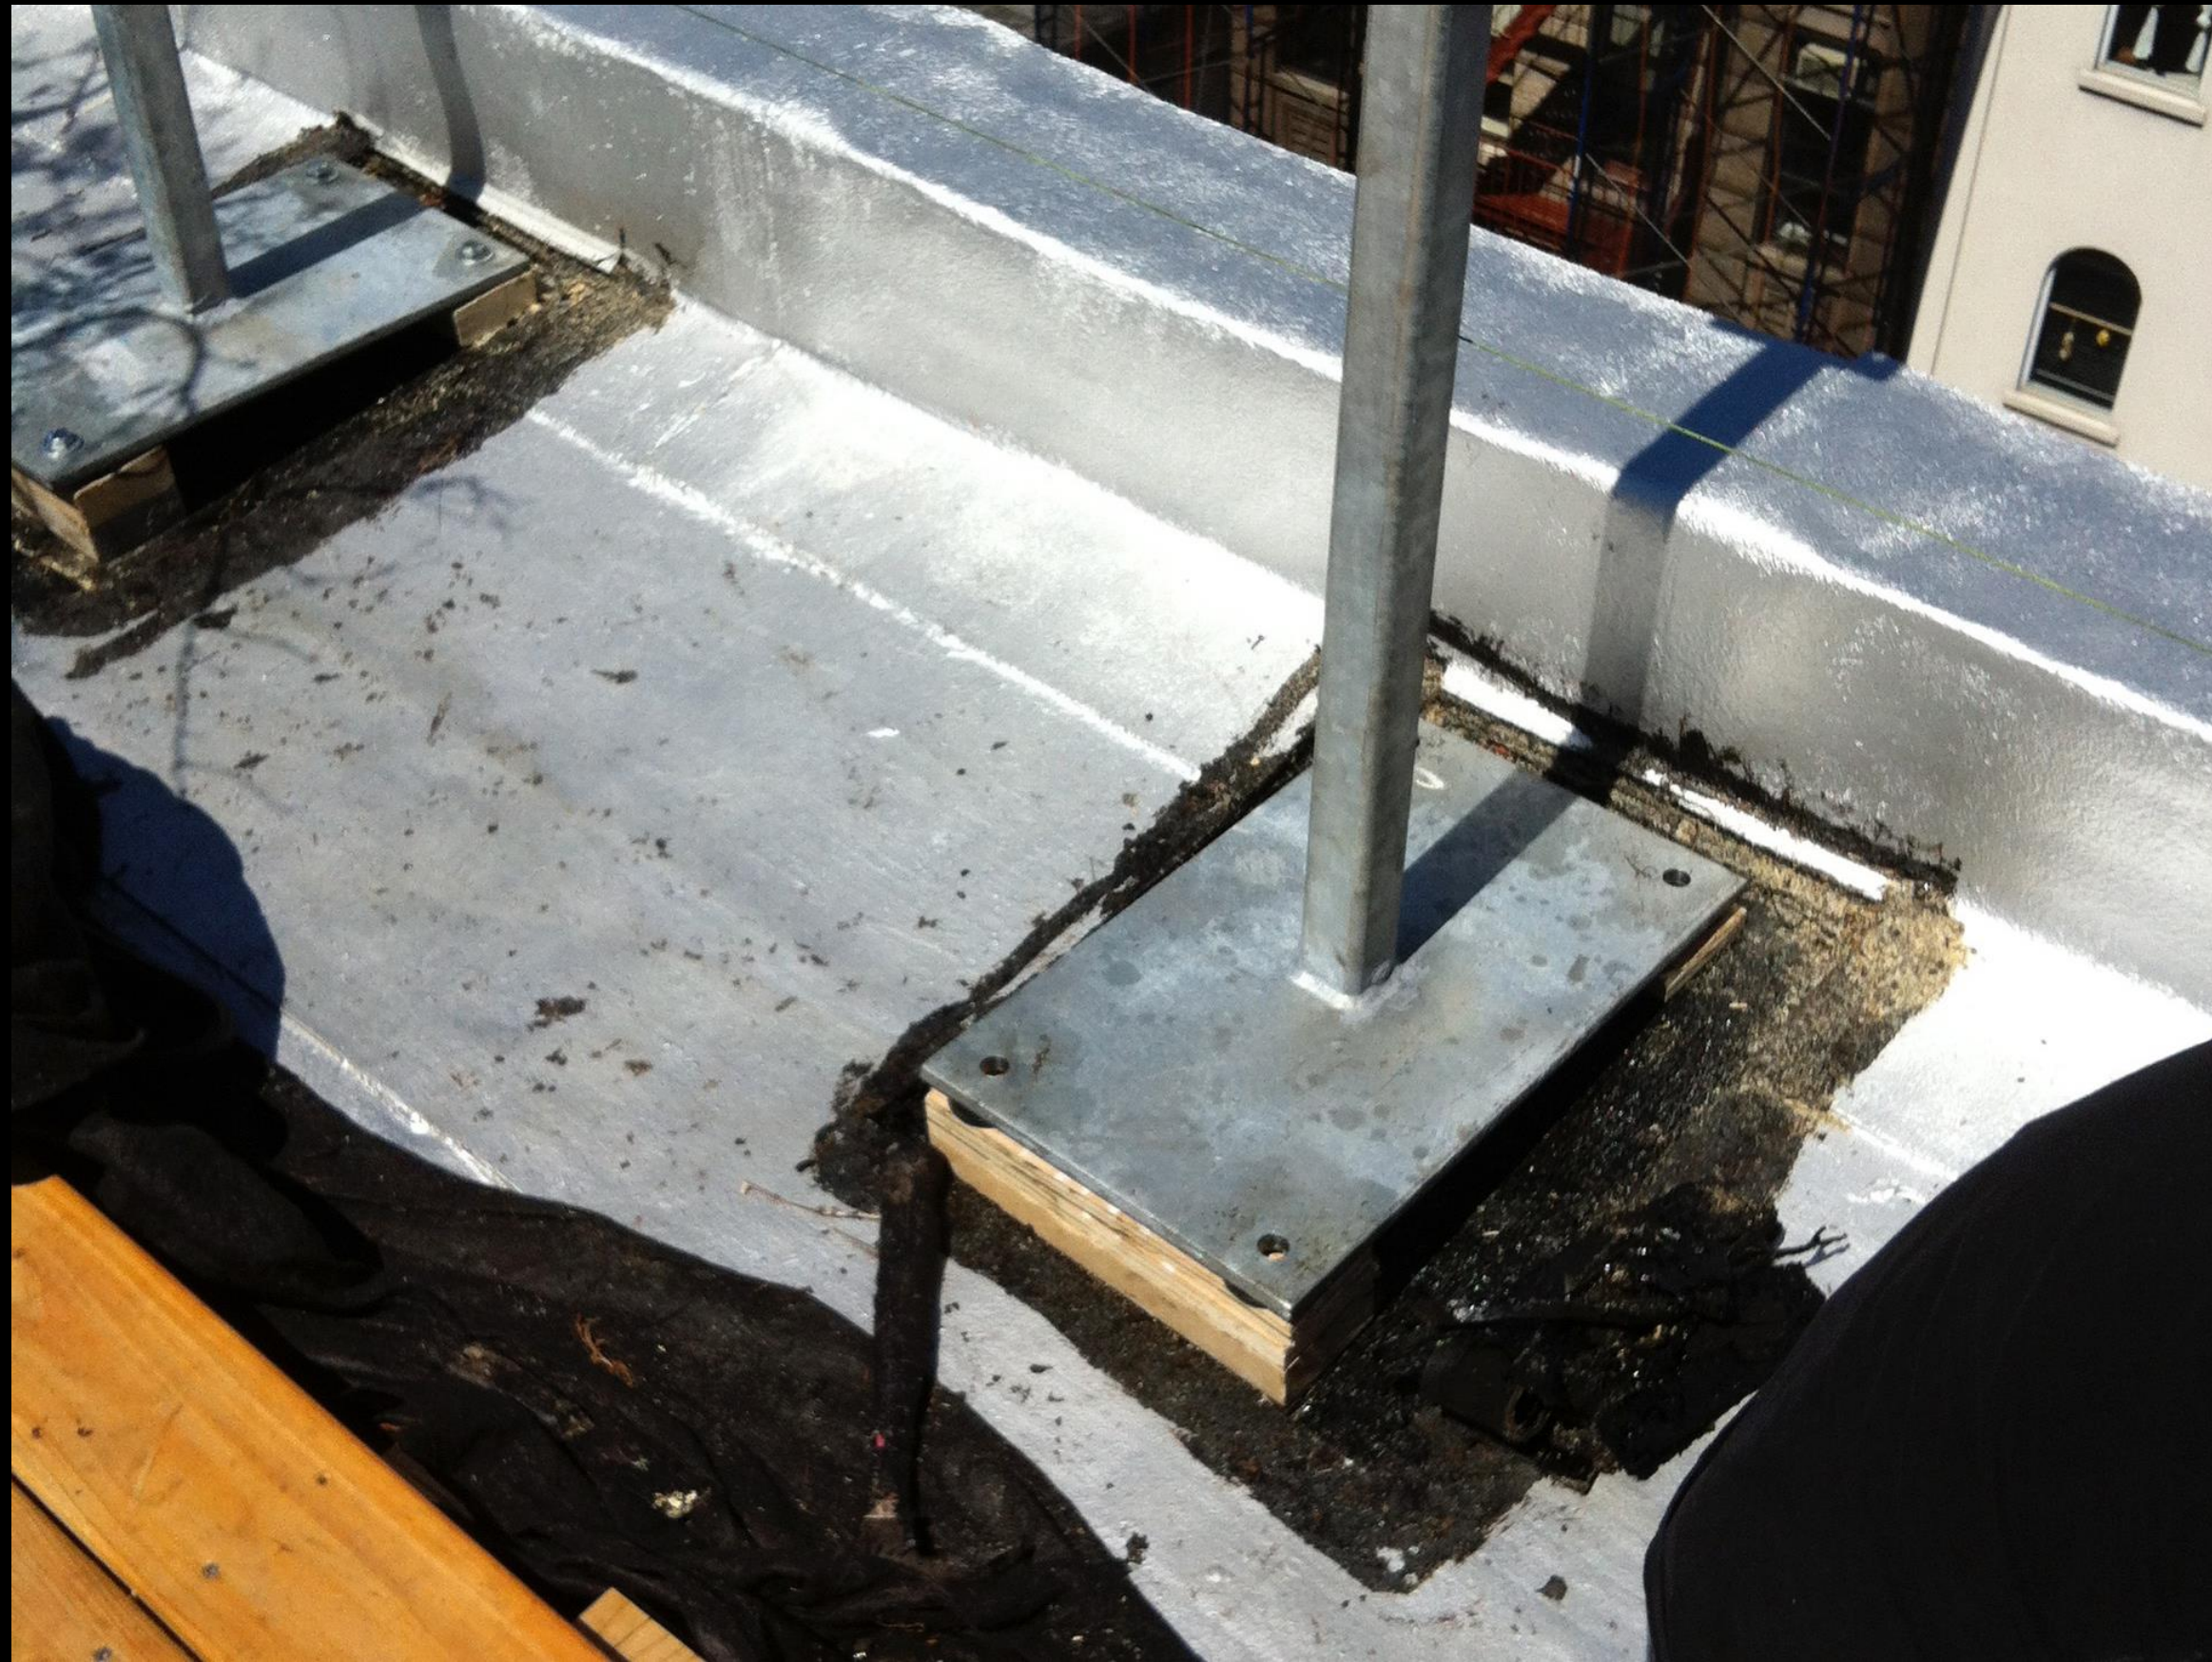
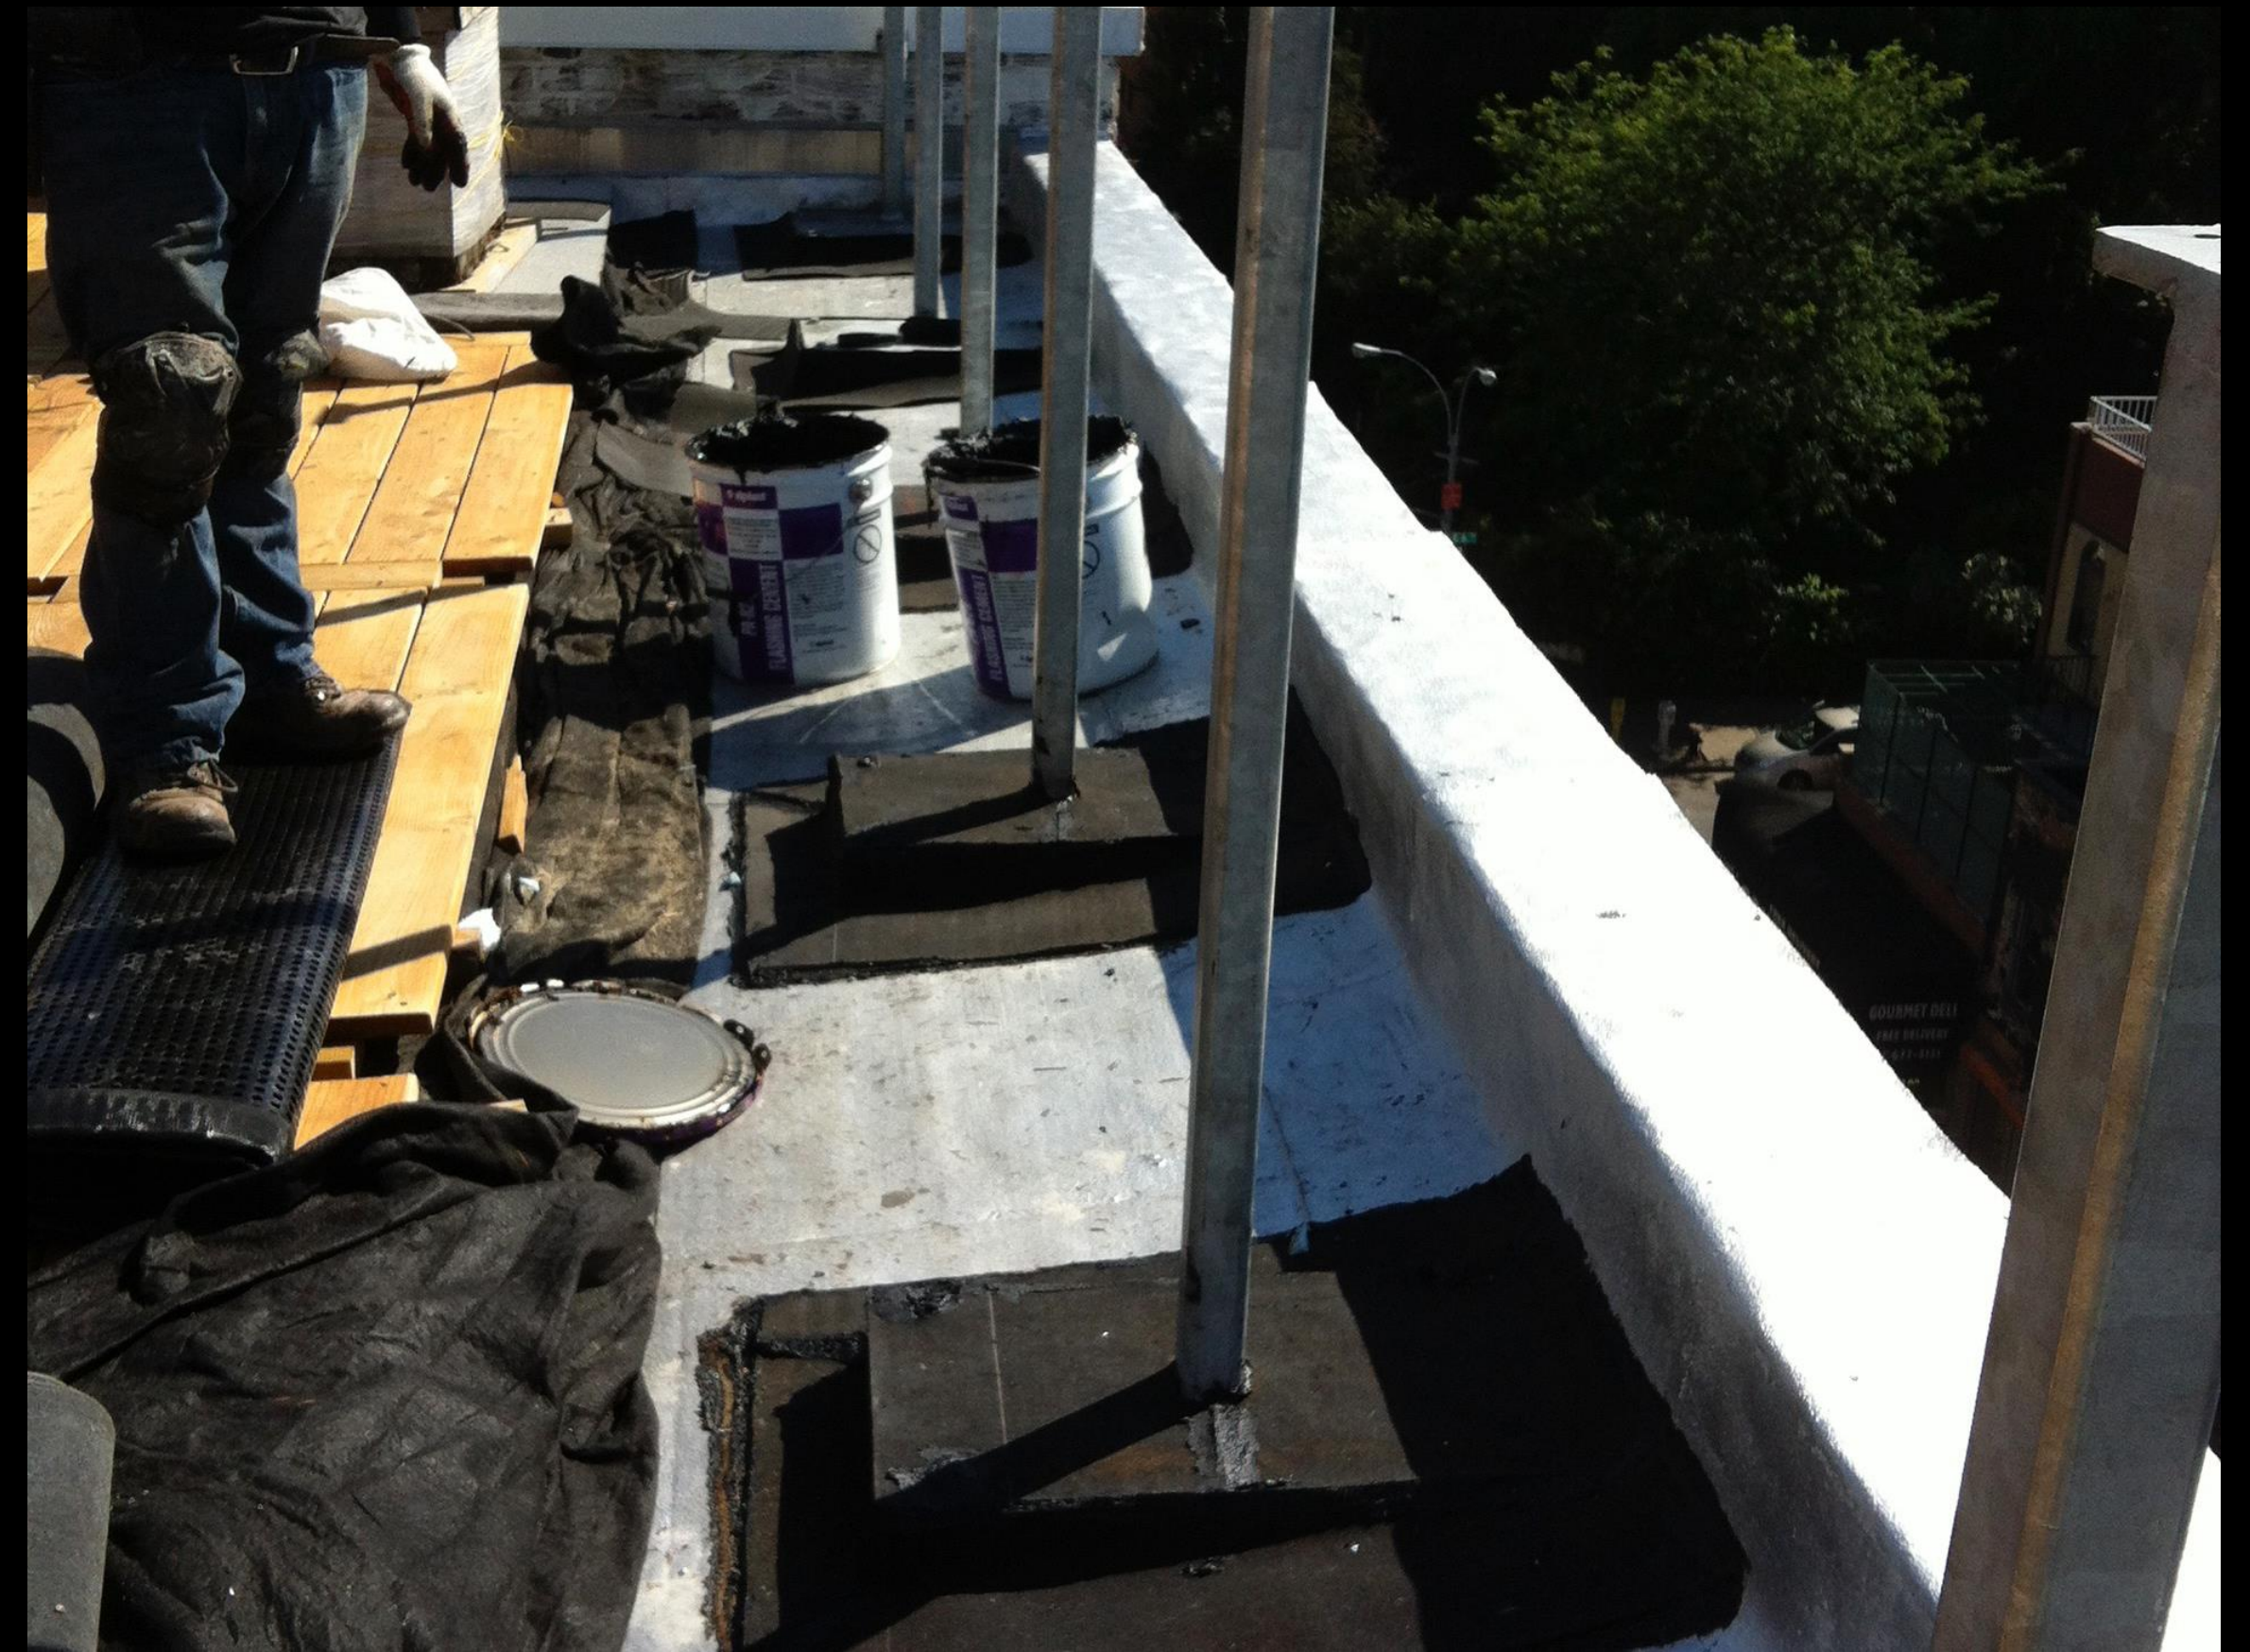
One Large Connection Point.

No outriggers. No pitch pockets. No maintenance issues. Long term durability

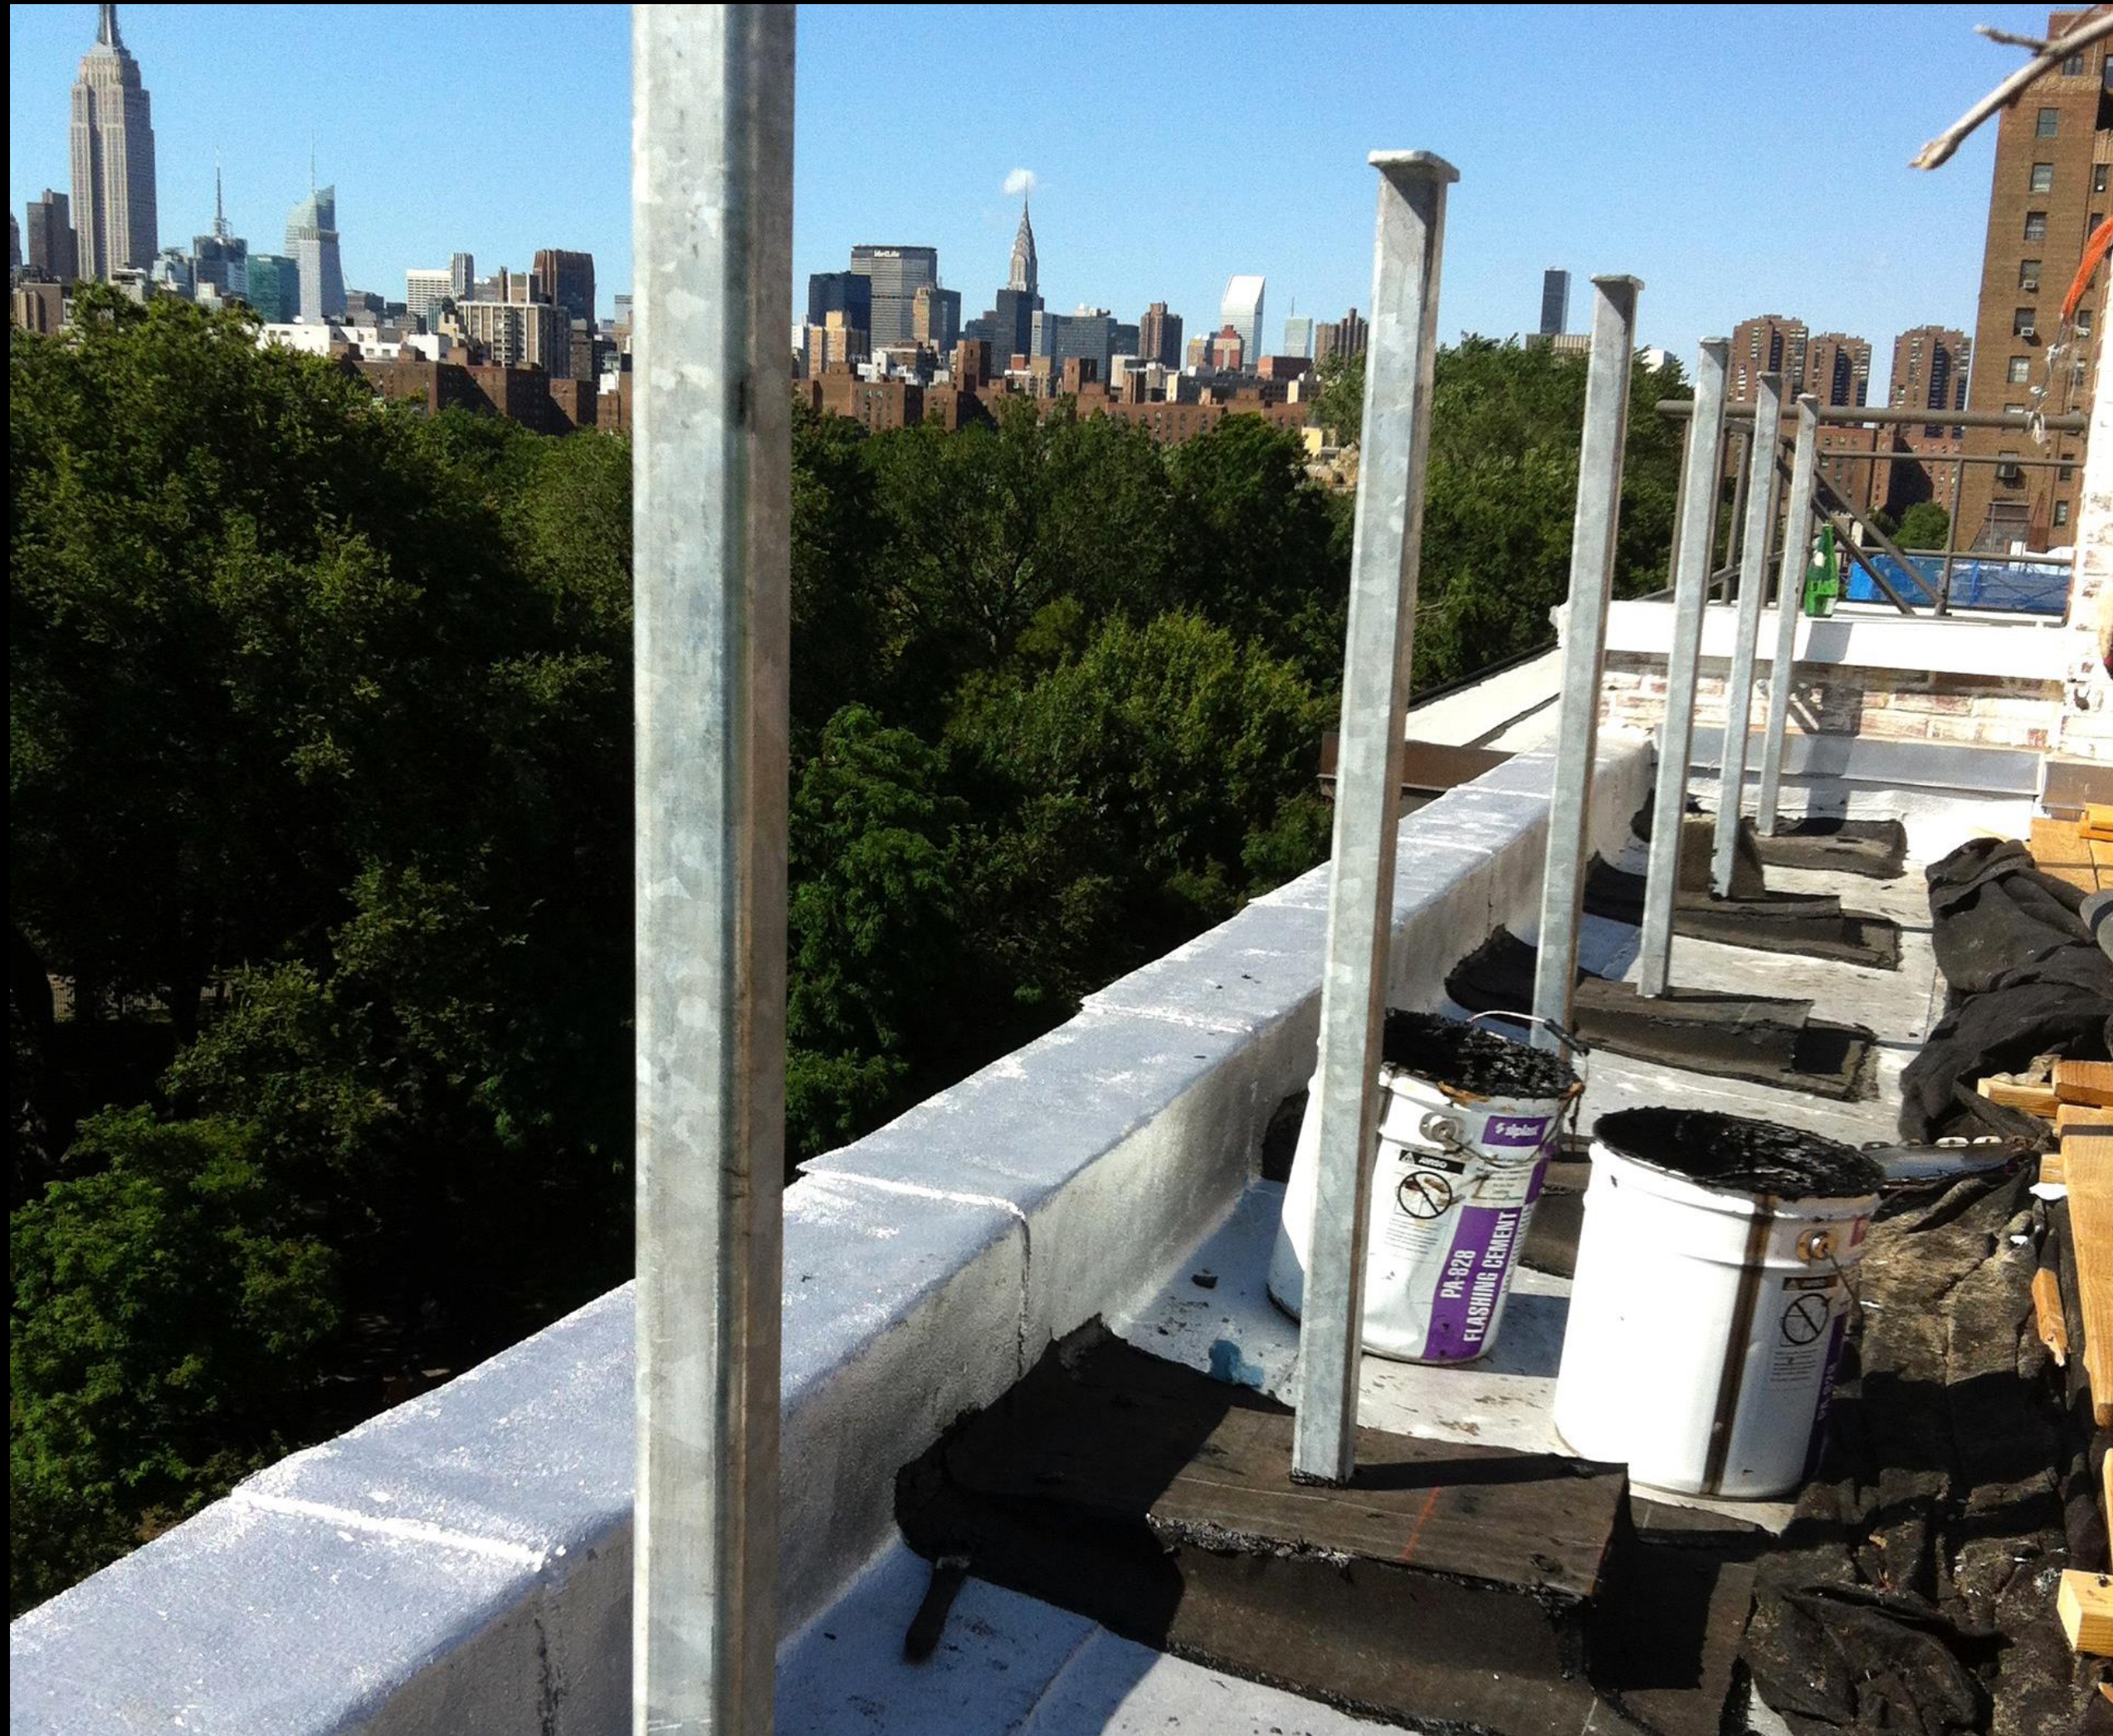
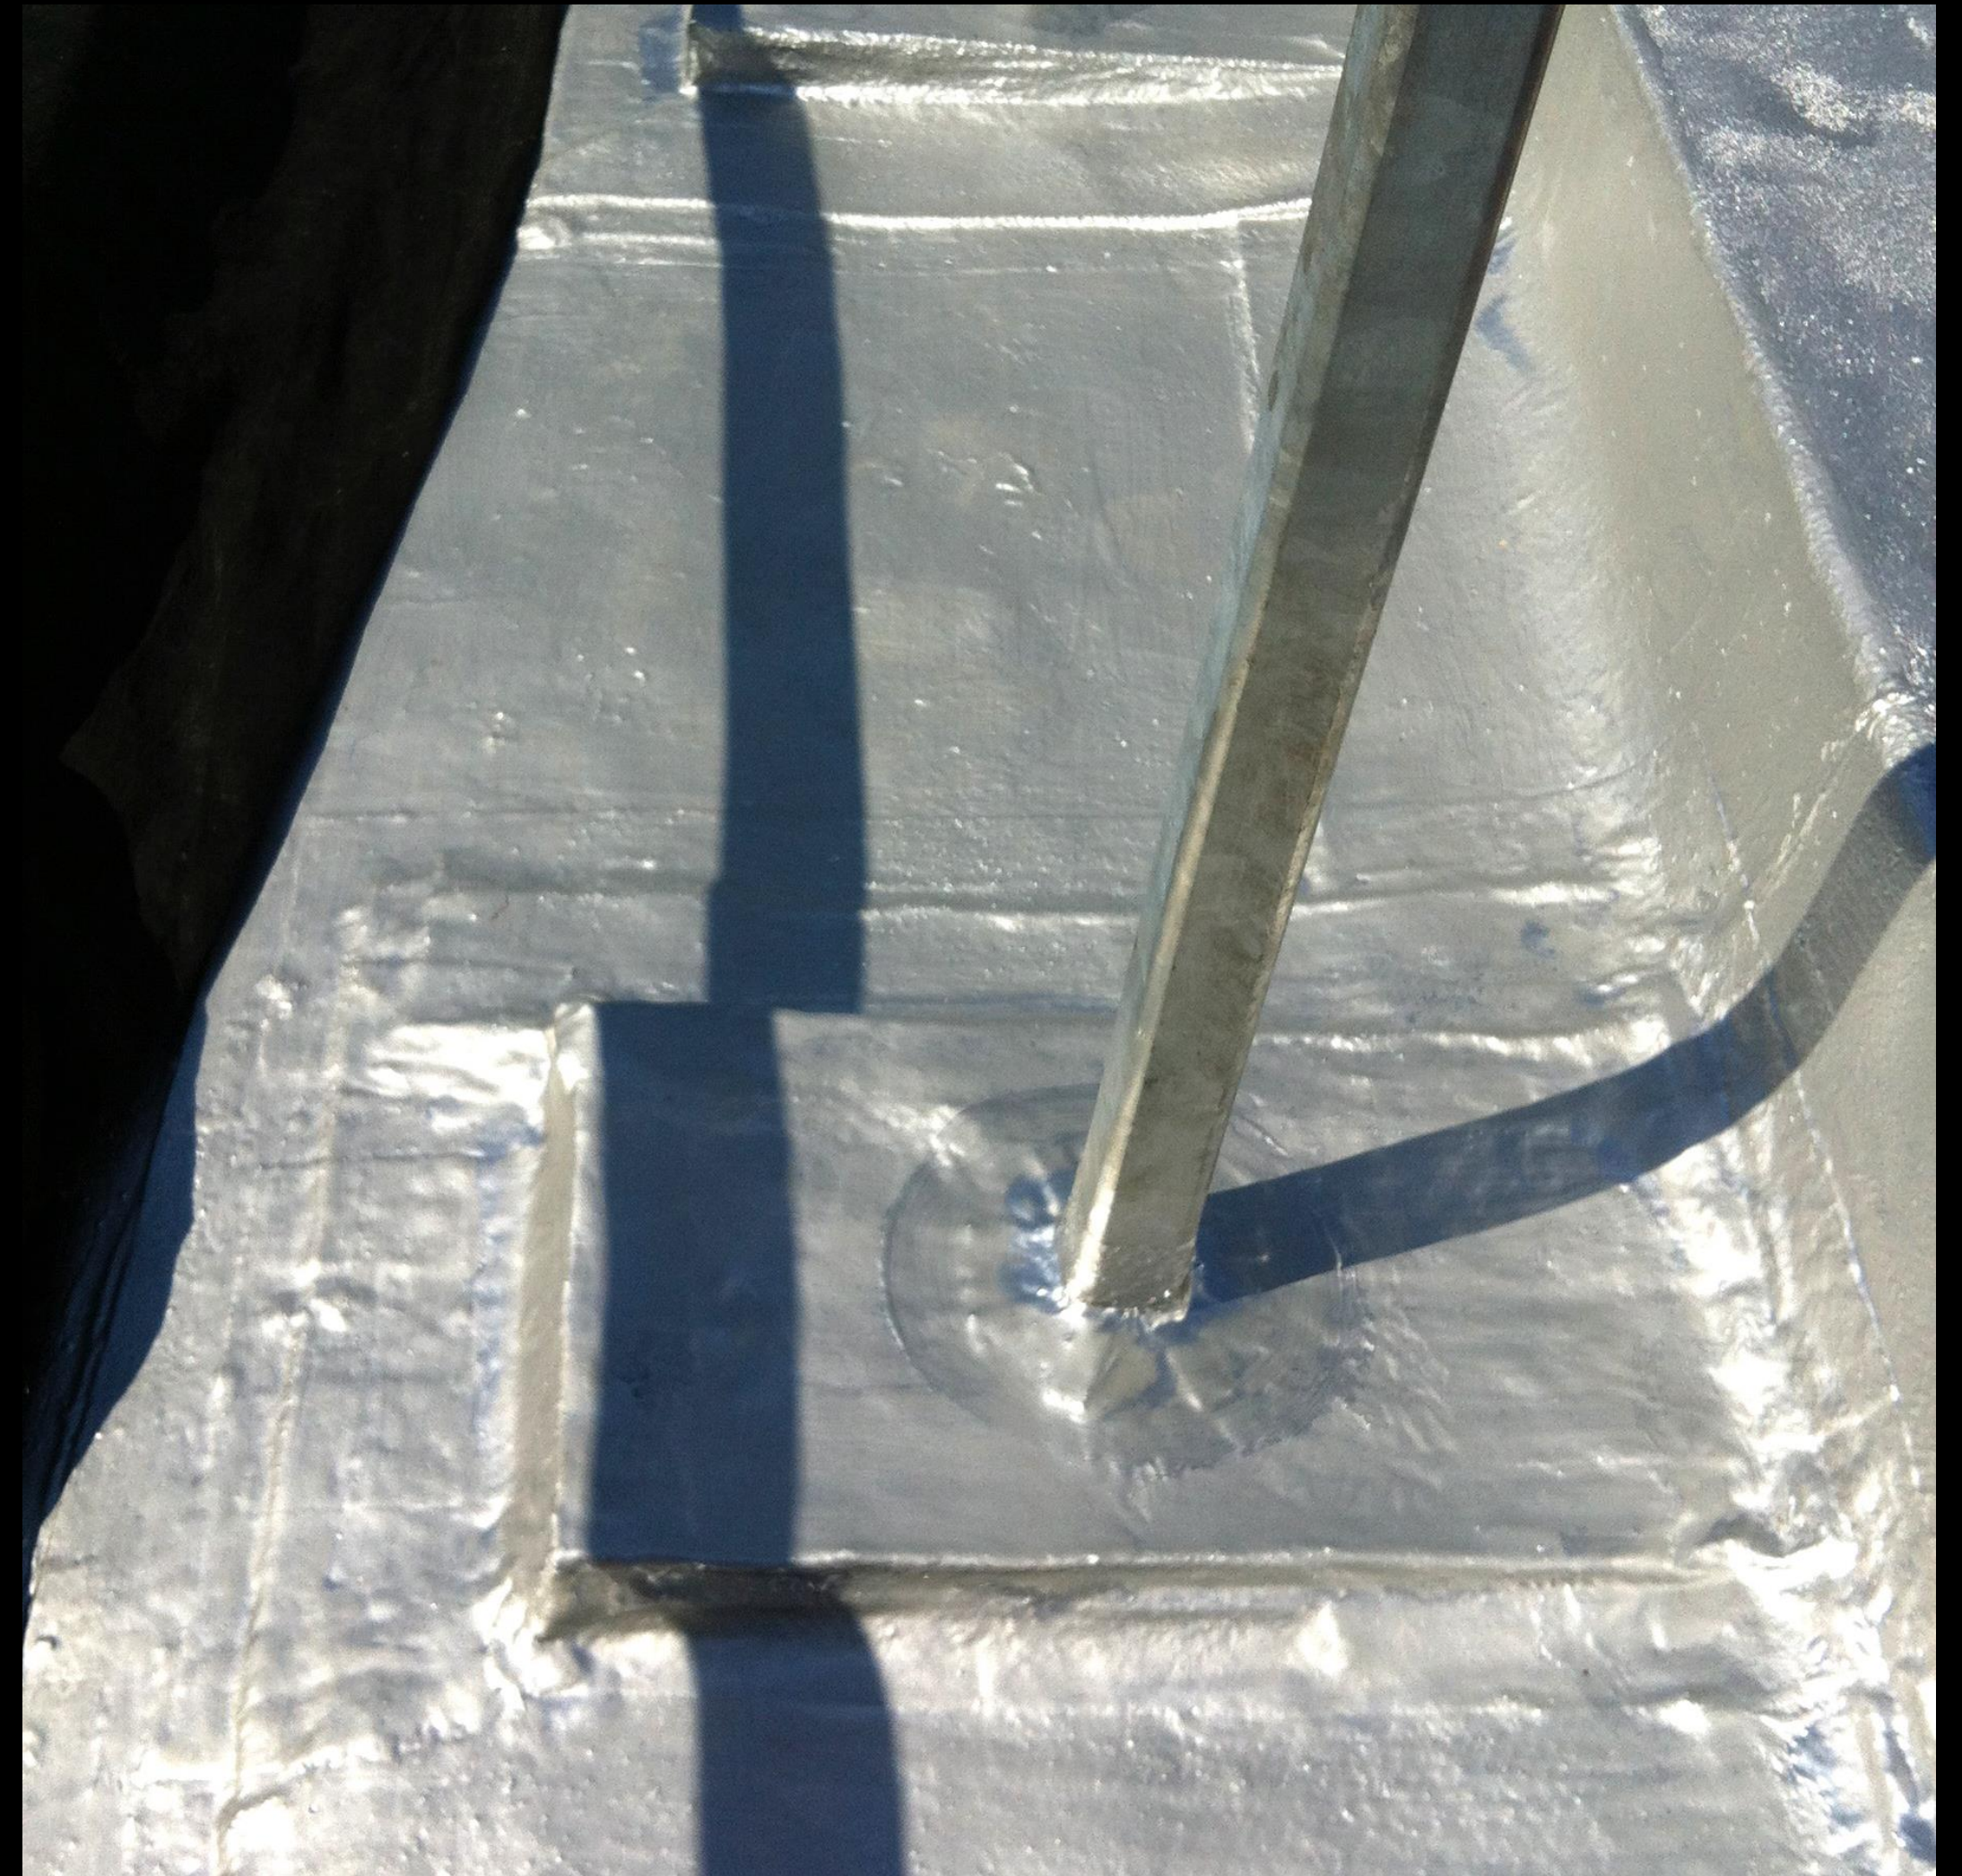
Two coats of liquid roofing applied over post base and over entire new roof membrane. **Building in longevity.**

Rebuilt masonry parapet with peel and stick membrane under aluminum capping and core drilled posts.

All steel was prefabricated and then sent to galvanizer and bolted together on site. No welding on site.

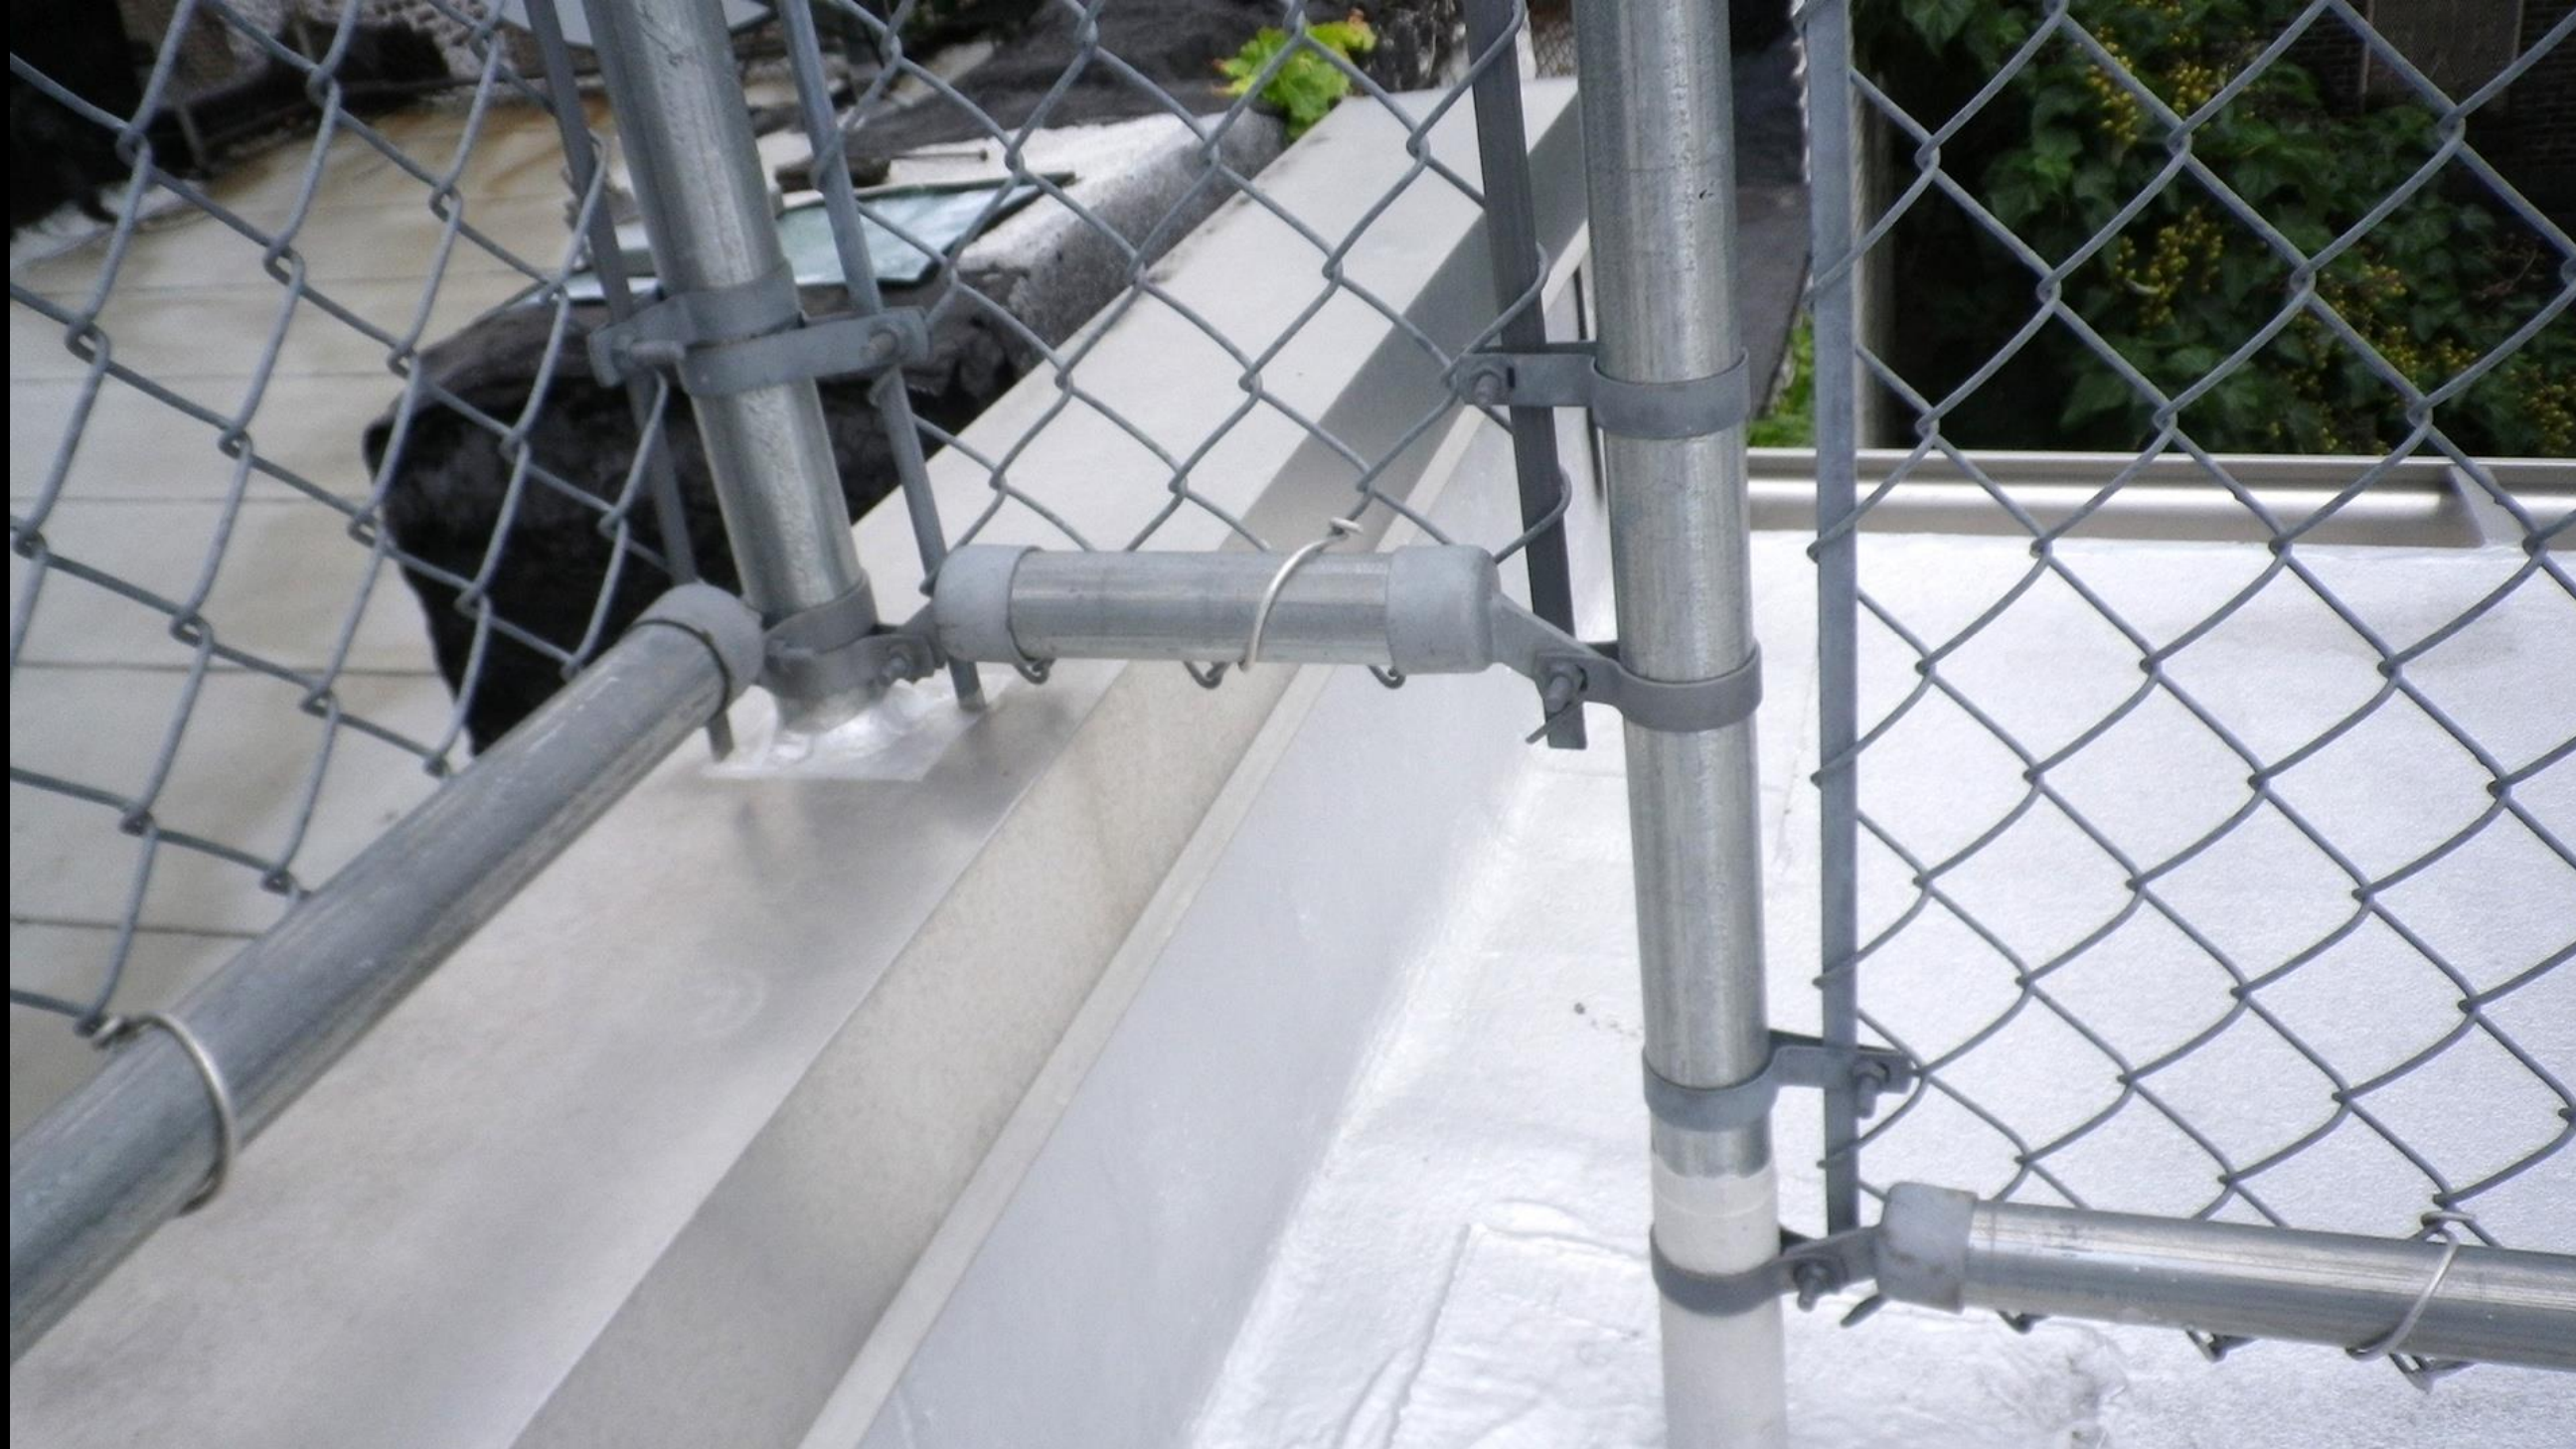
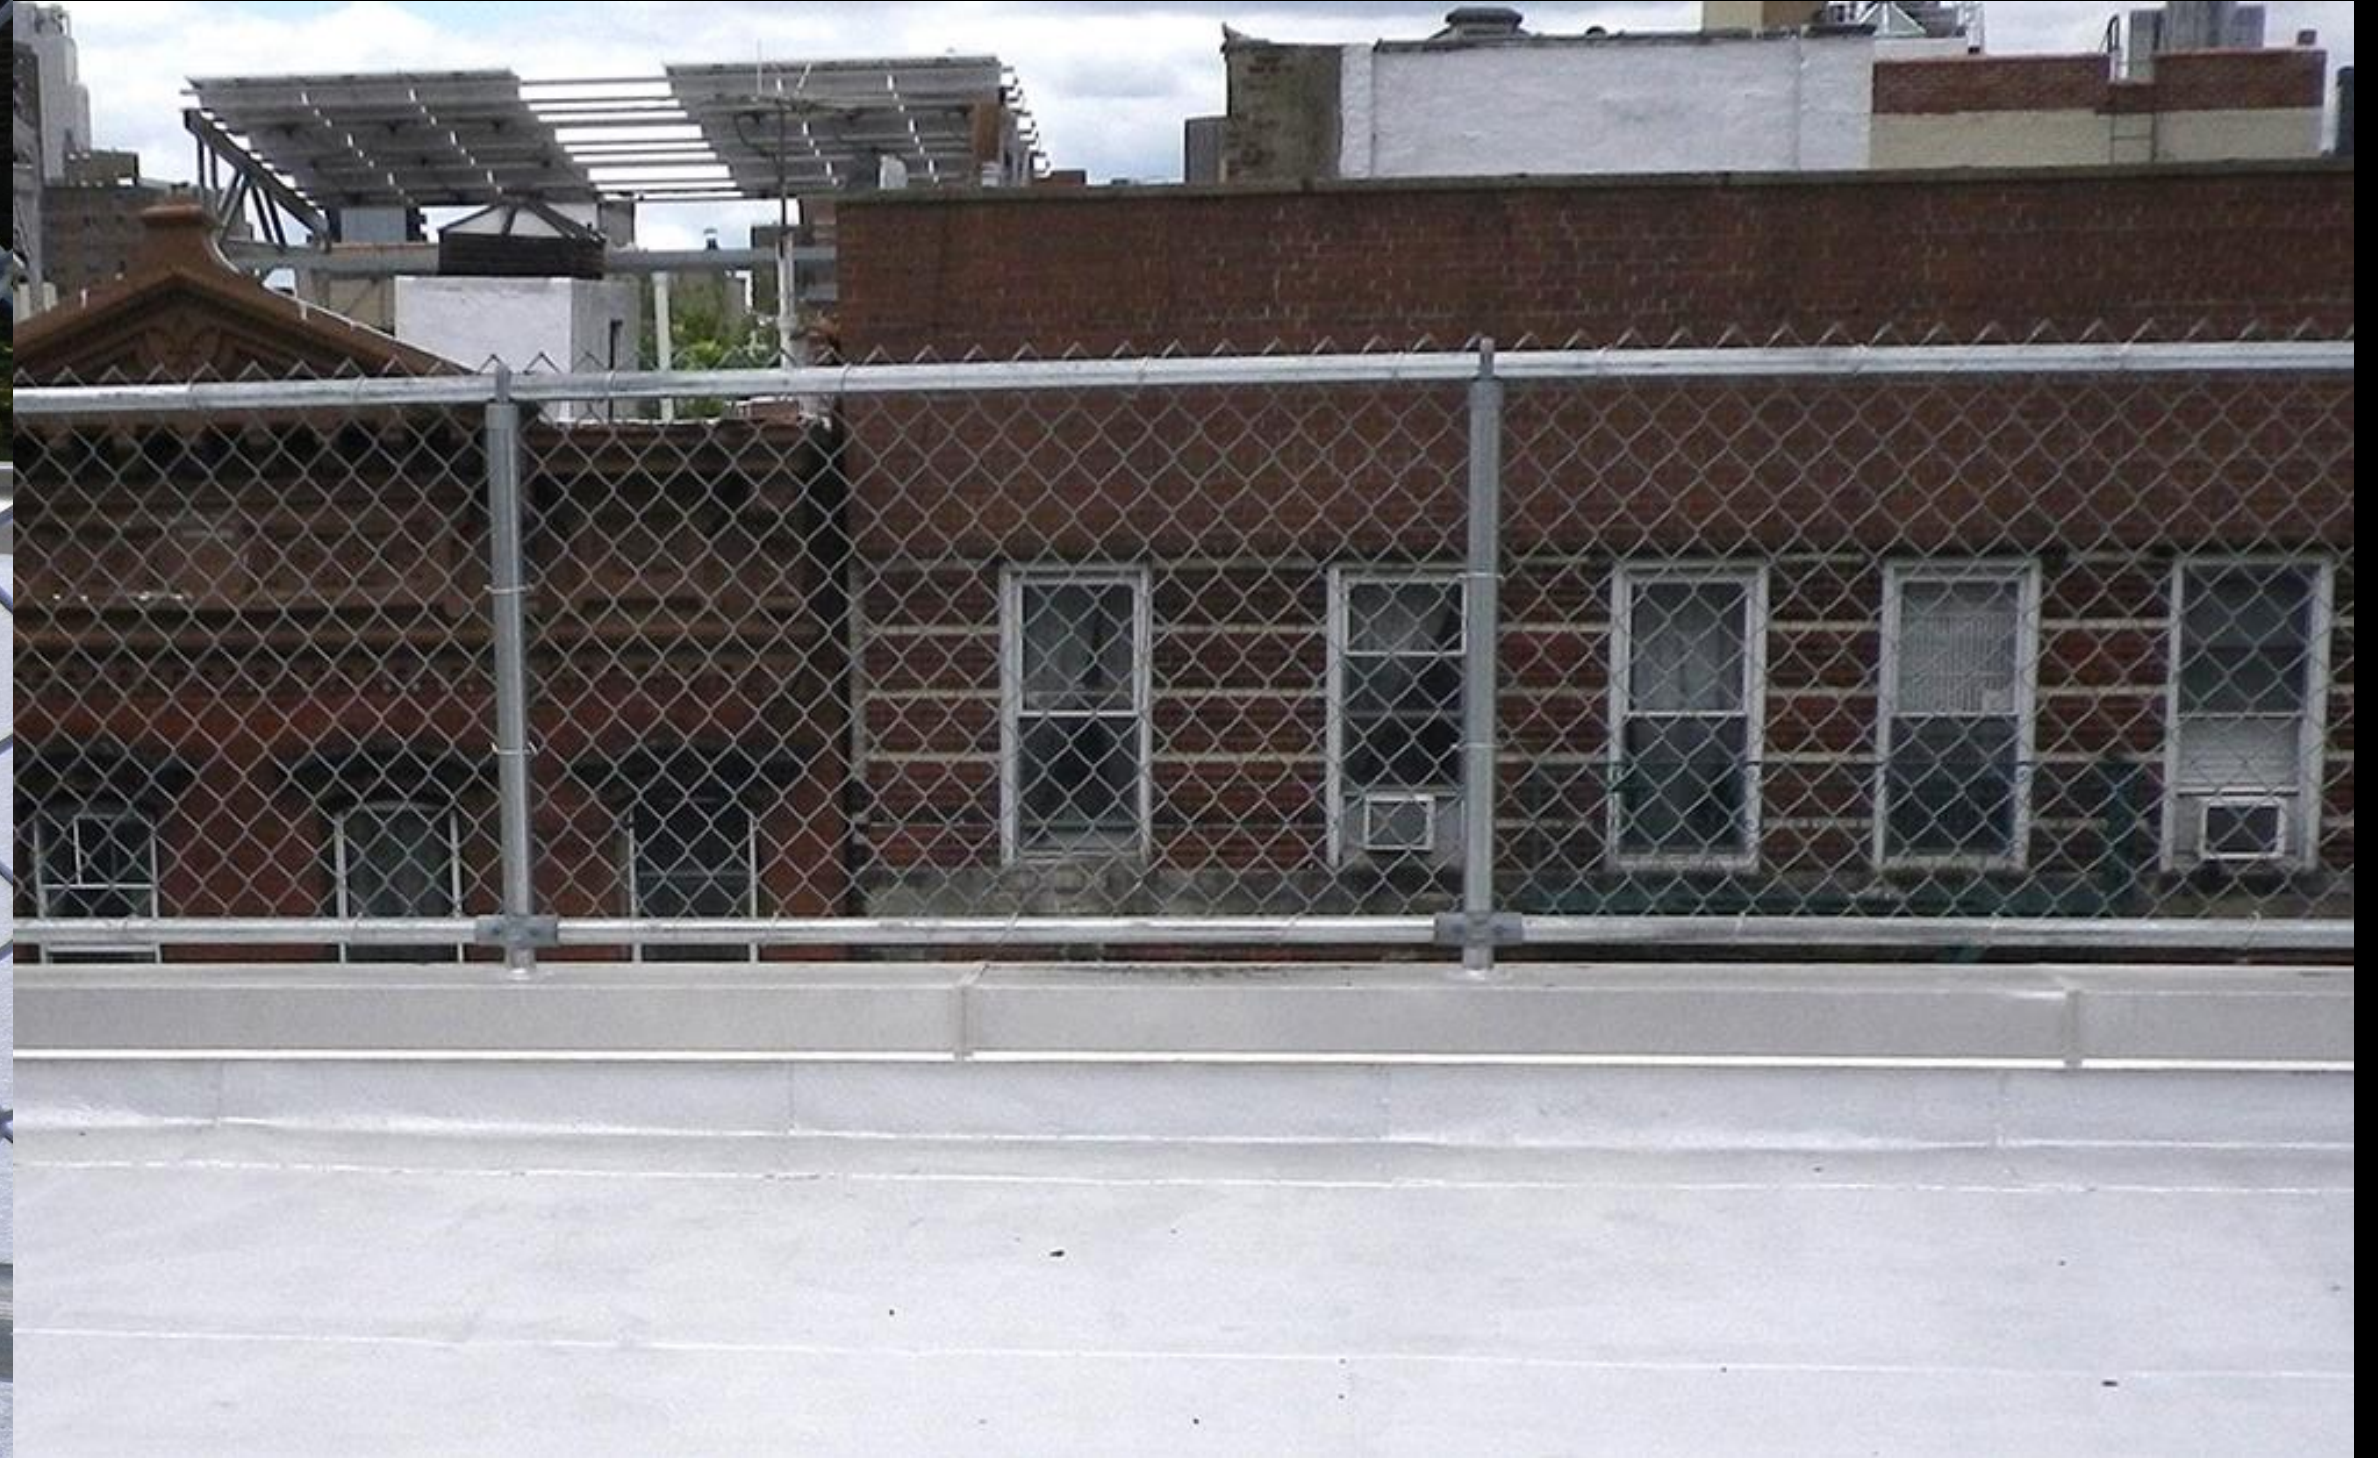
Less expensive detail. New railing posts in solid masonry. Liquid applied membrane eliminating pitch pockets.
