ROOFING REALITIES NESEA March 2016

IT'S ALL IN THE DETAILS

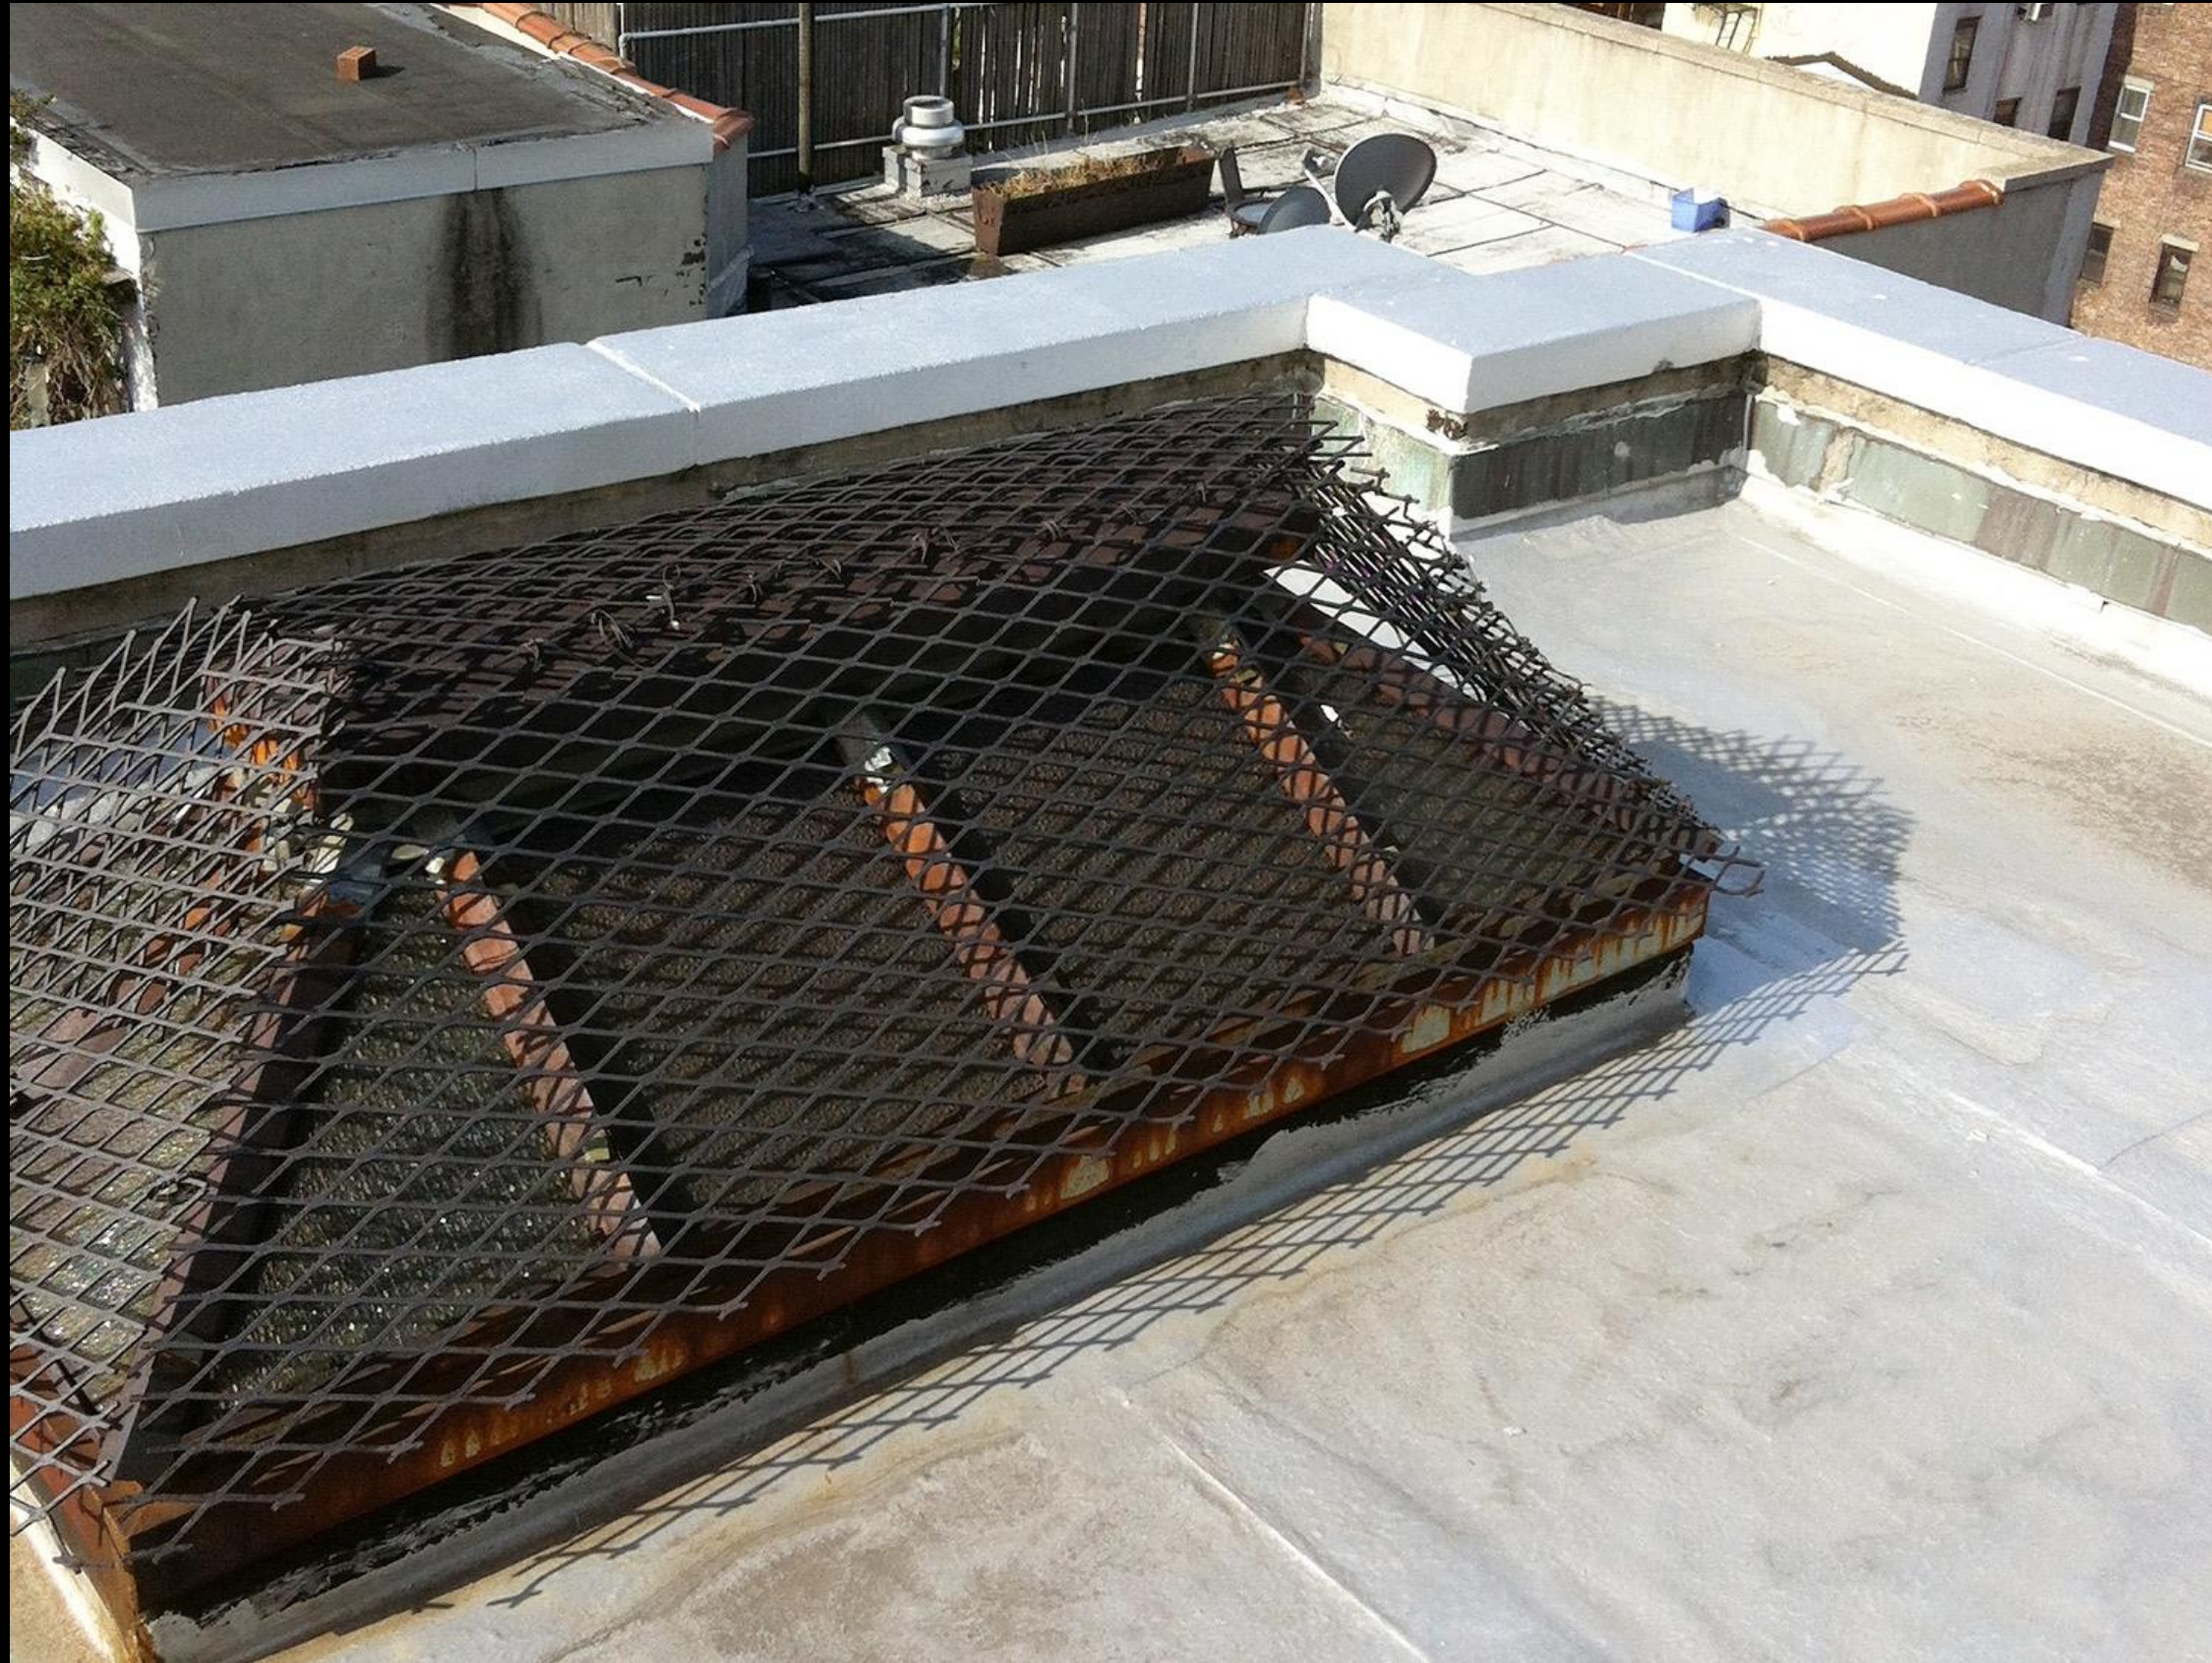
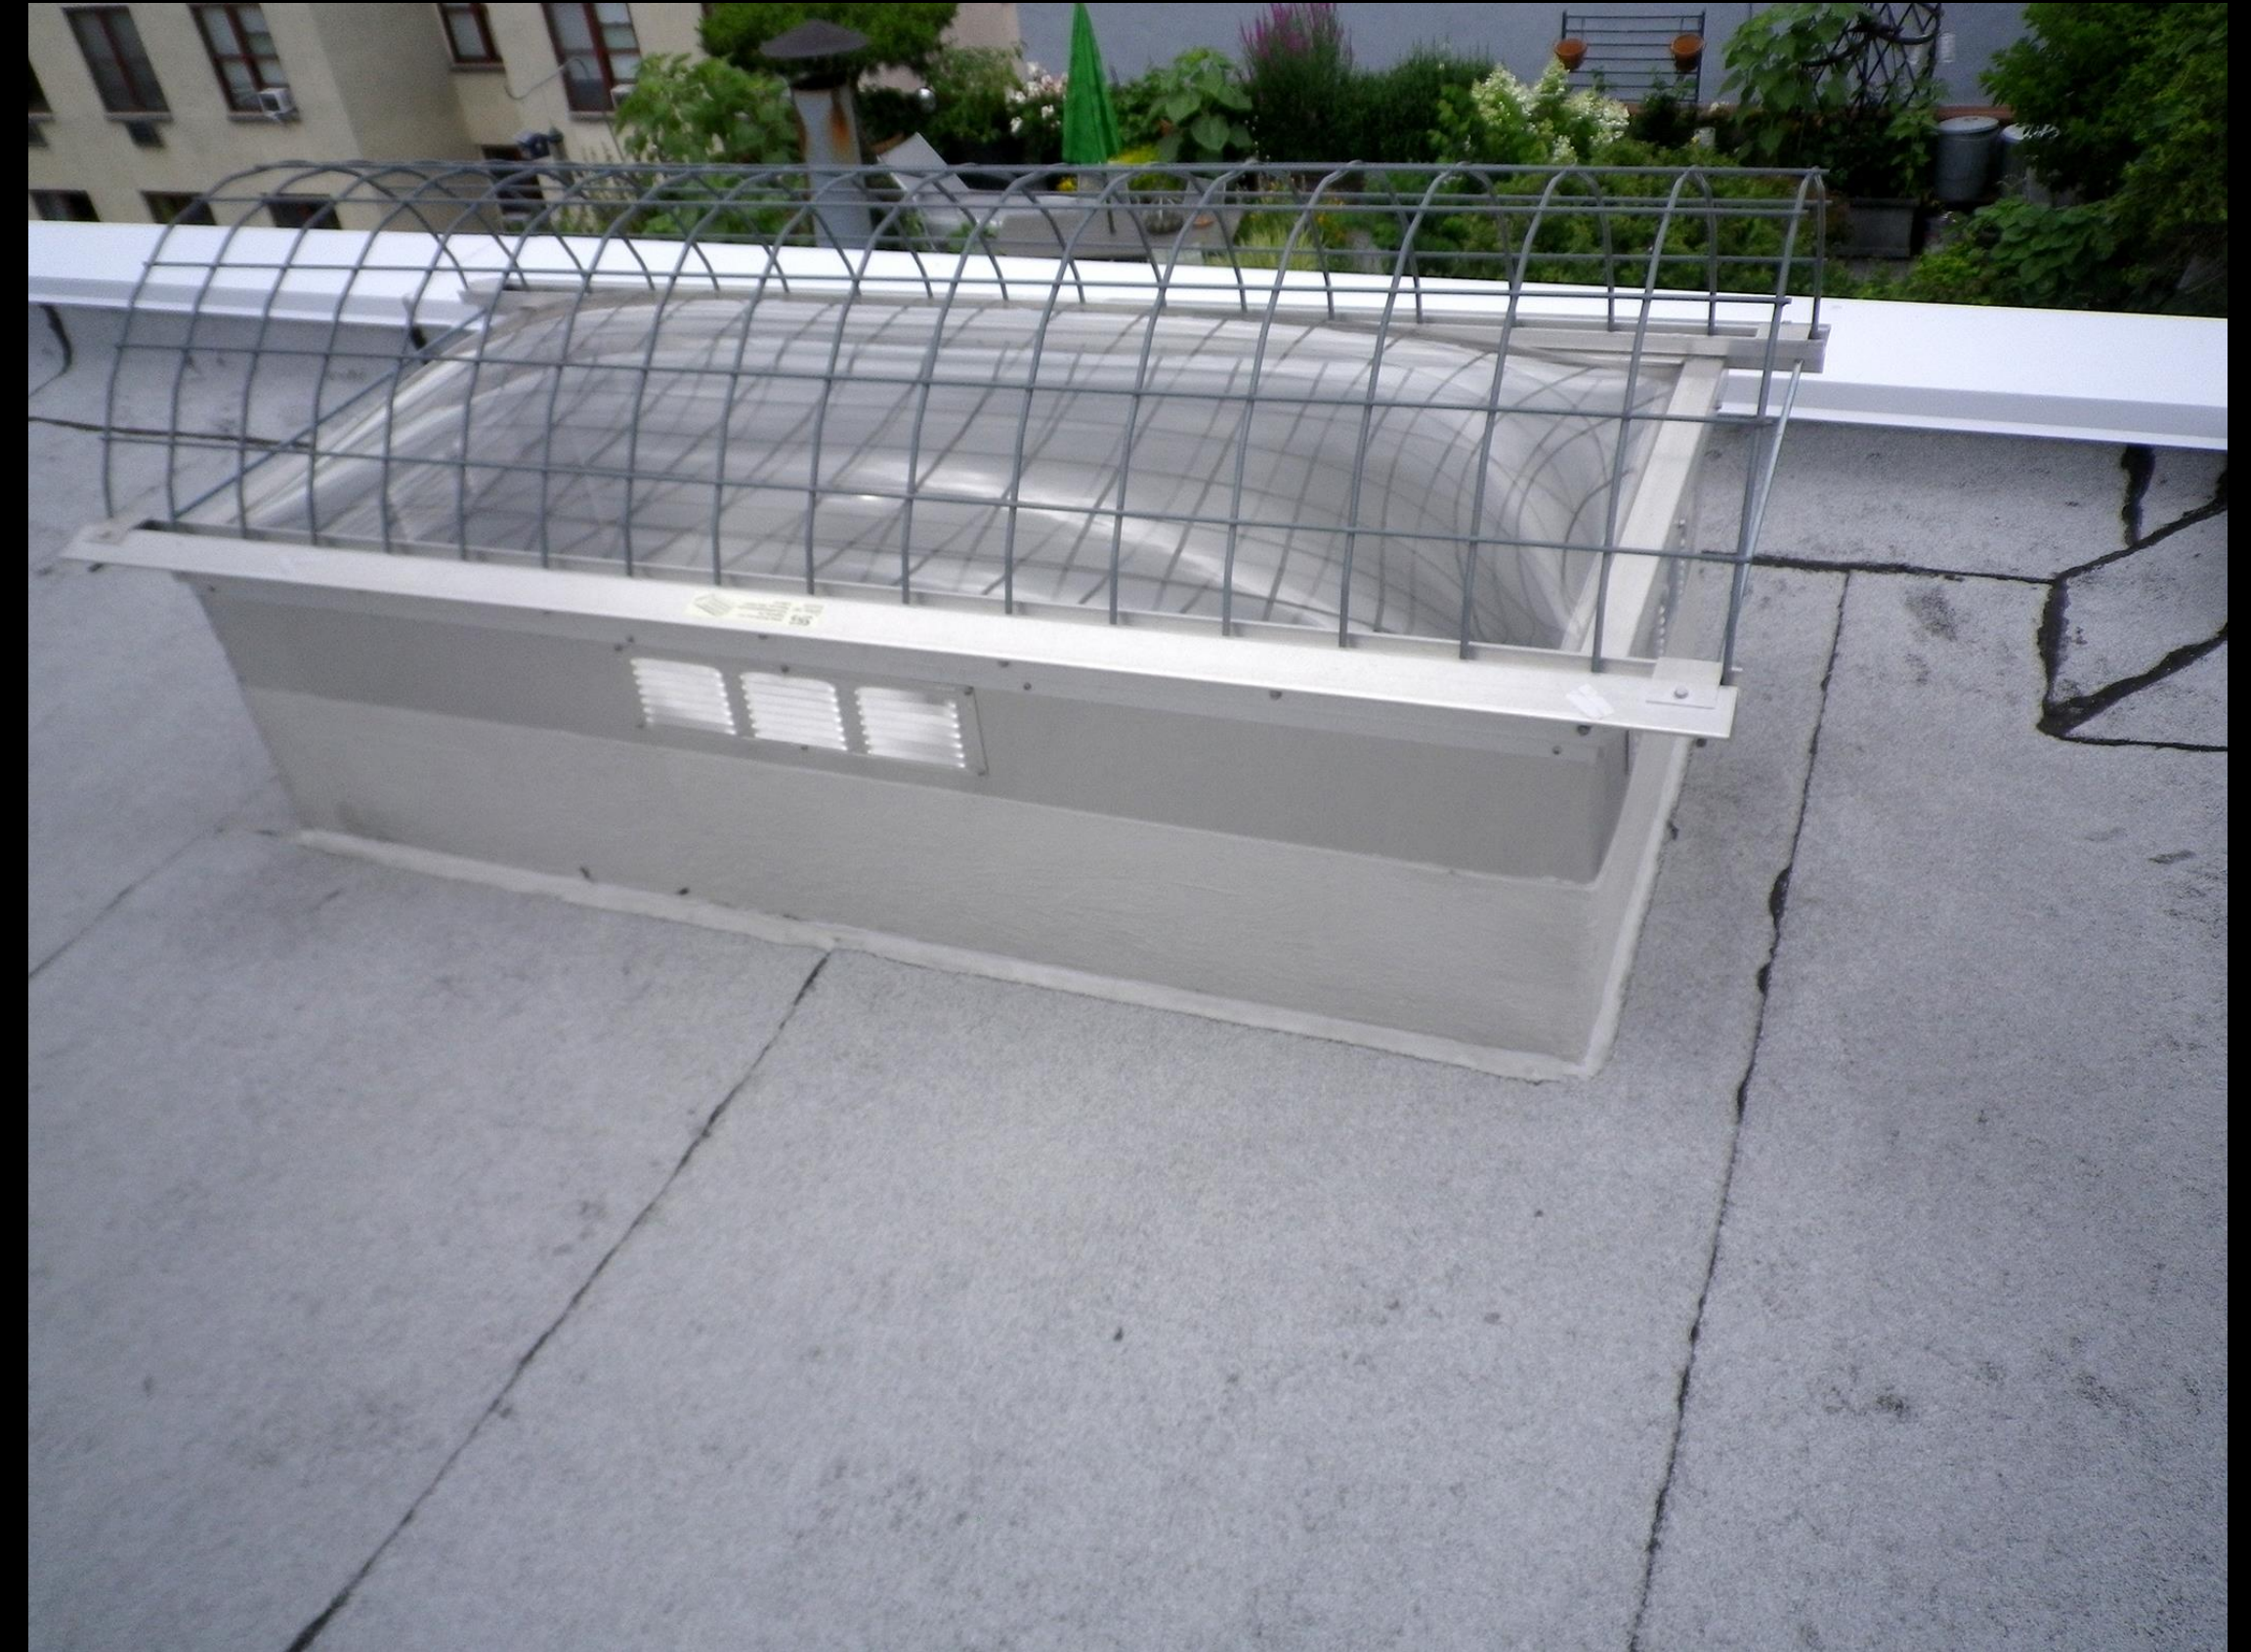
Over-ventilated, galvanized skylight versus skylight with integral insulated aluminum clad curb, custom sizes and accurate ventilation.

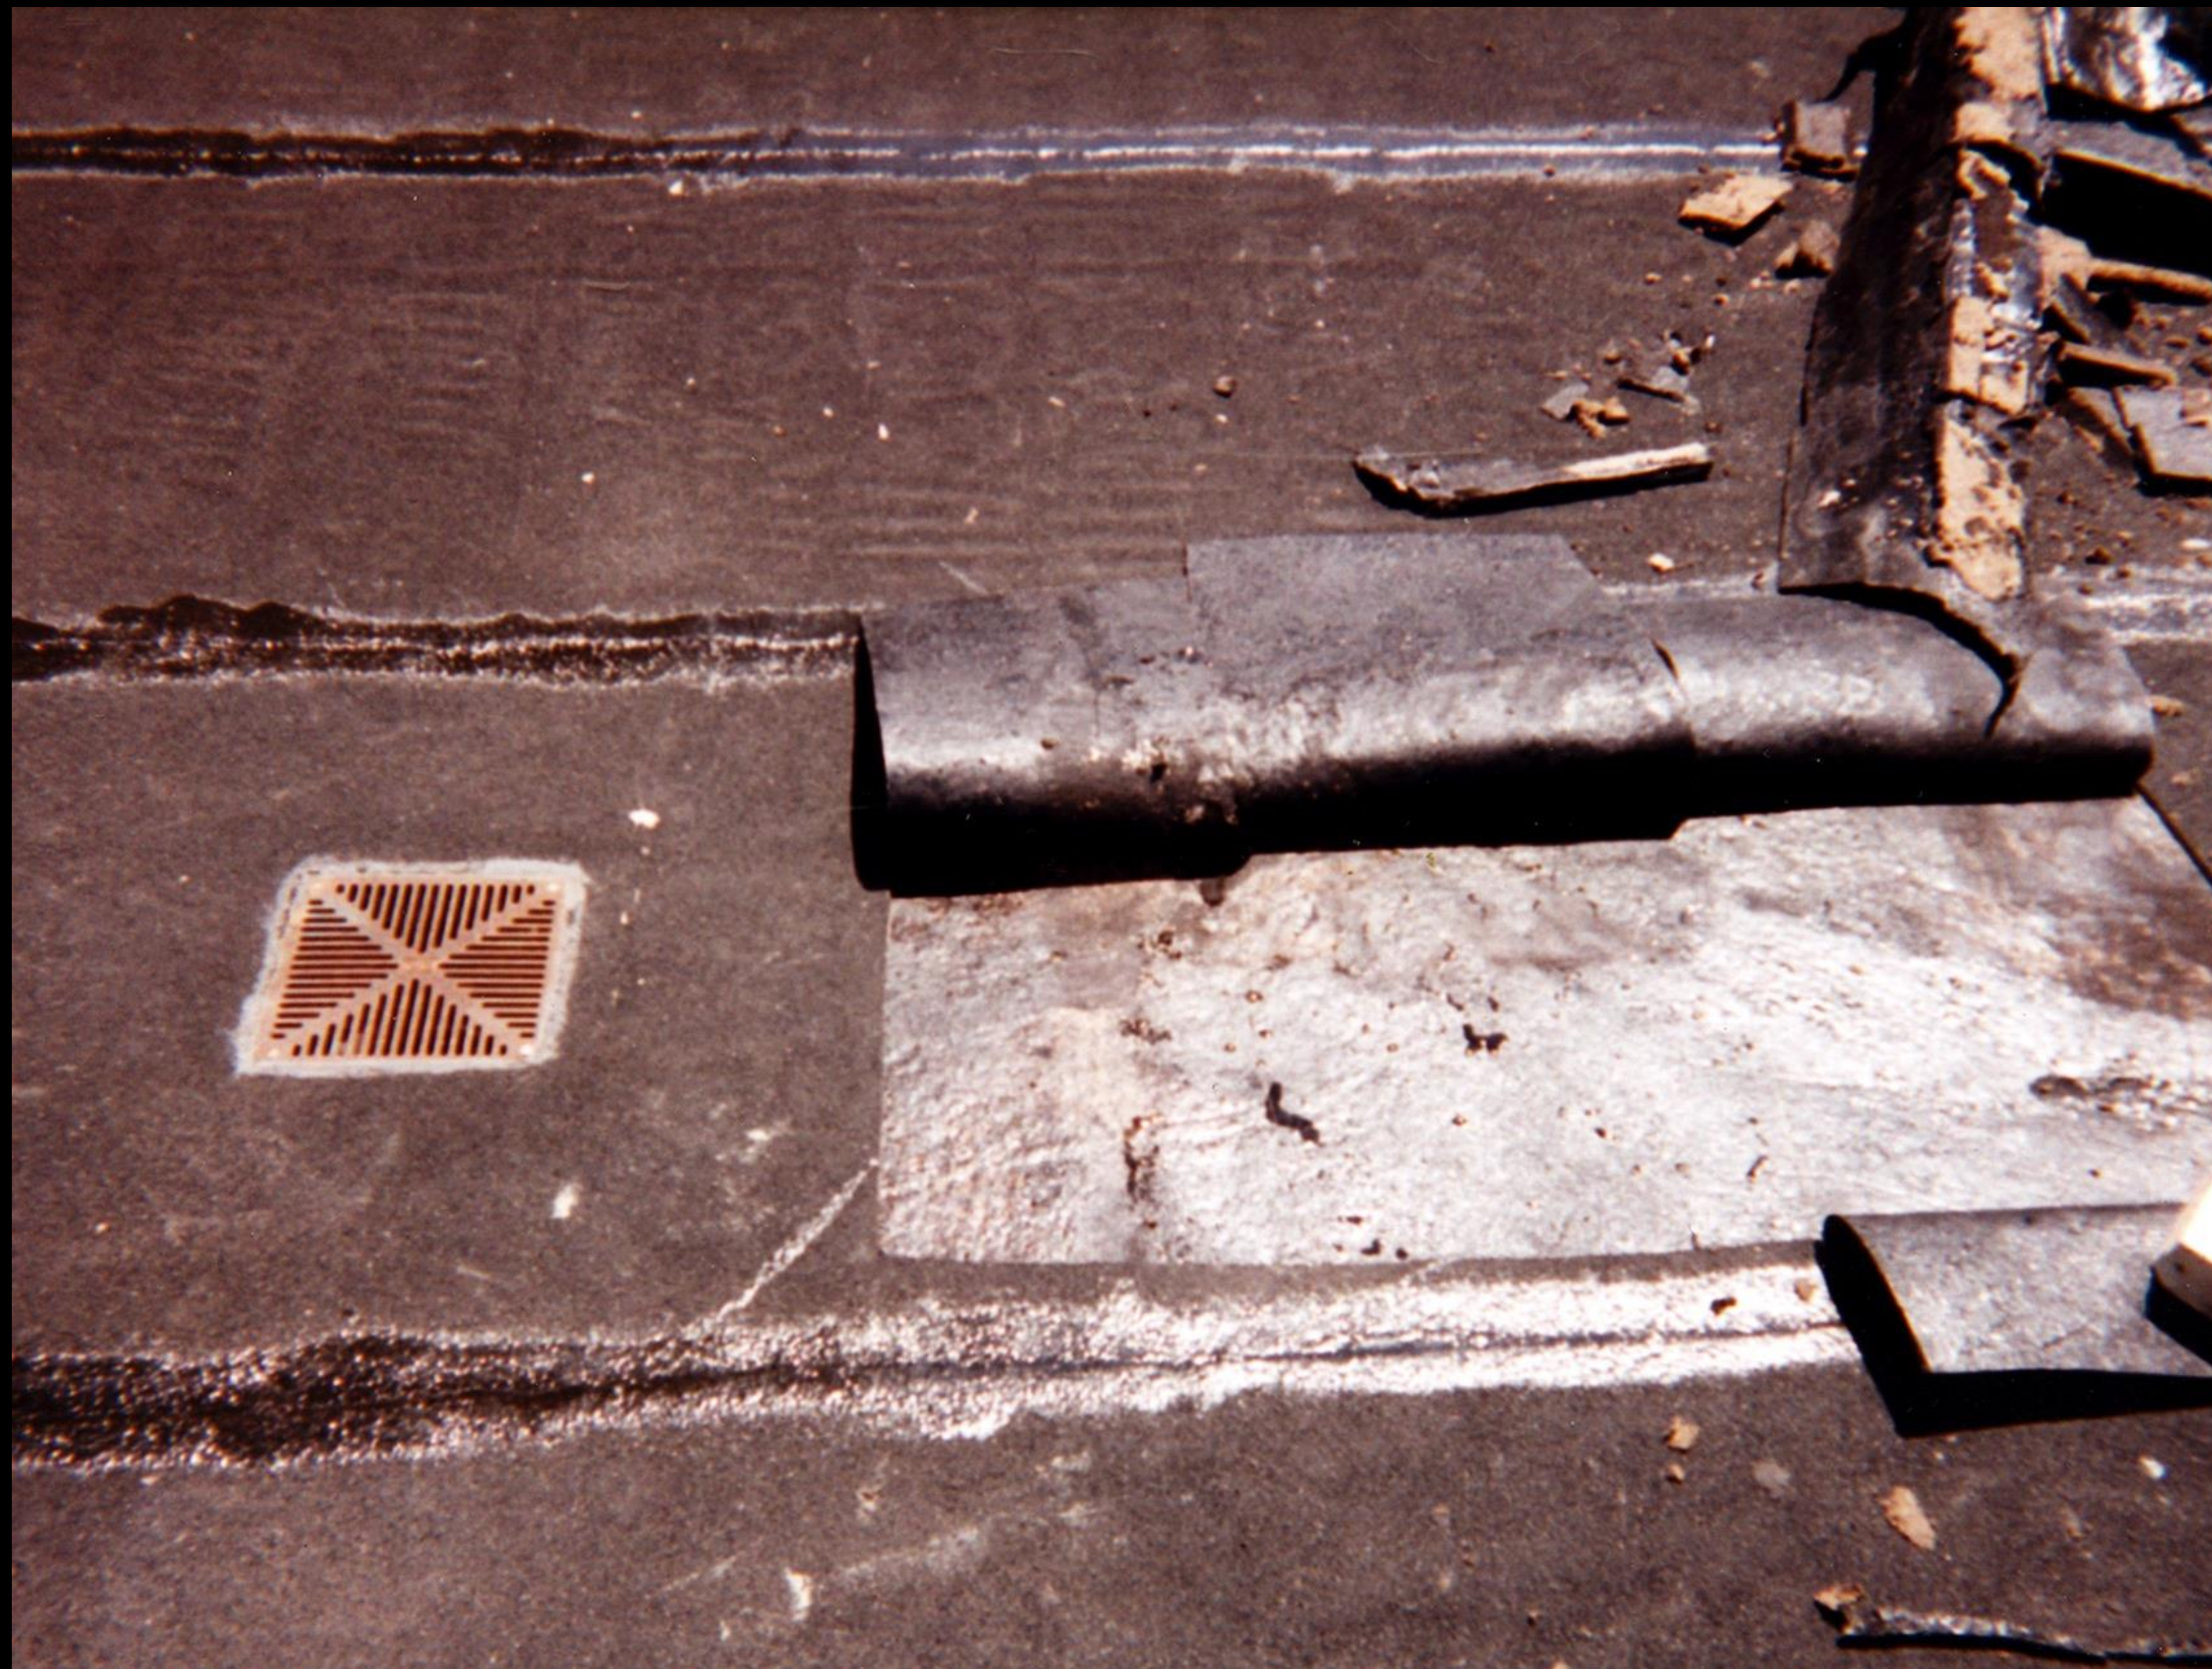
Improper roof drain leading to premature roof failure at 3 months!

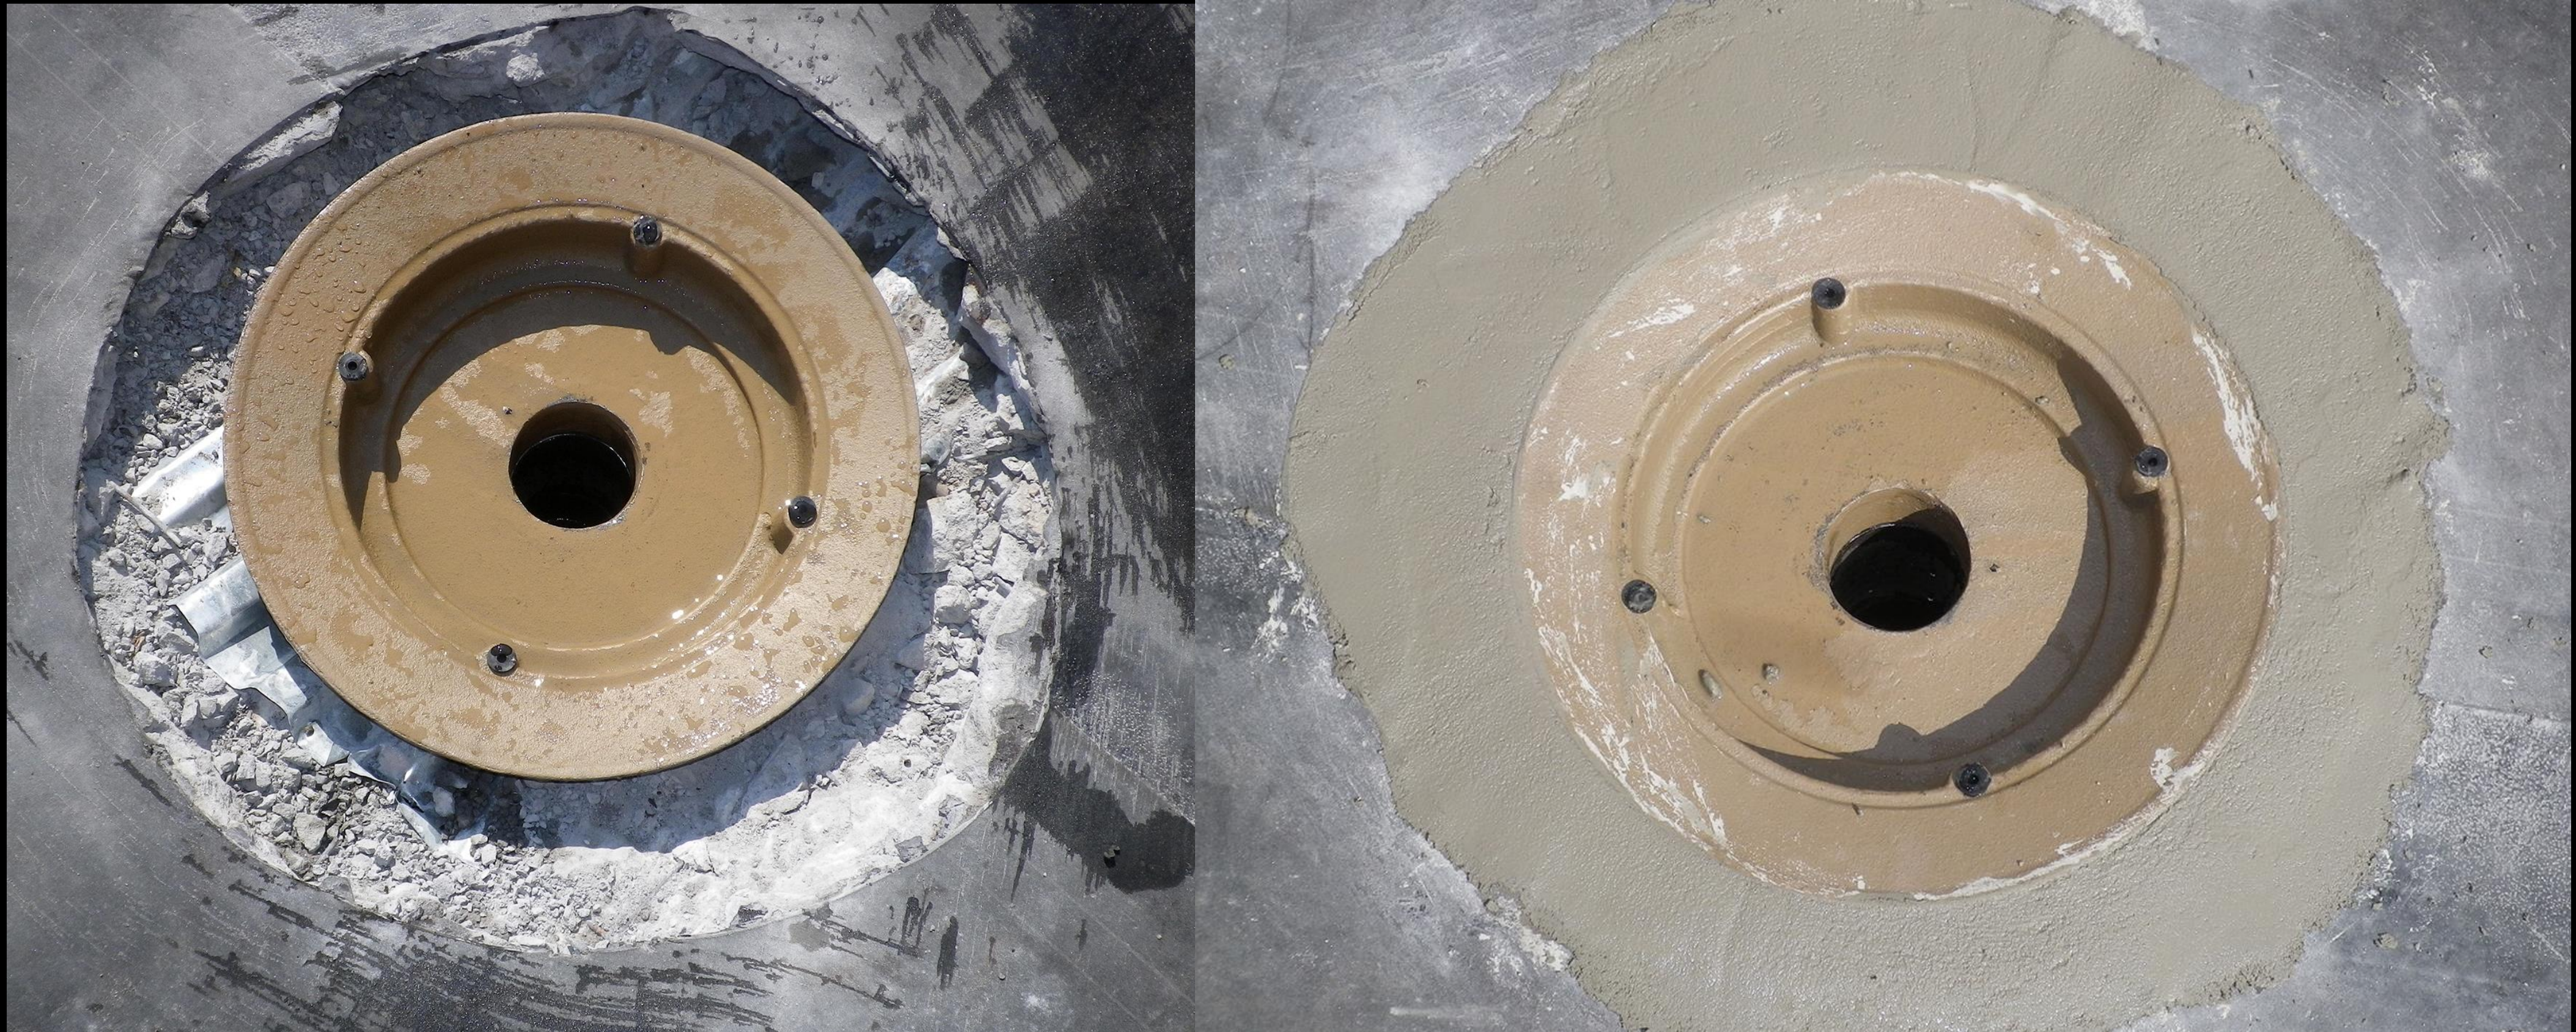
Changing the roof drains as part of a retrofit. **Sensible Practice.**

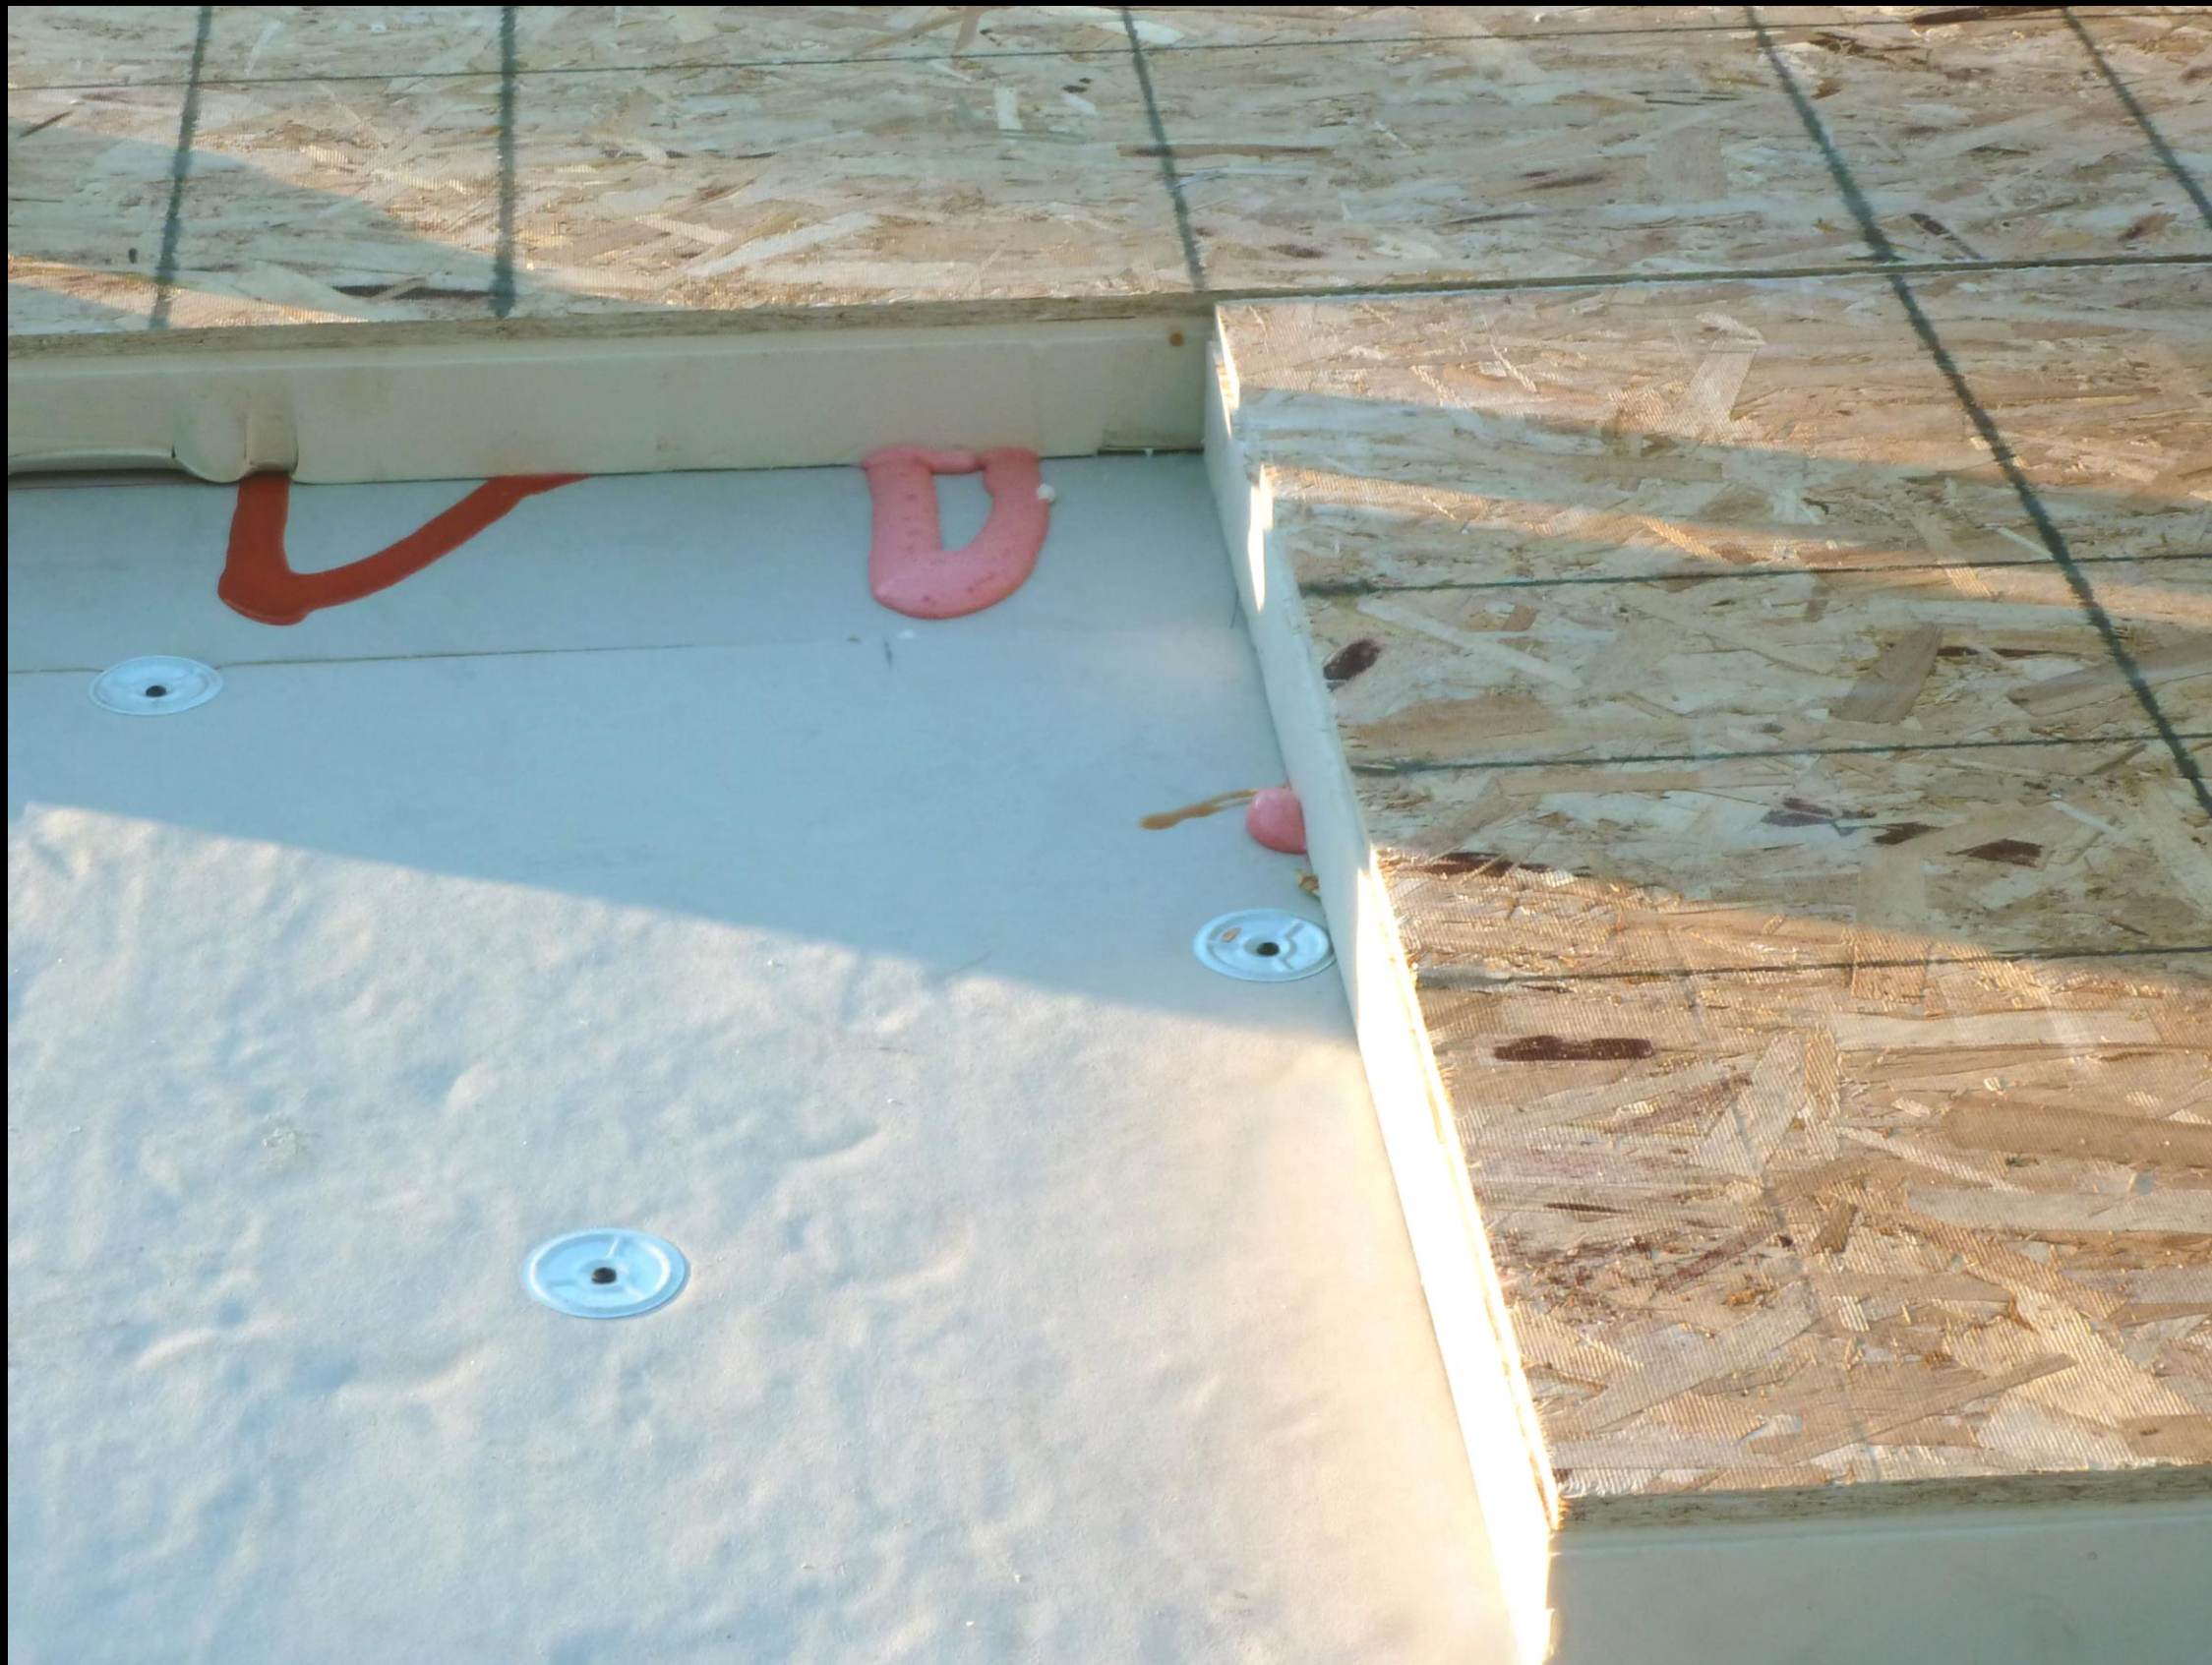
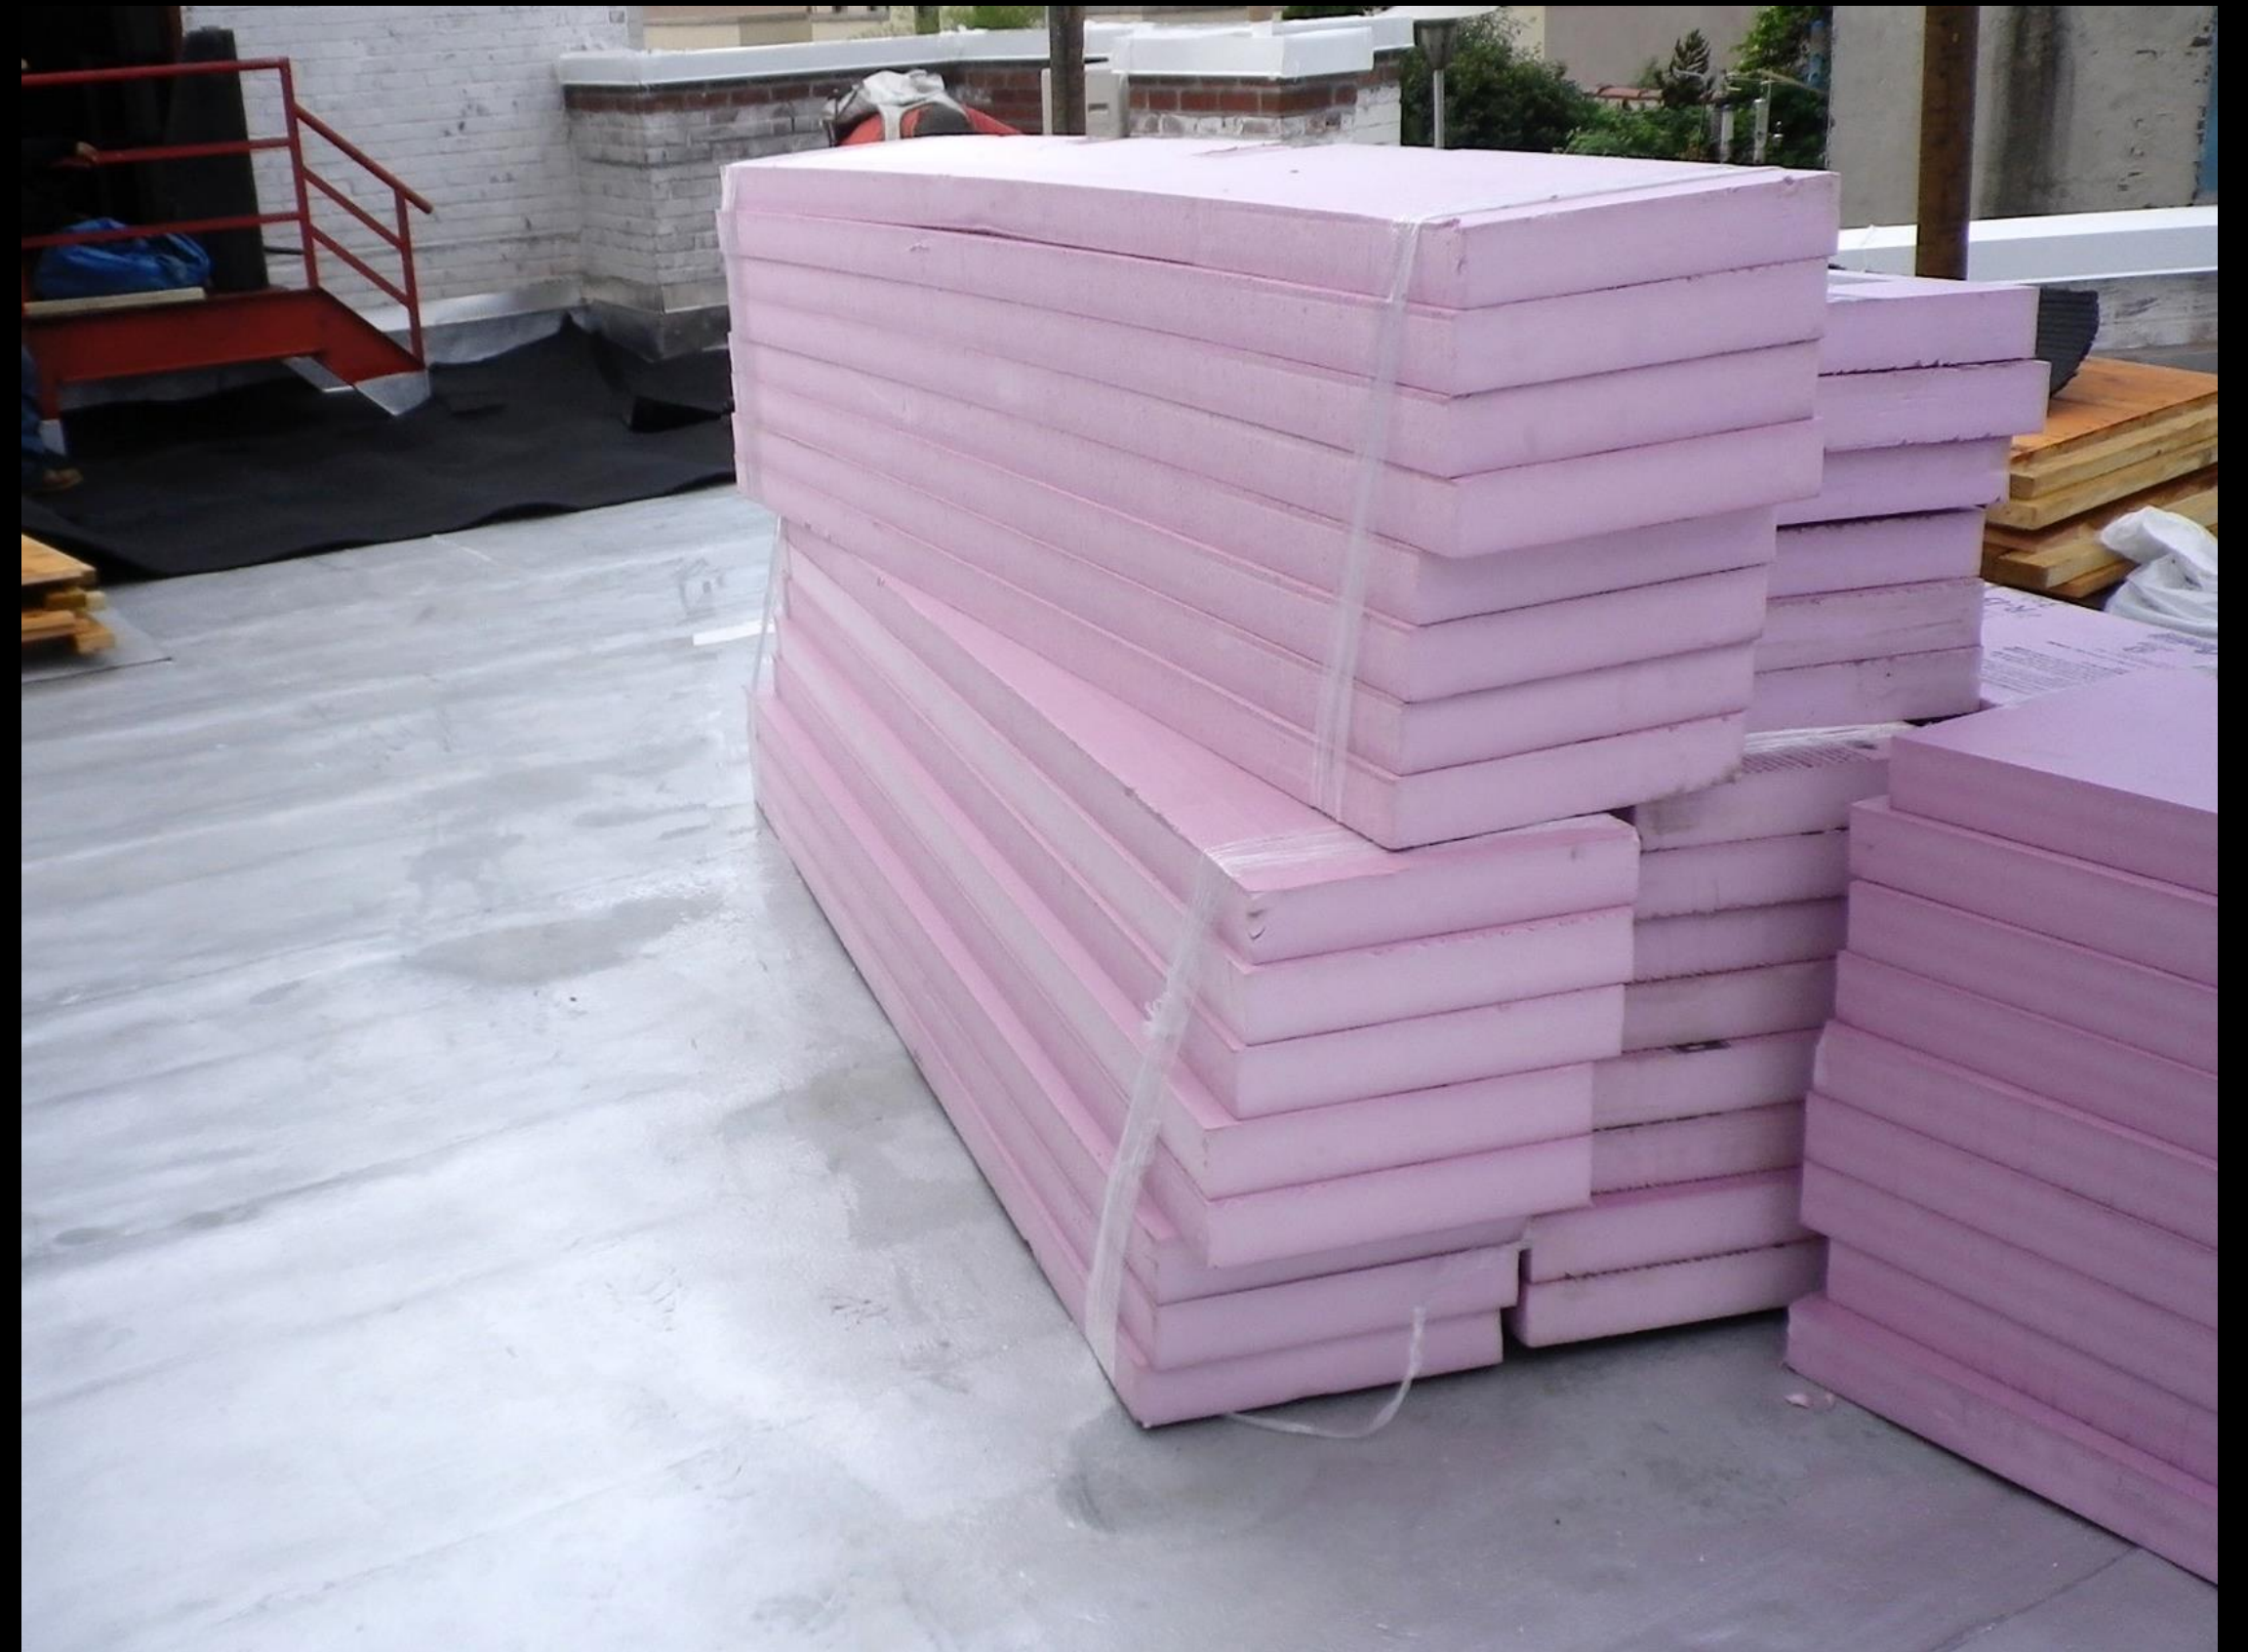
We have many options for insulation. Always use multiple cross laid layers. Adding insulation increases the deck height so consider the extra cost involved in raising guardrails especially in a retrofit situation.
