ROOFING REALITIES NESEA March 2016

IT'S ALL IN THE DETAILS

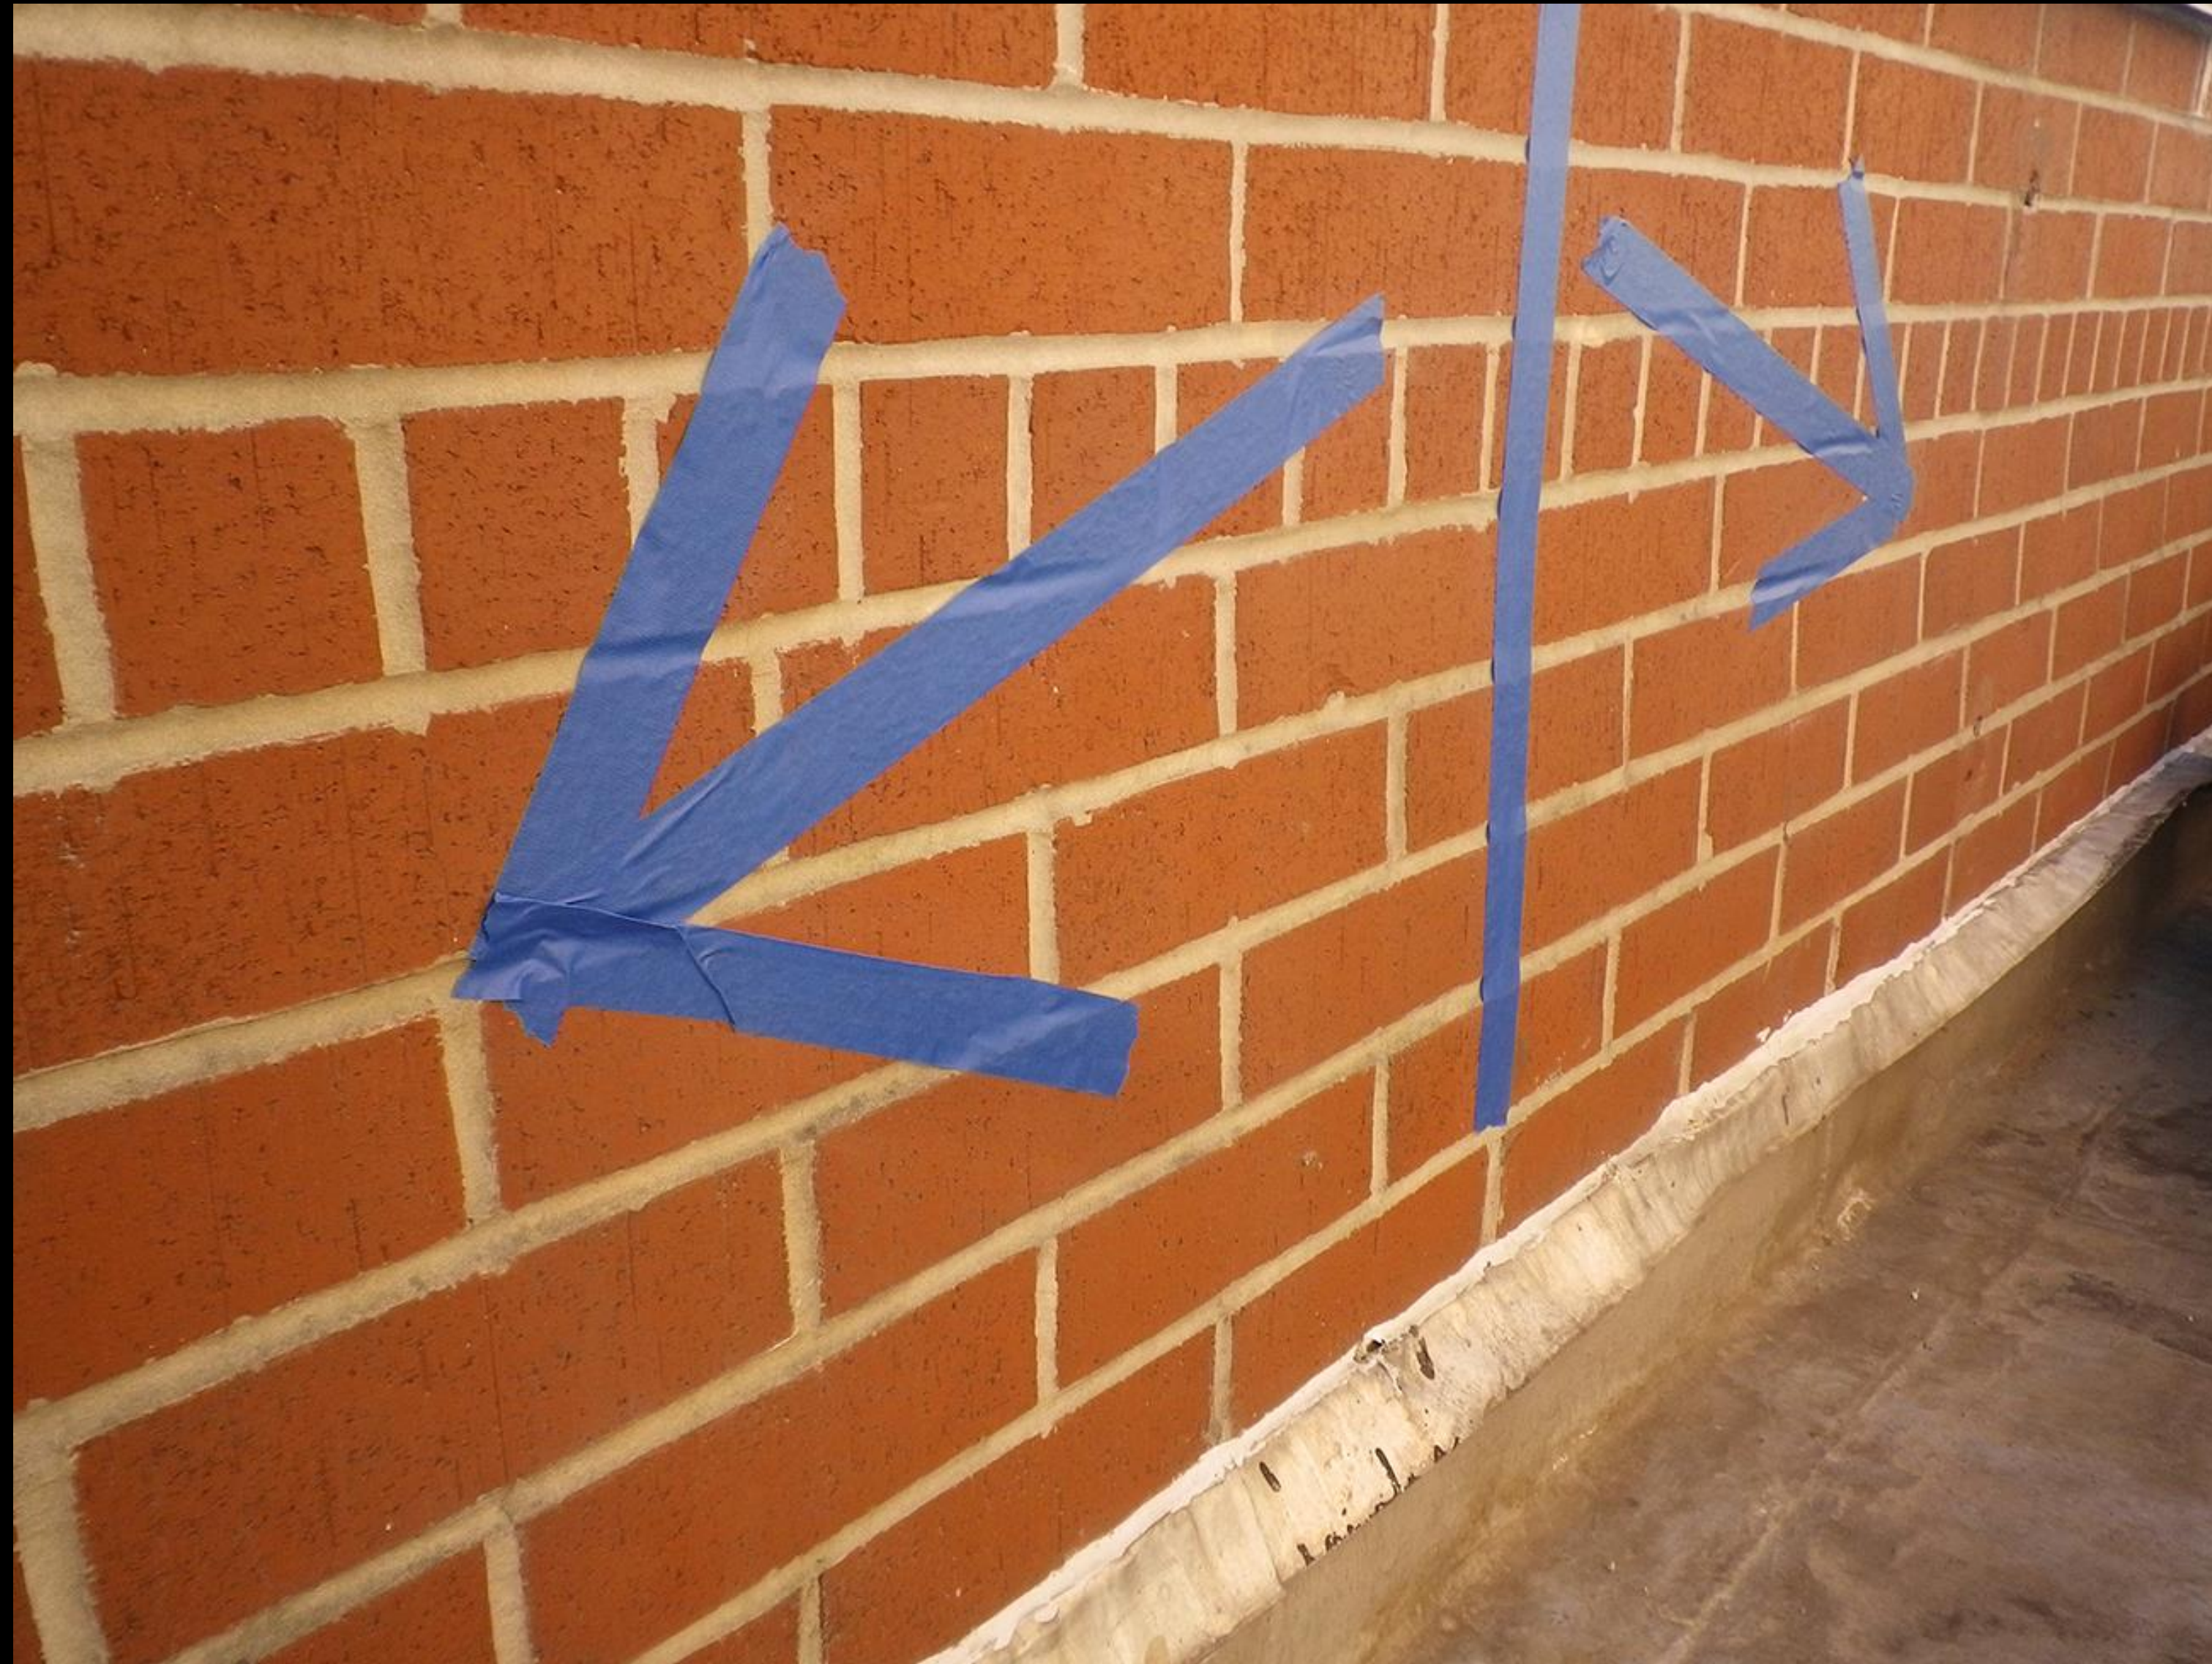
Find the high point and make sure that it pitches to drain.

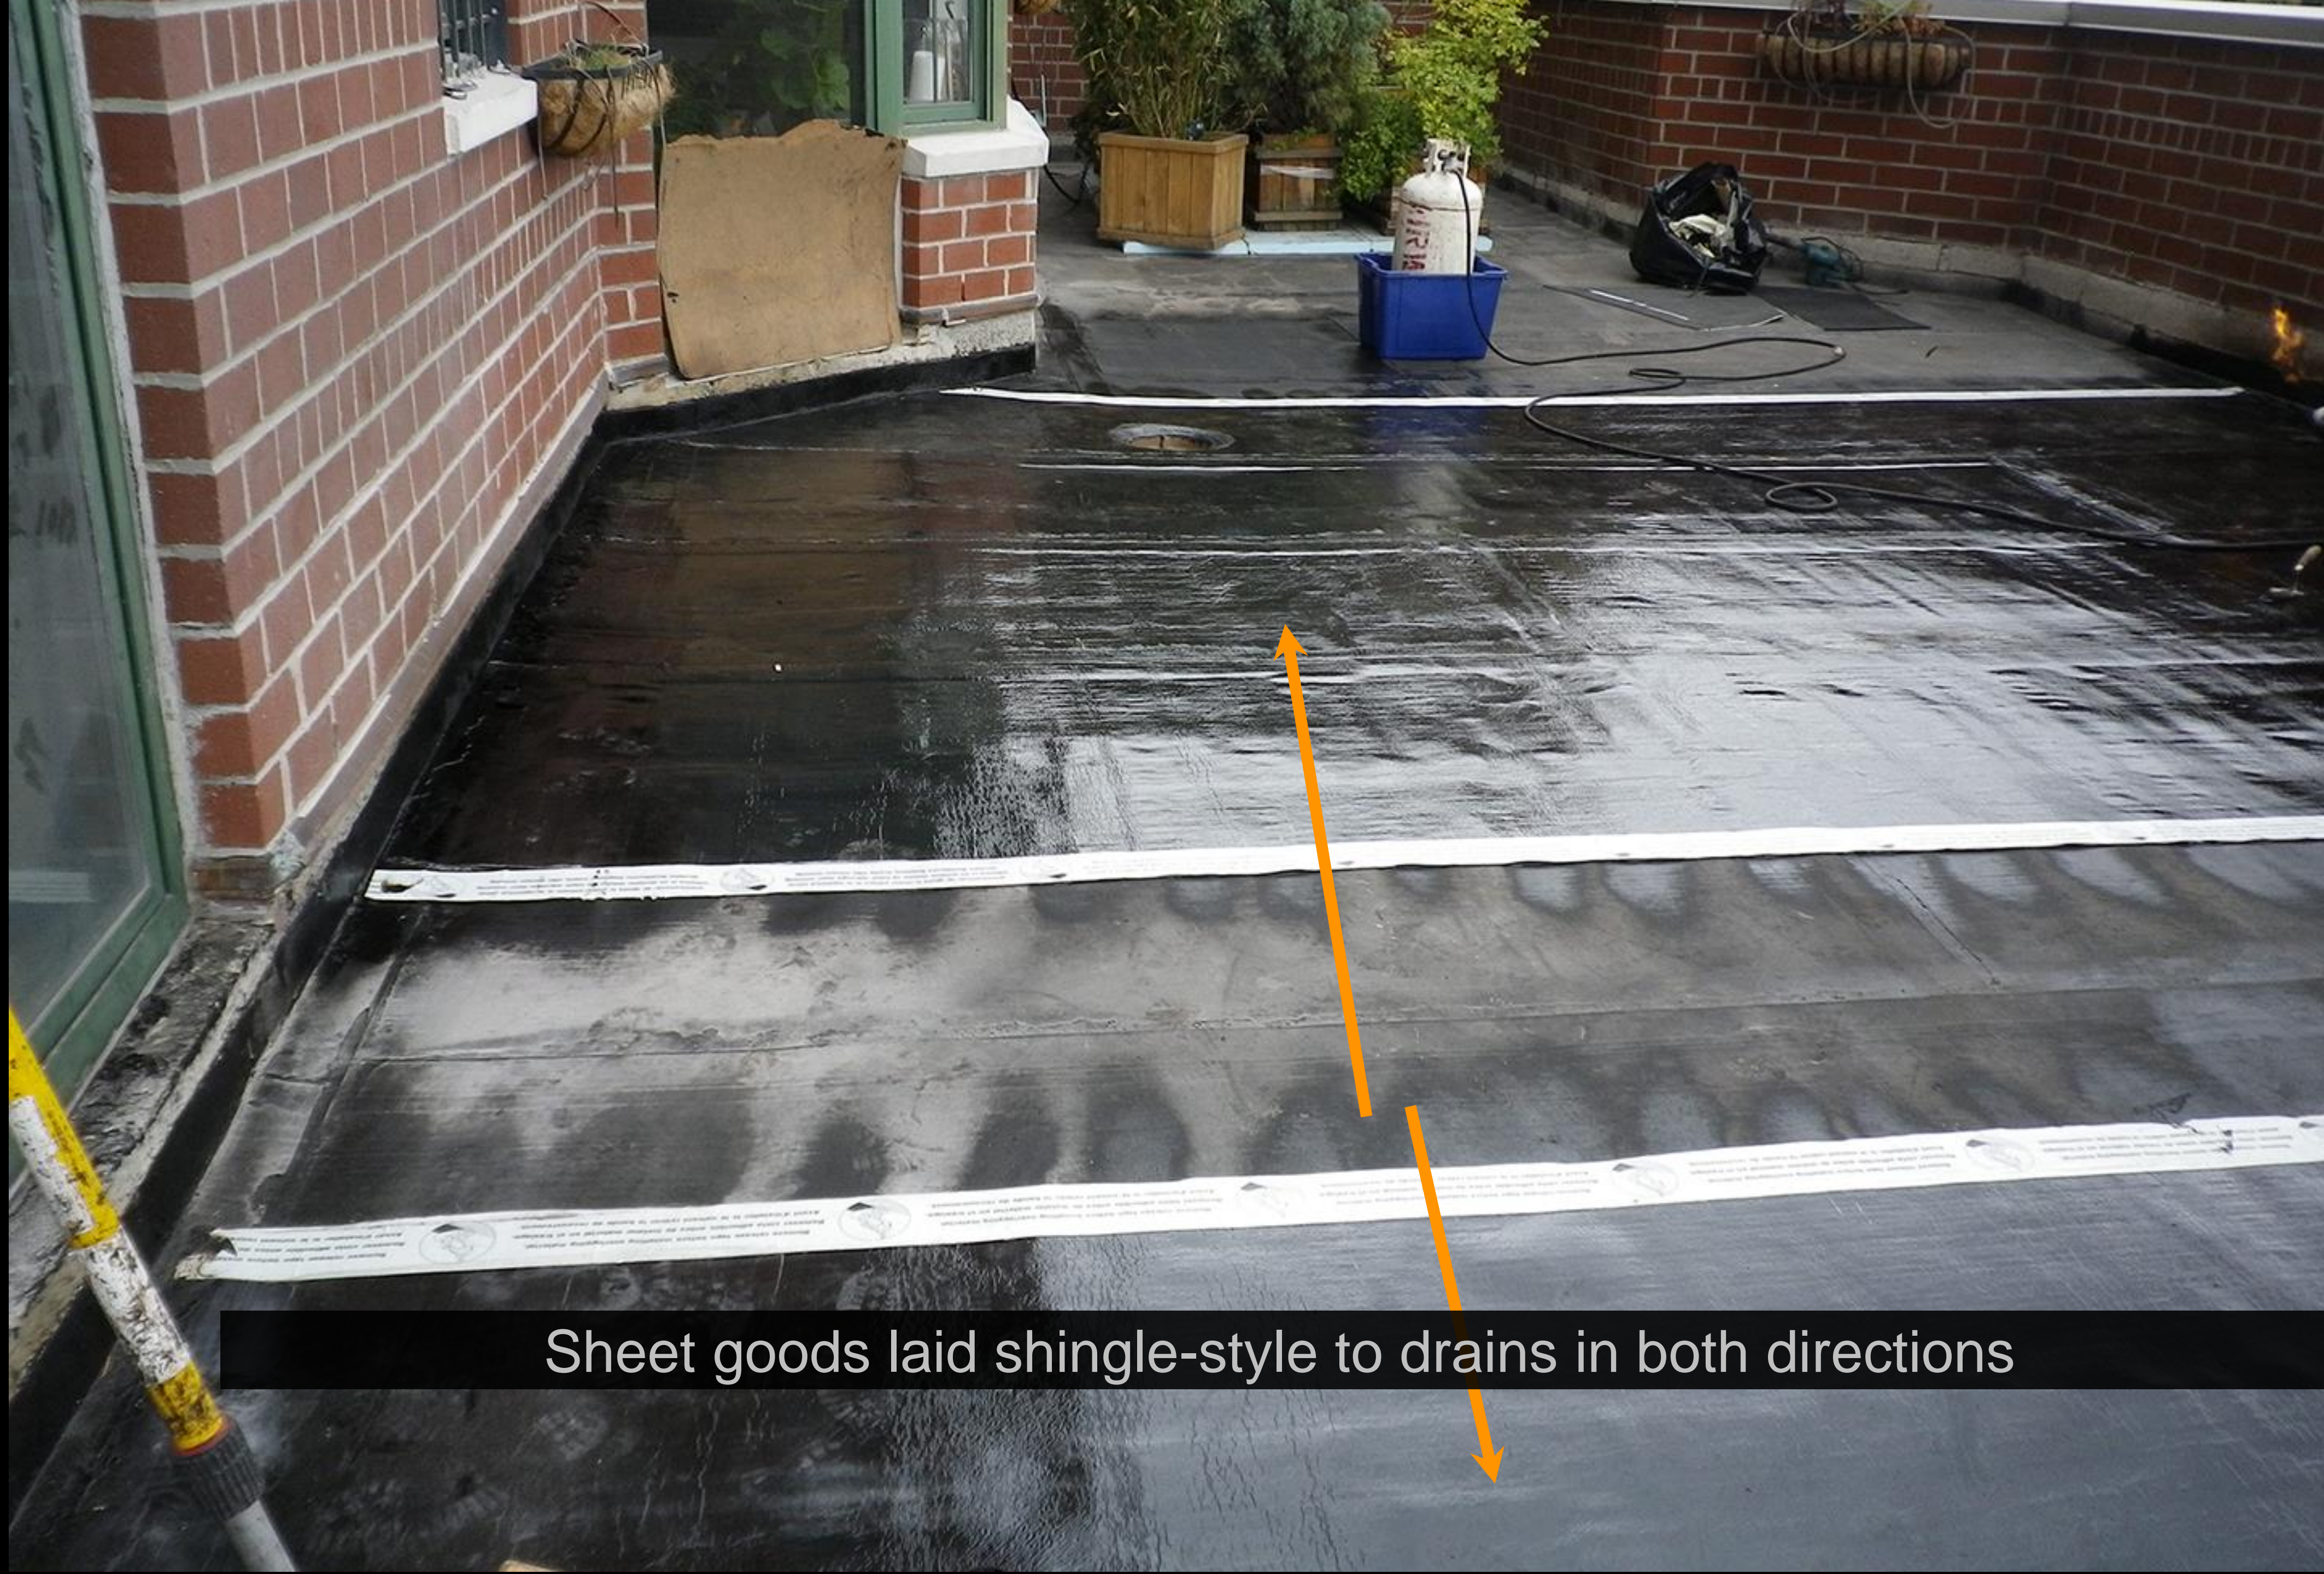
Sheet goods laid shingle-style to drains in both directions

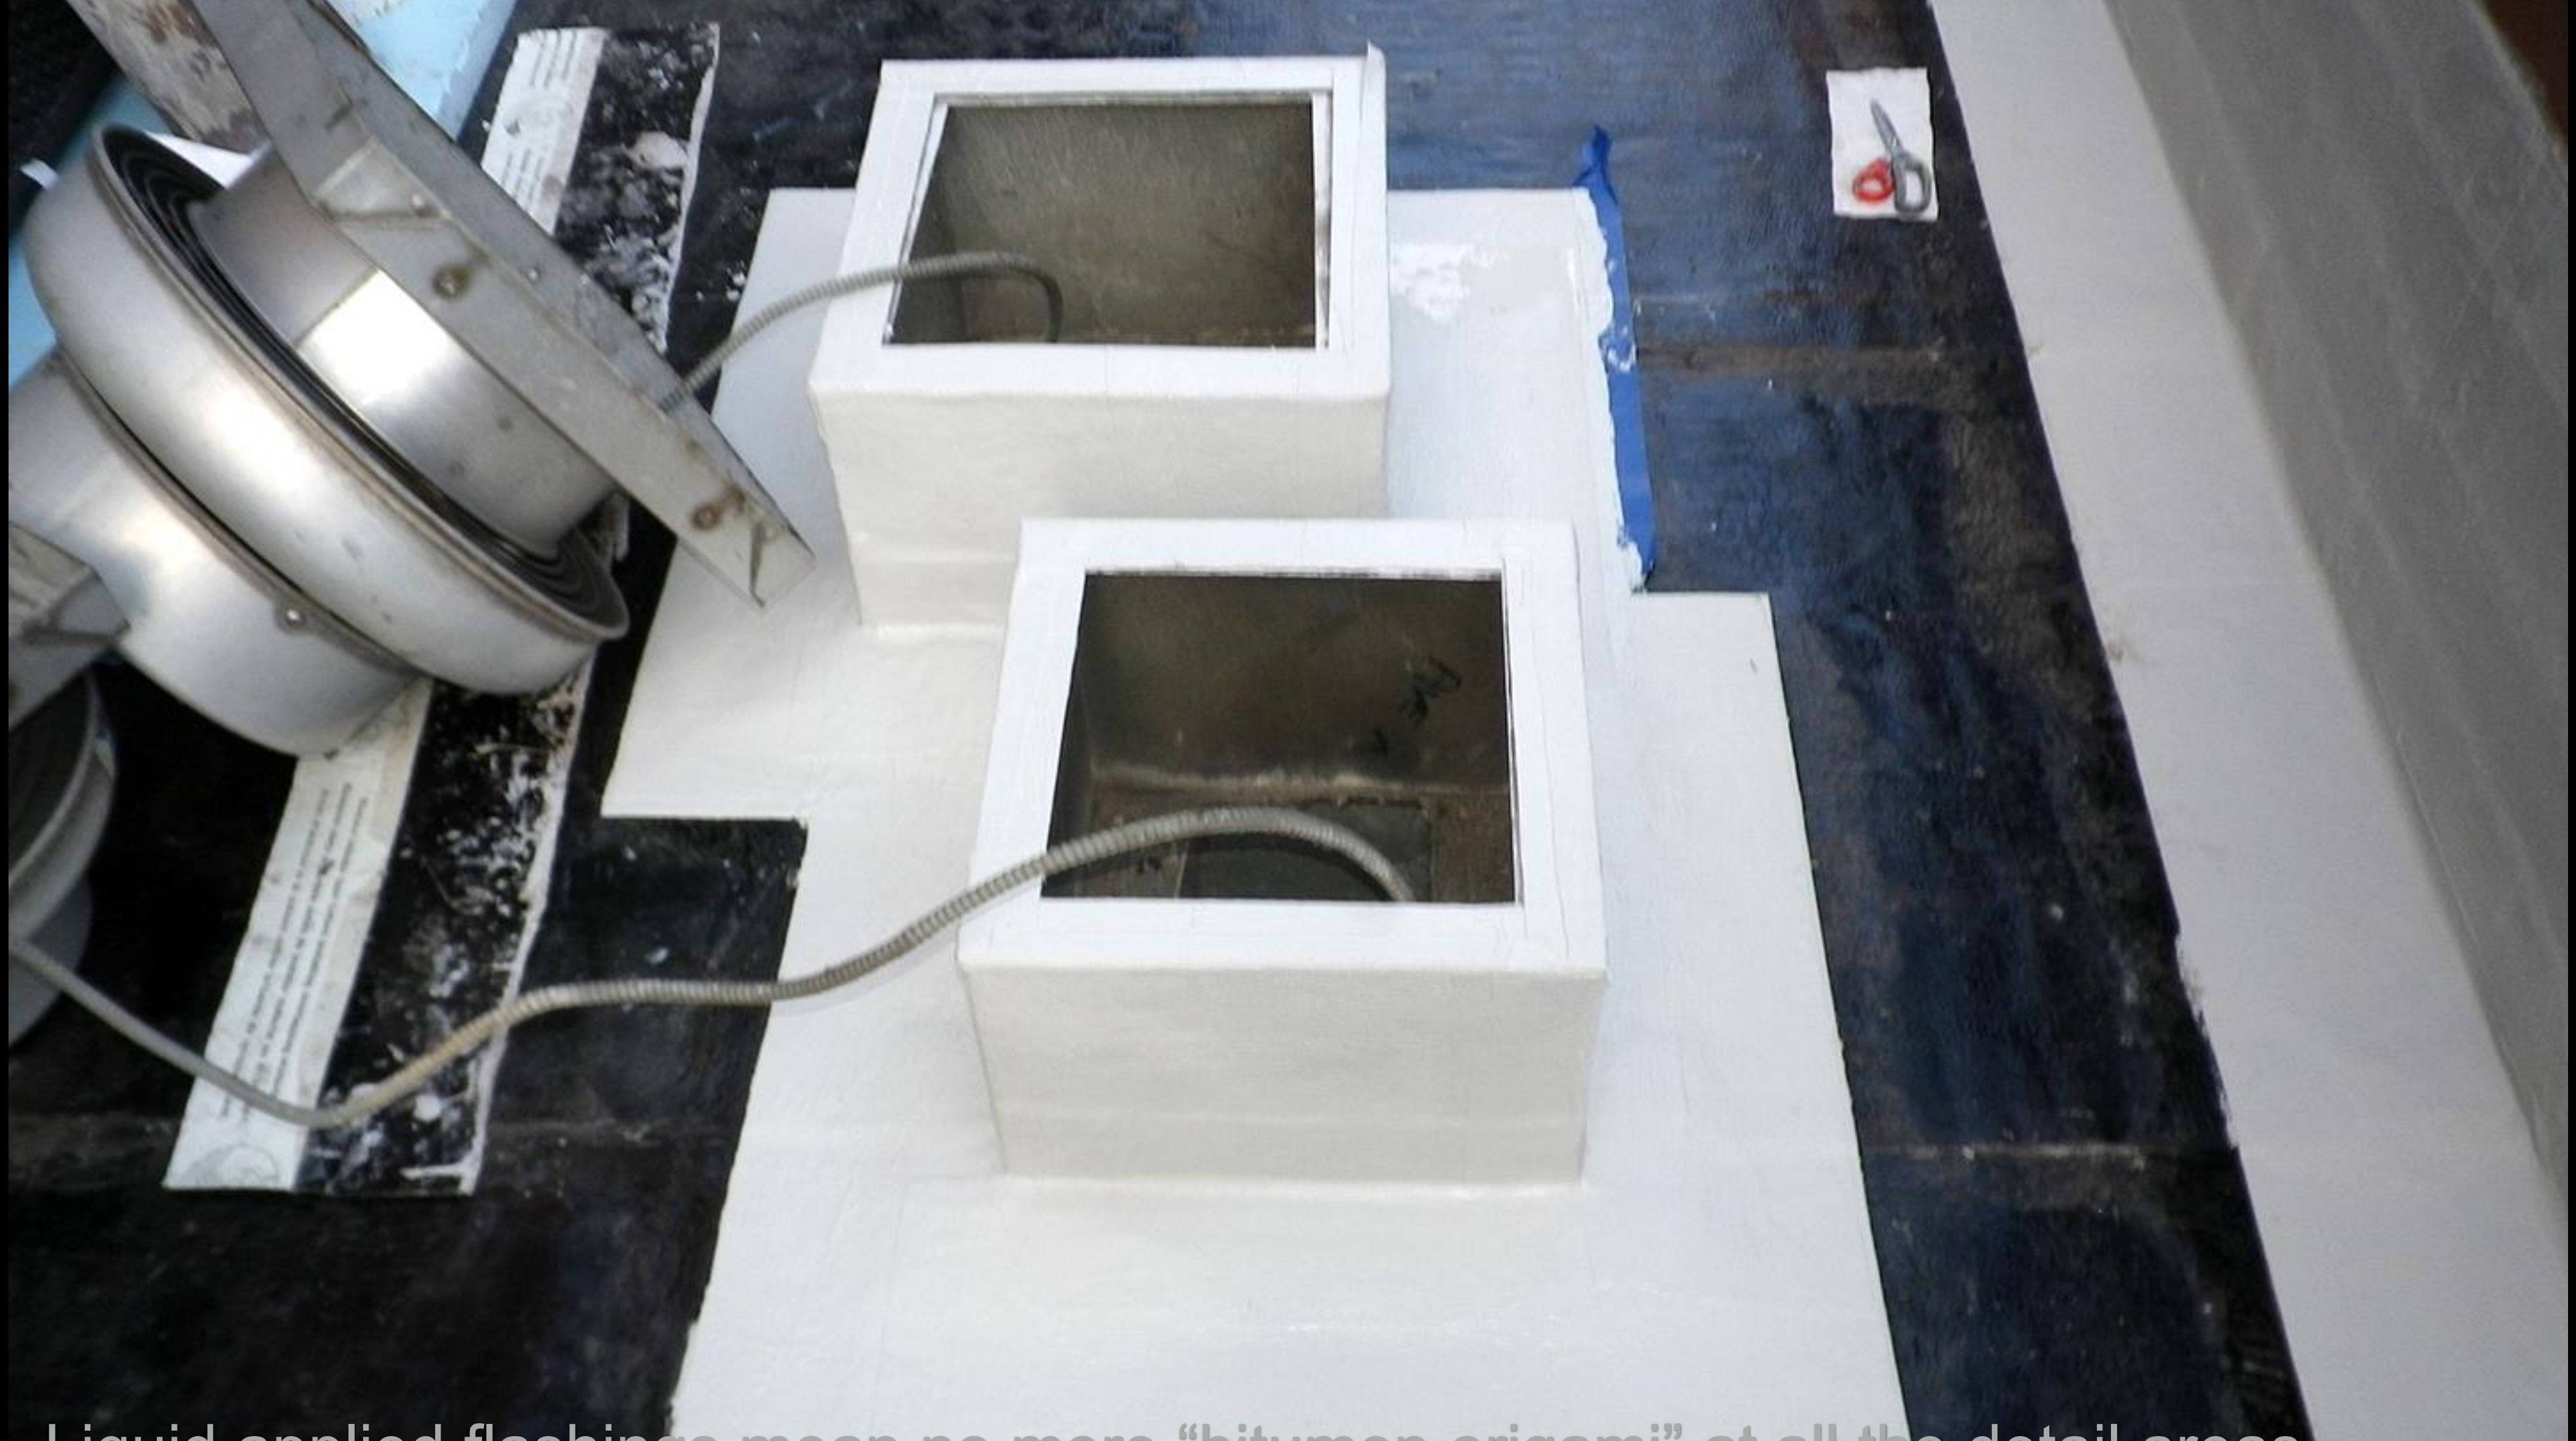
Liquid applied flashings mean no more “bitumen origami” at all the detail areas. Manufacturers realize the value of designing the liquid applied flashings into their specifications.

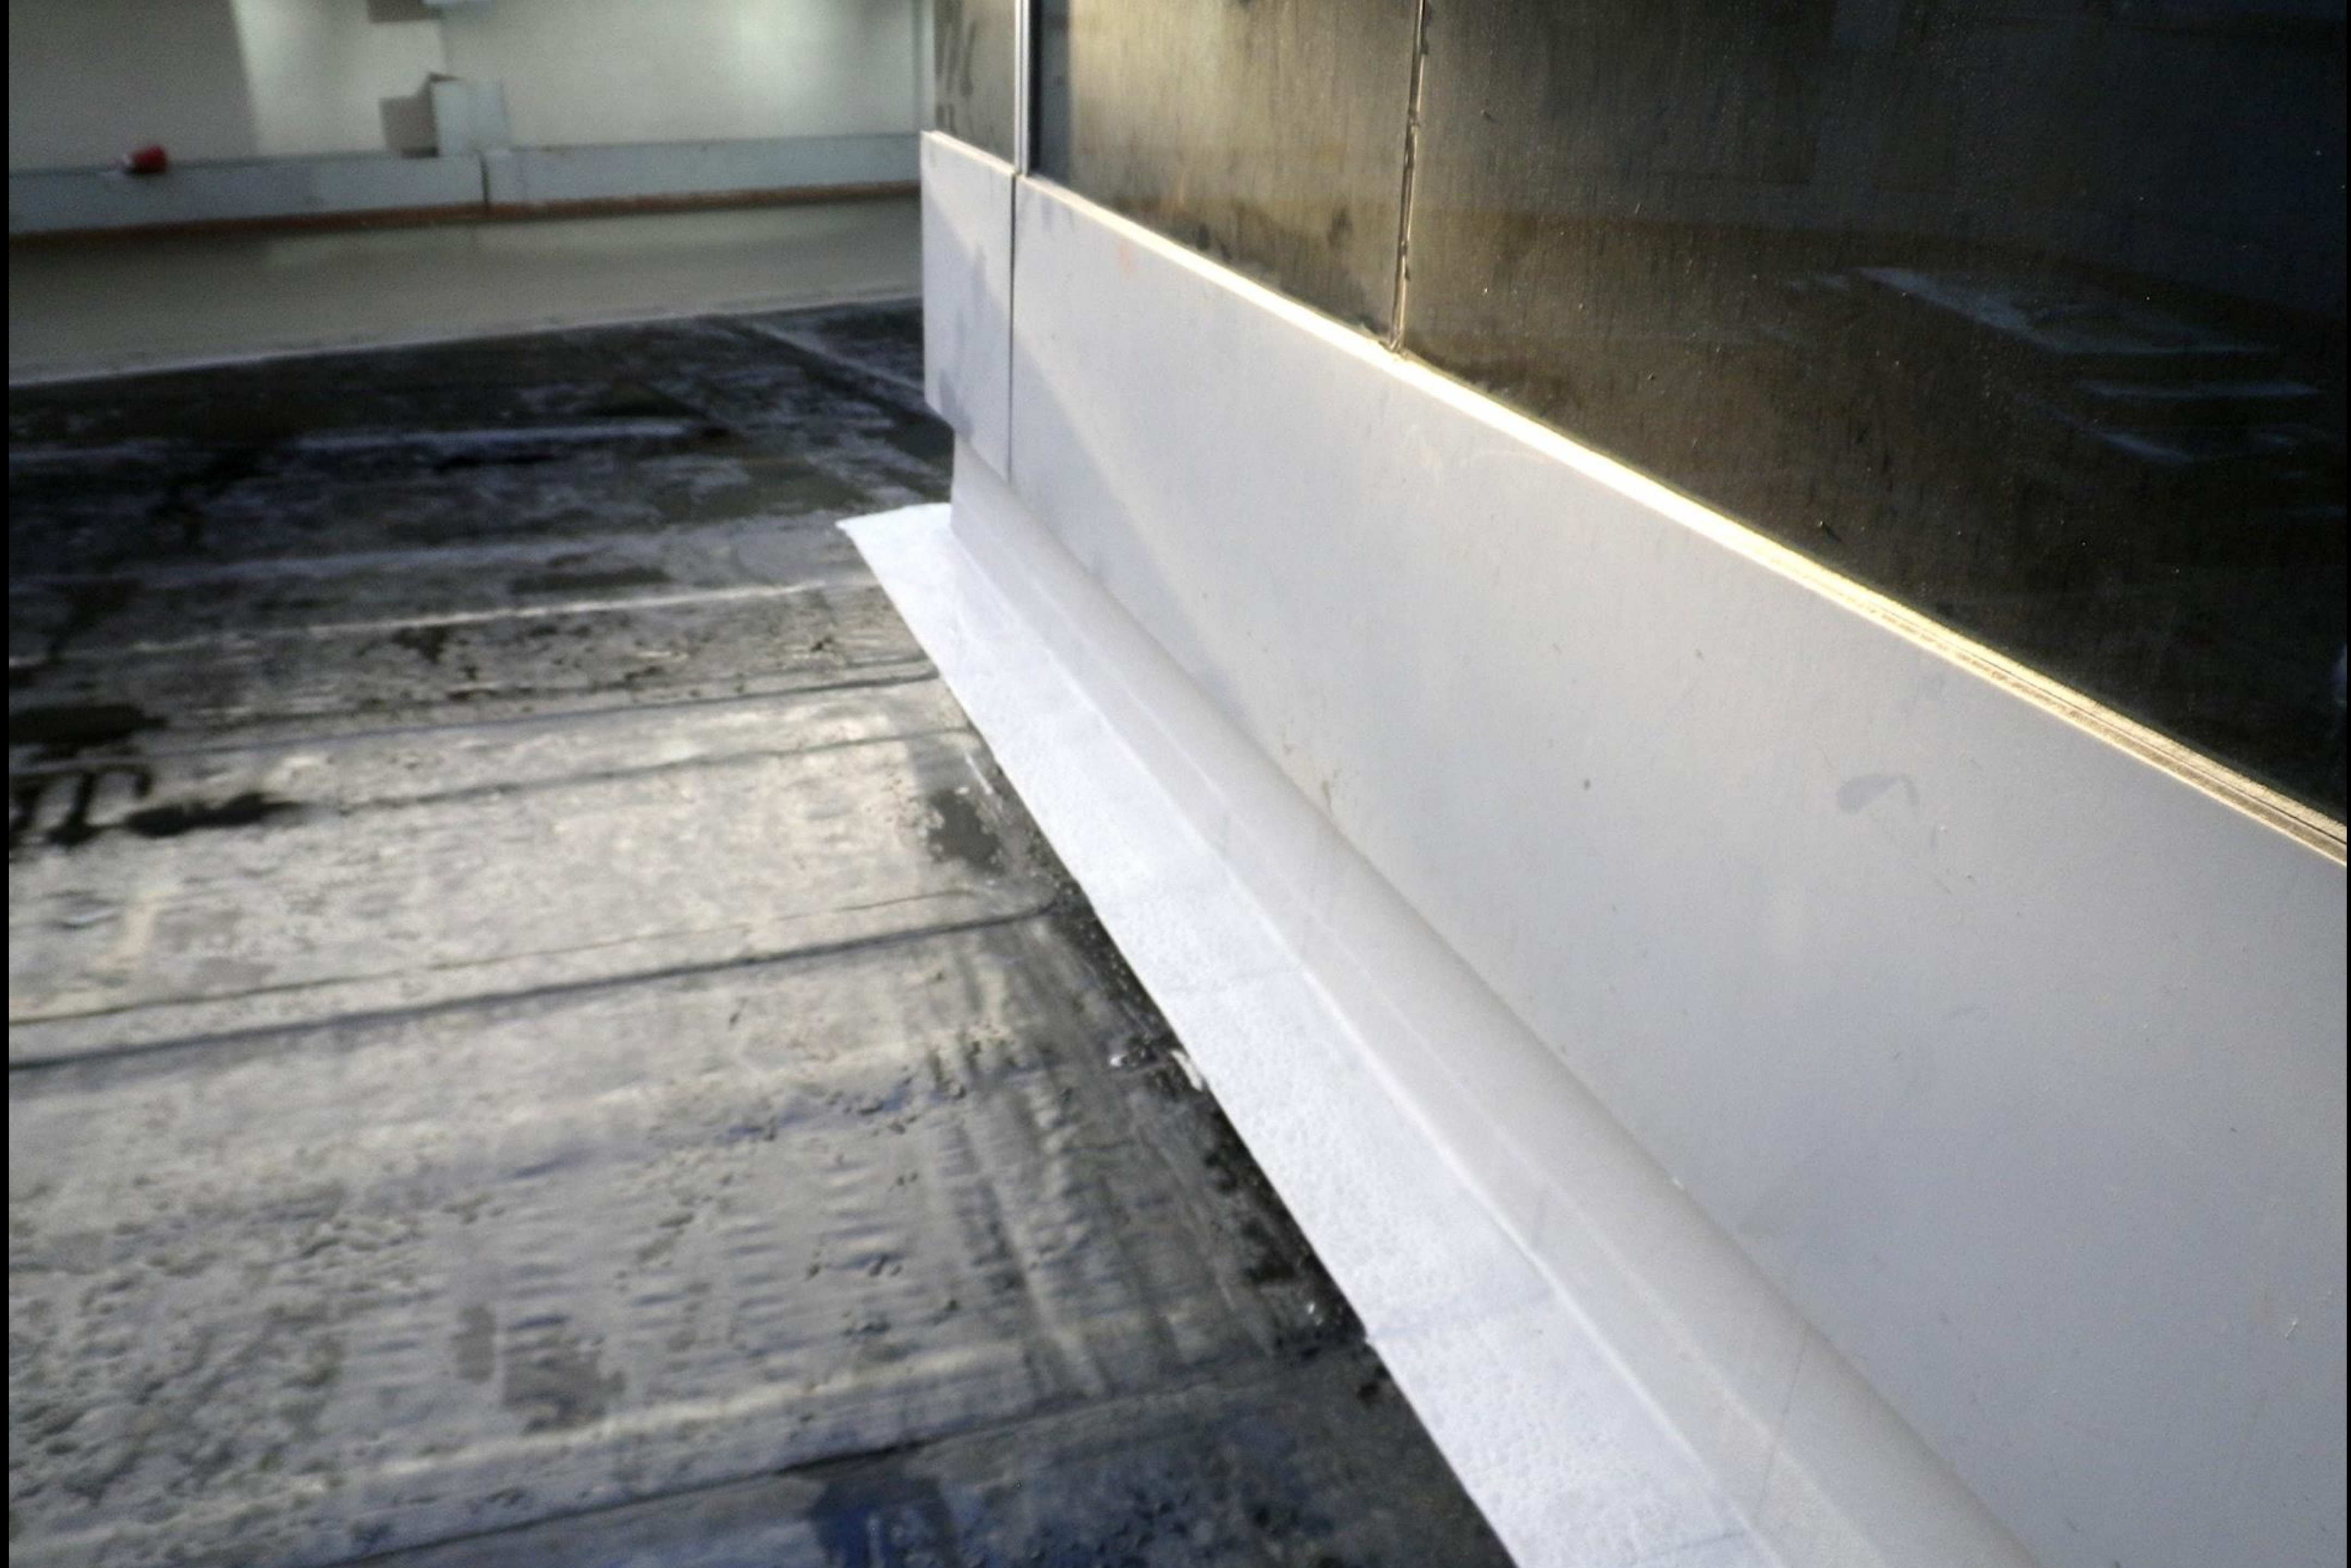
Extending the life of membranes by
applying coating systems.

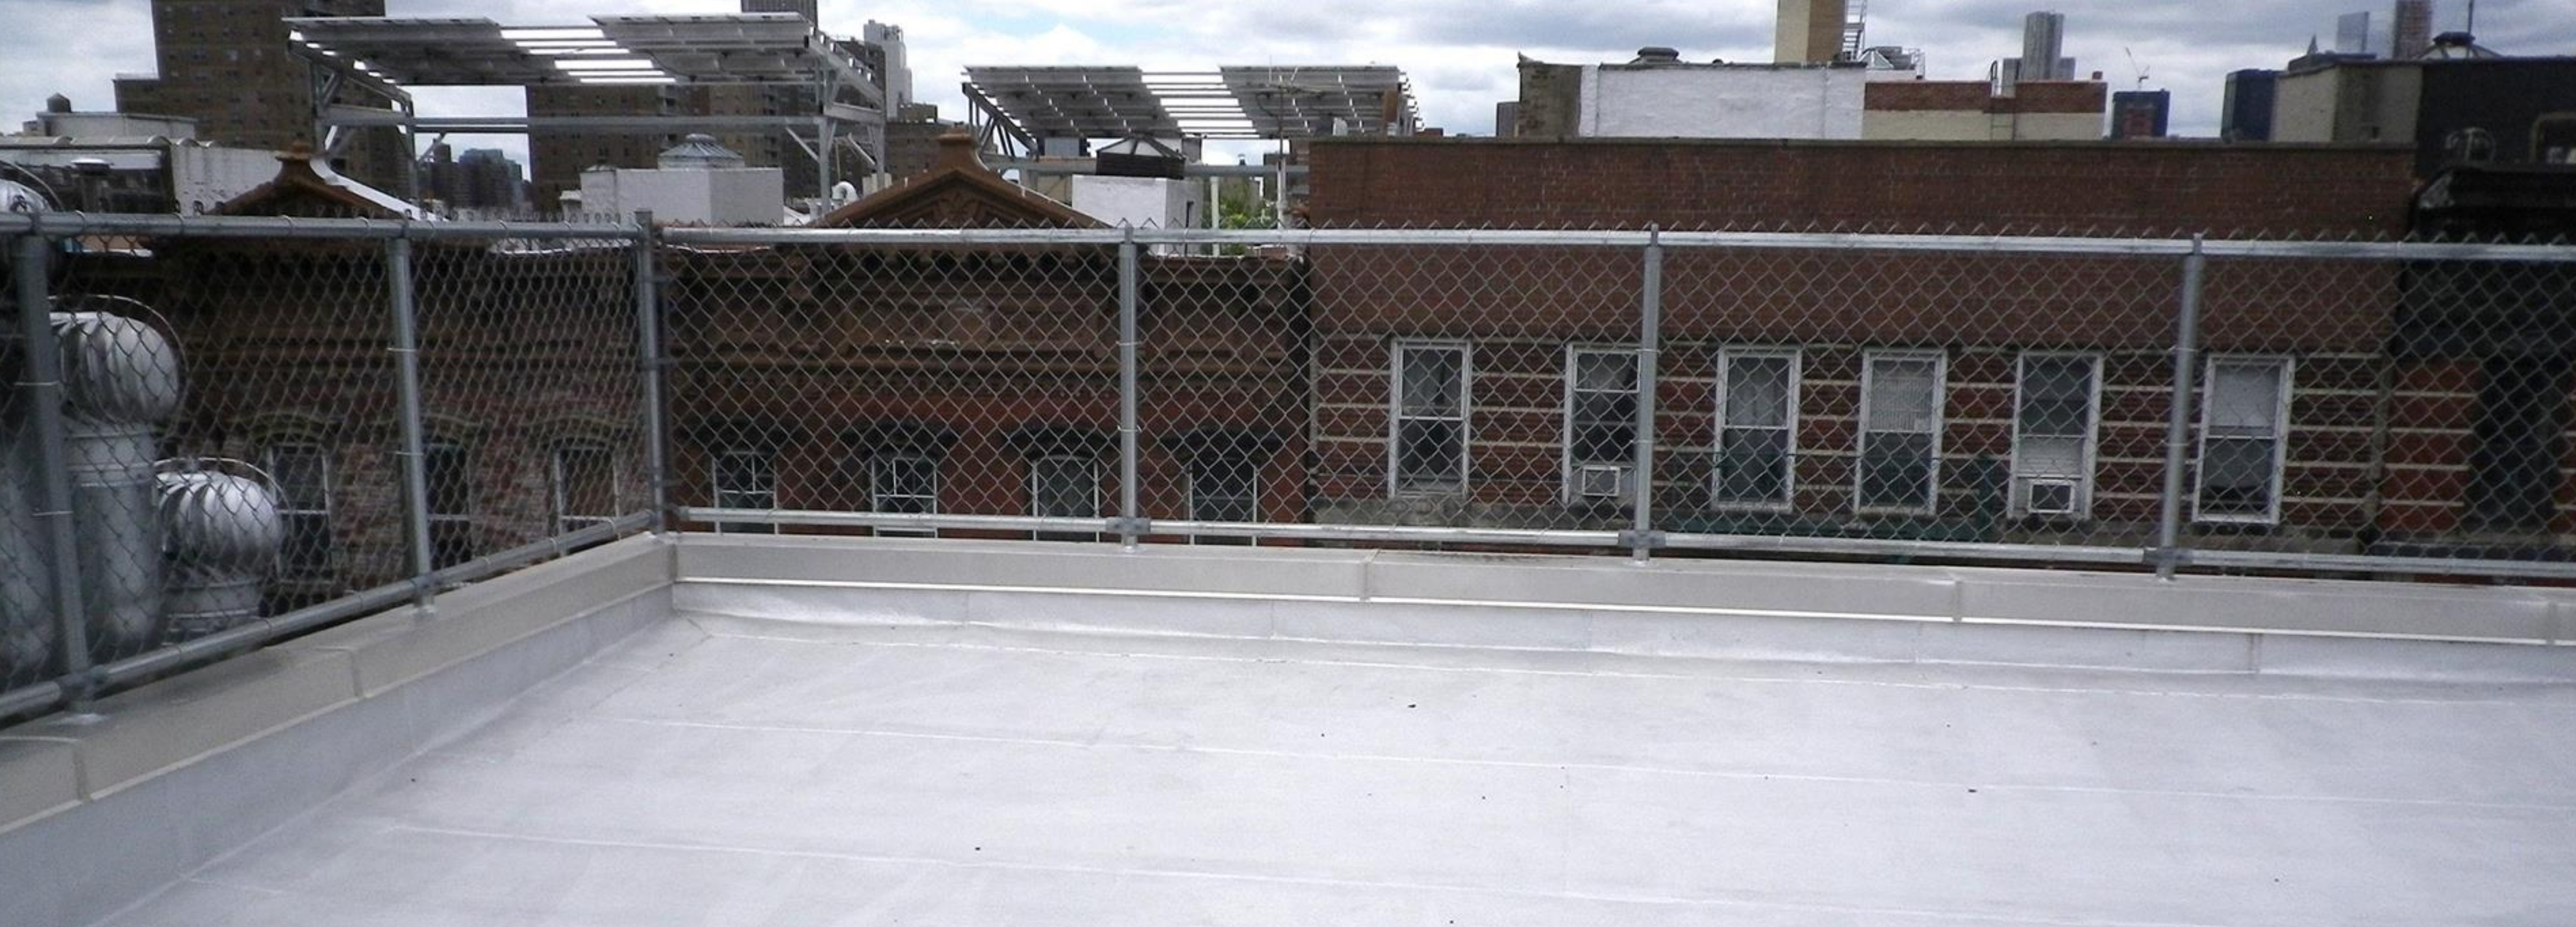
MAINTENANCE CAN WORK. New roof completed in 2007. Exposed membrane over 6" XPS.

Coating was applied in 2008. This photograph was taken in July 2015.

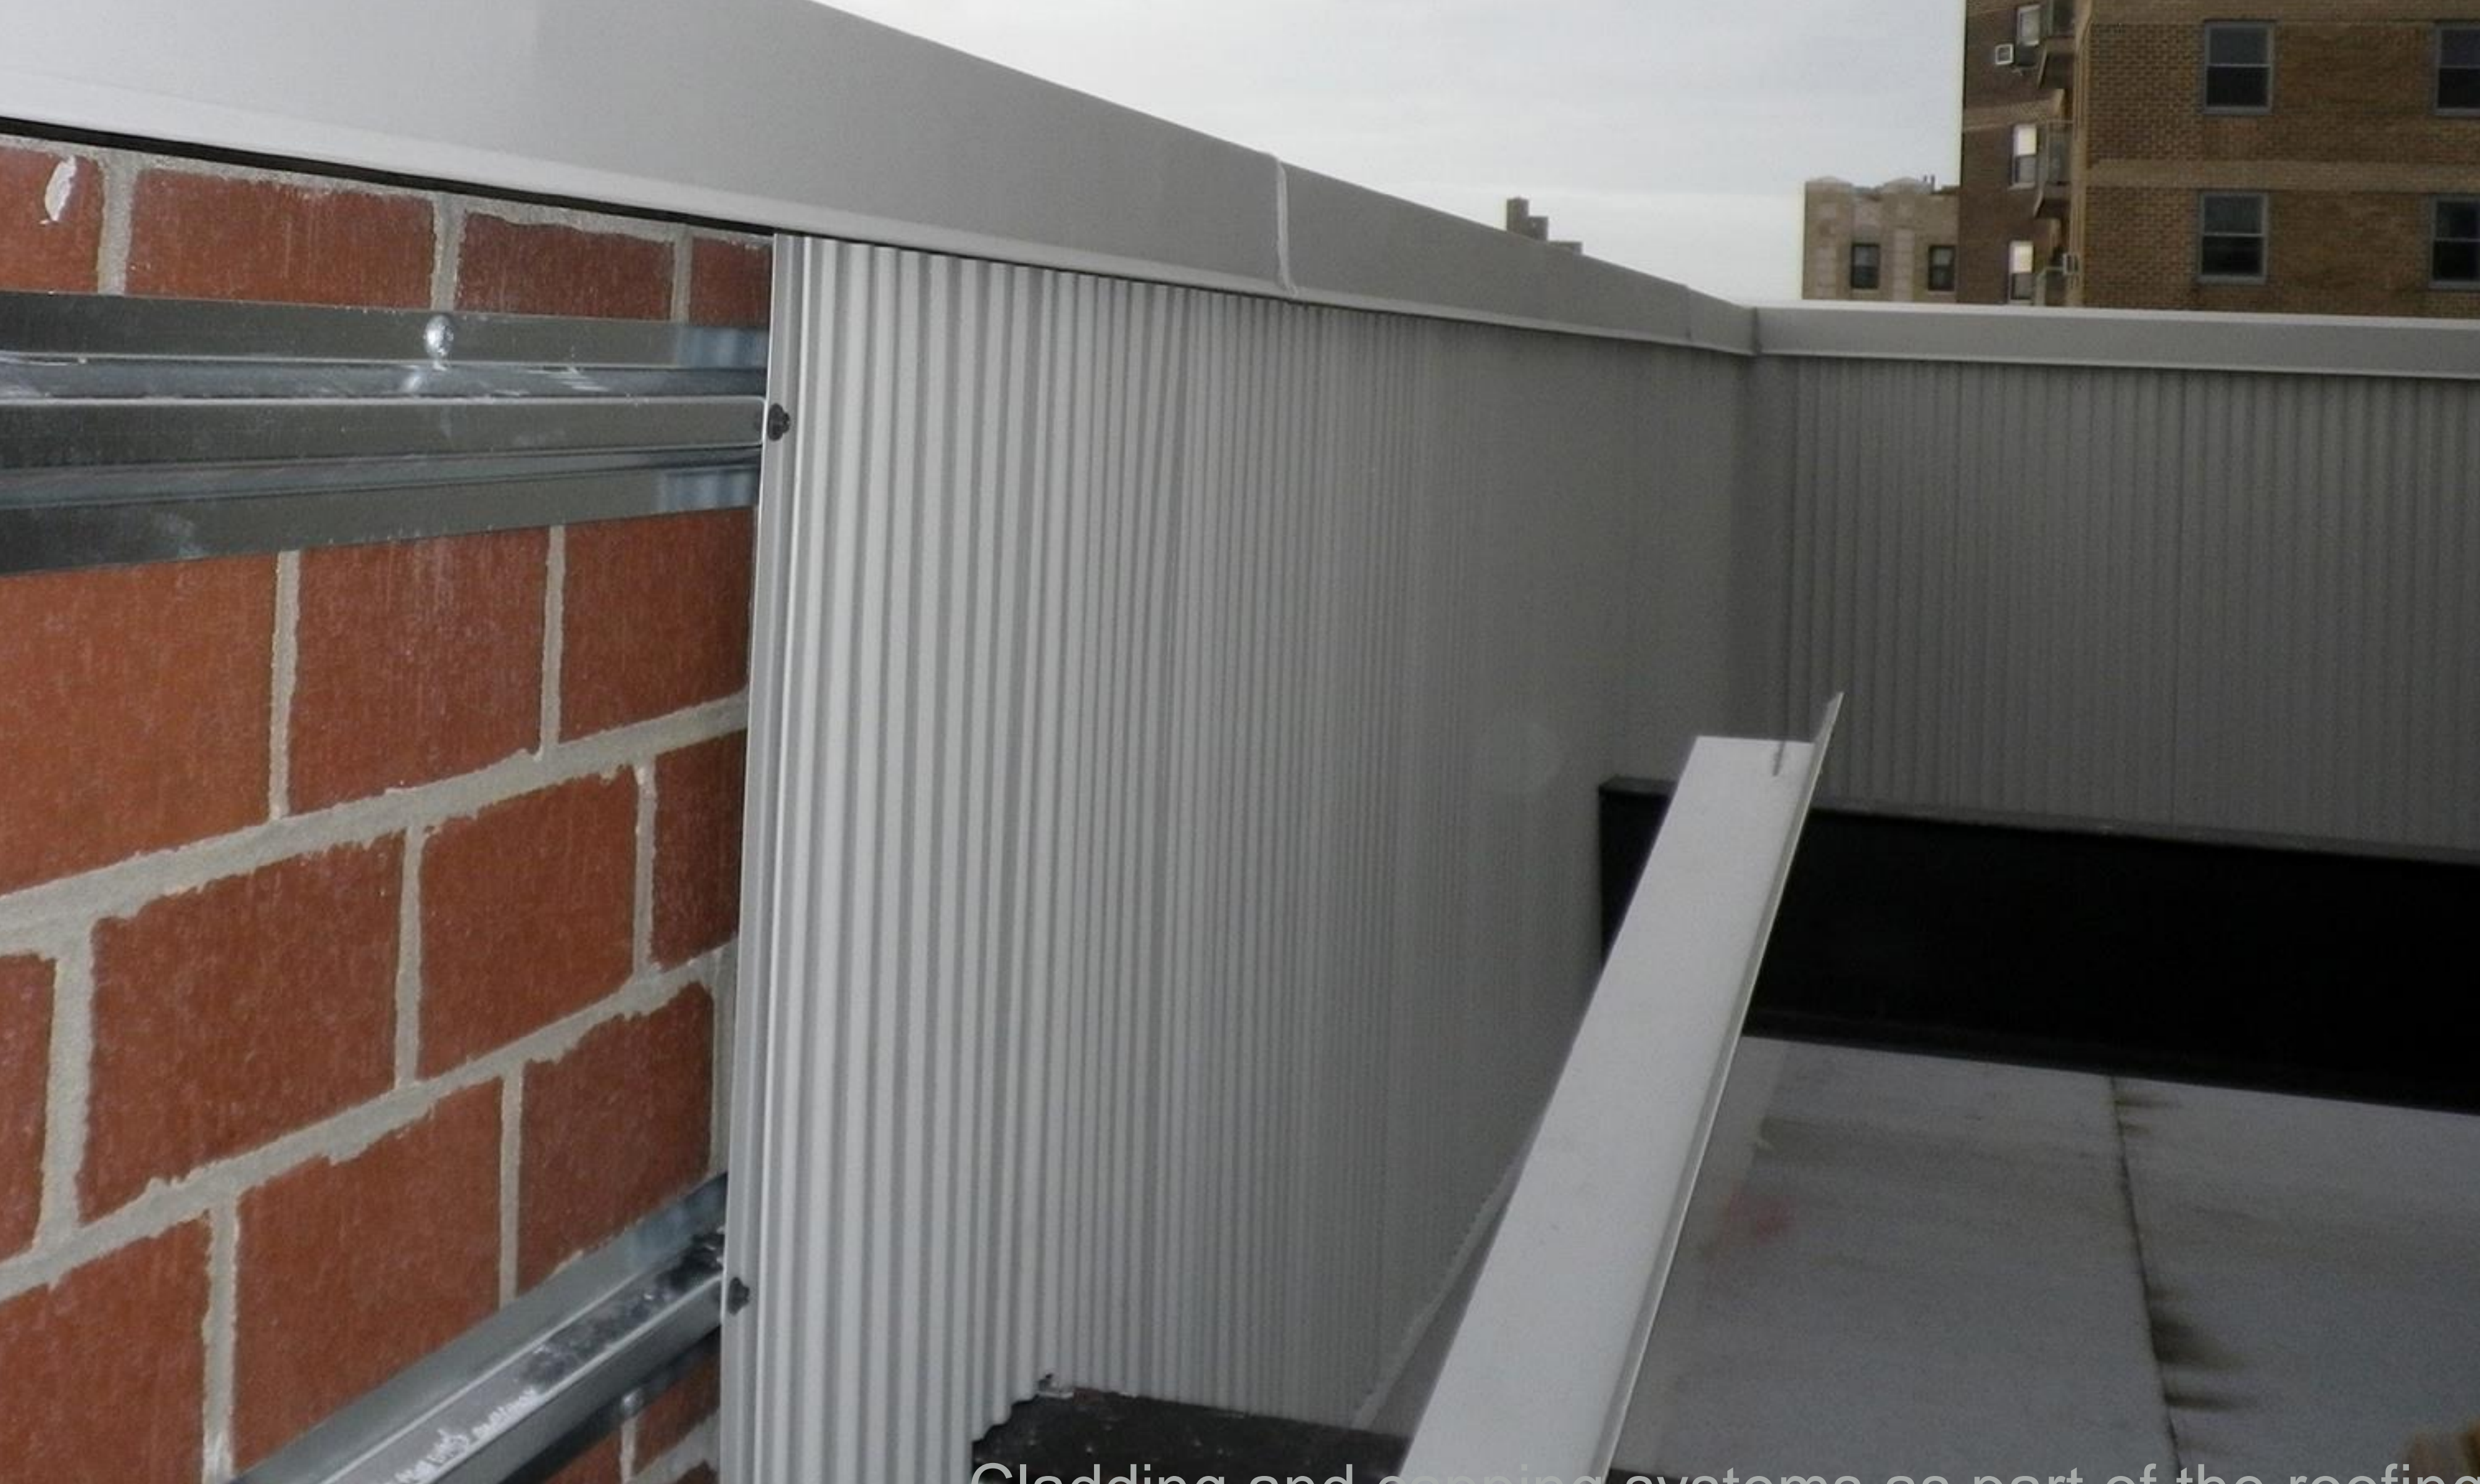
Cladding and capping systems as part of the roofing system allows the elimination of problematic traditional wall flashing.
