ROOFING REALITIES NESEA March 2016

IT'S ALL IN THE DETAILS

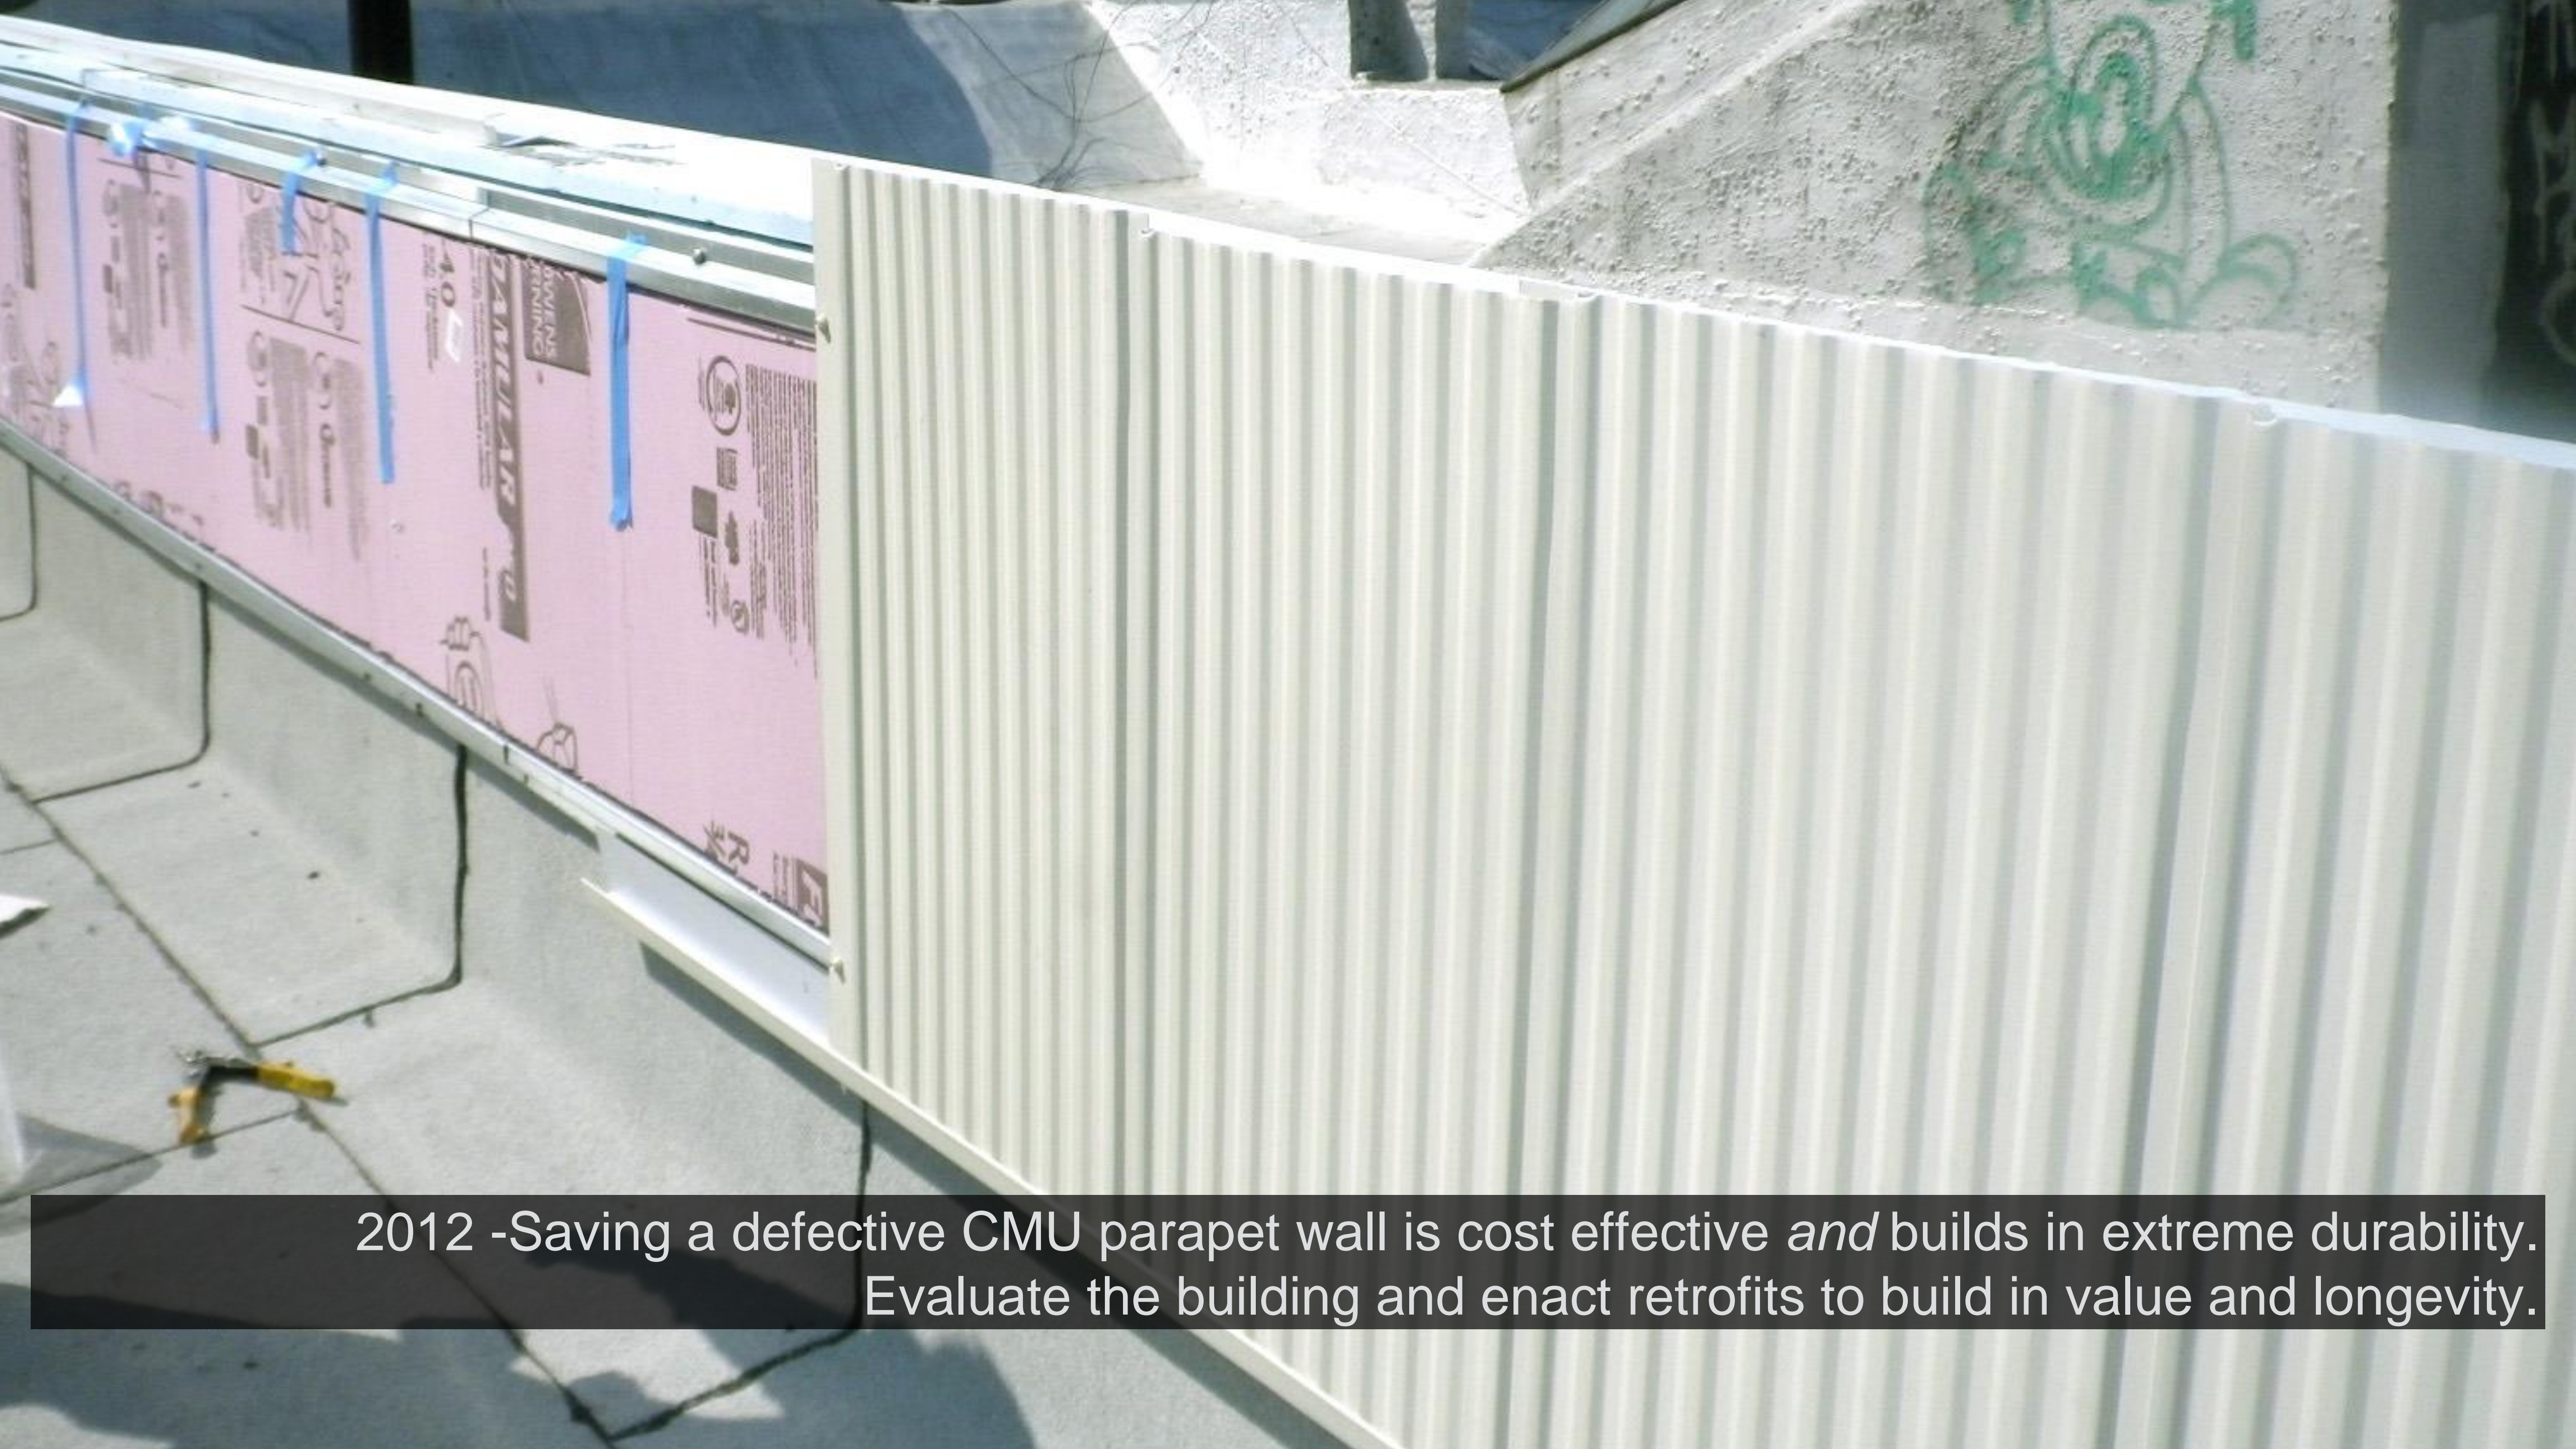
2012 -Saving a defective CMU parapet wall is cost effective *and* builds in extreme durability.
Evaluate the building and enact retrofits to build in value and longevity.

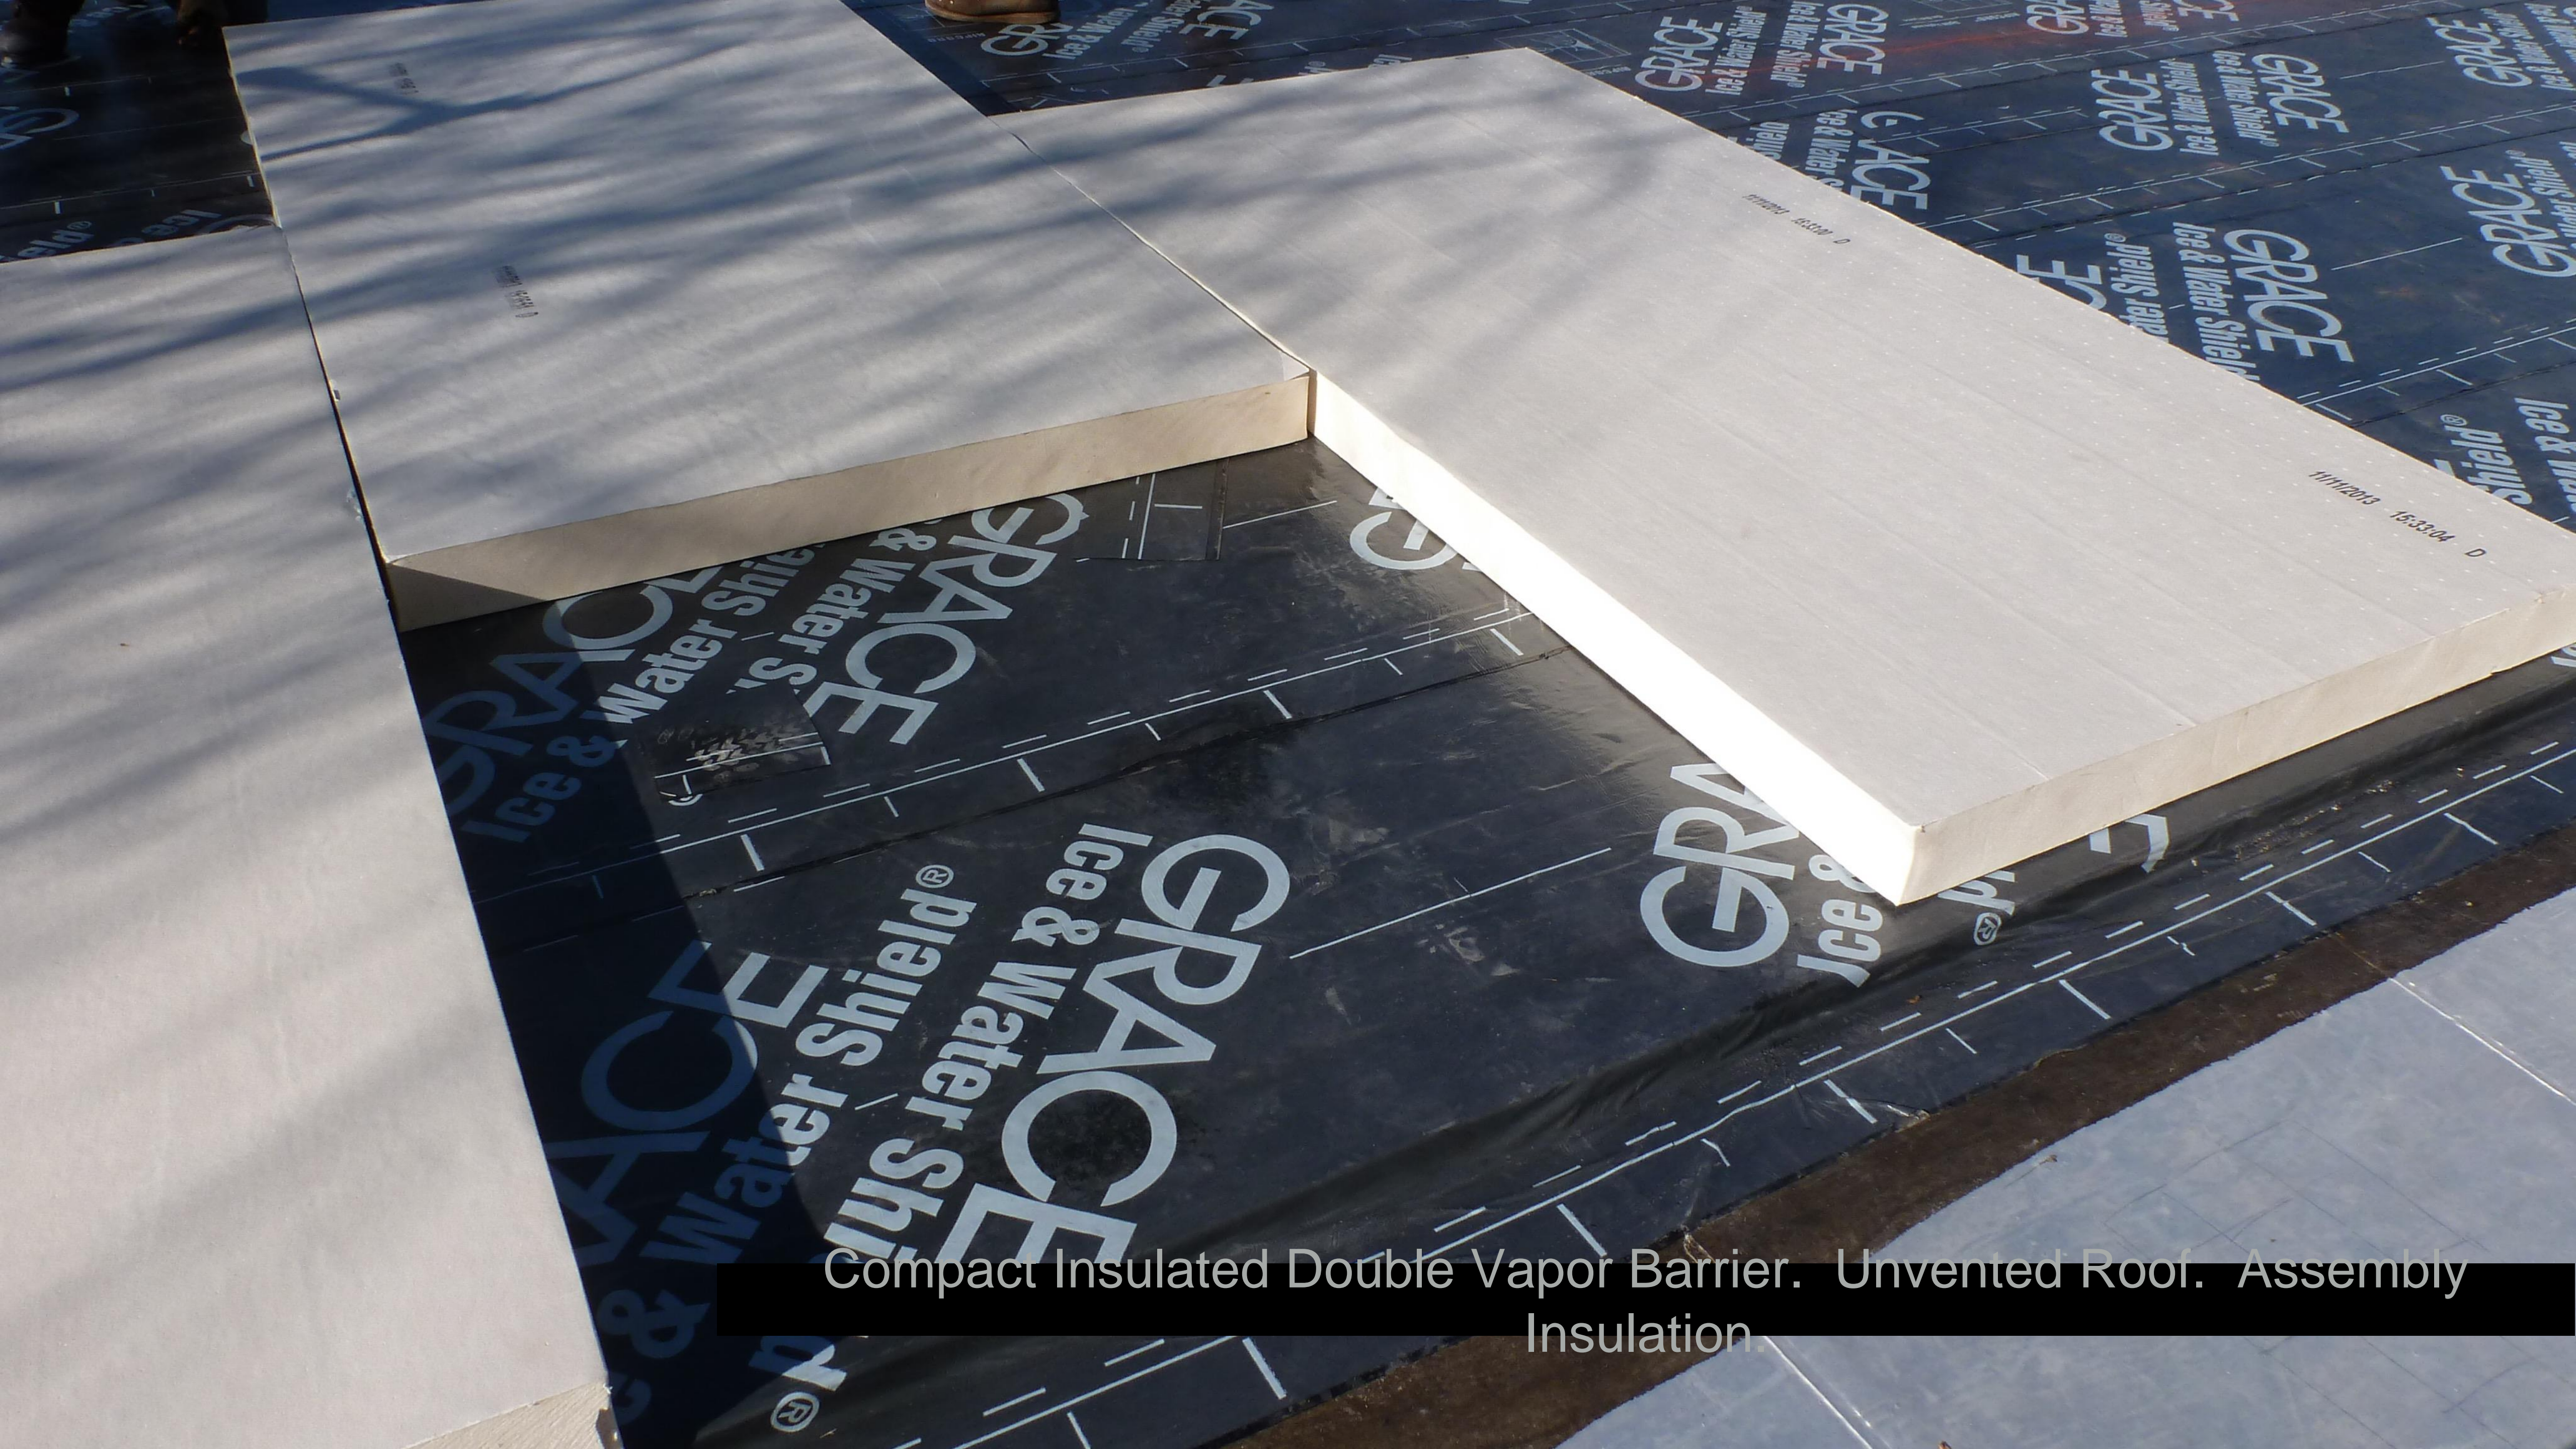
Compact Insulated Double Vapor Barrier. Unvented Roof. Assembly Insulation.

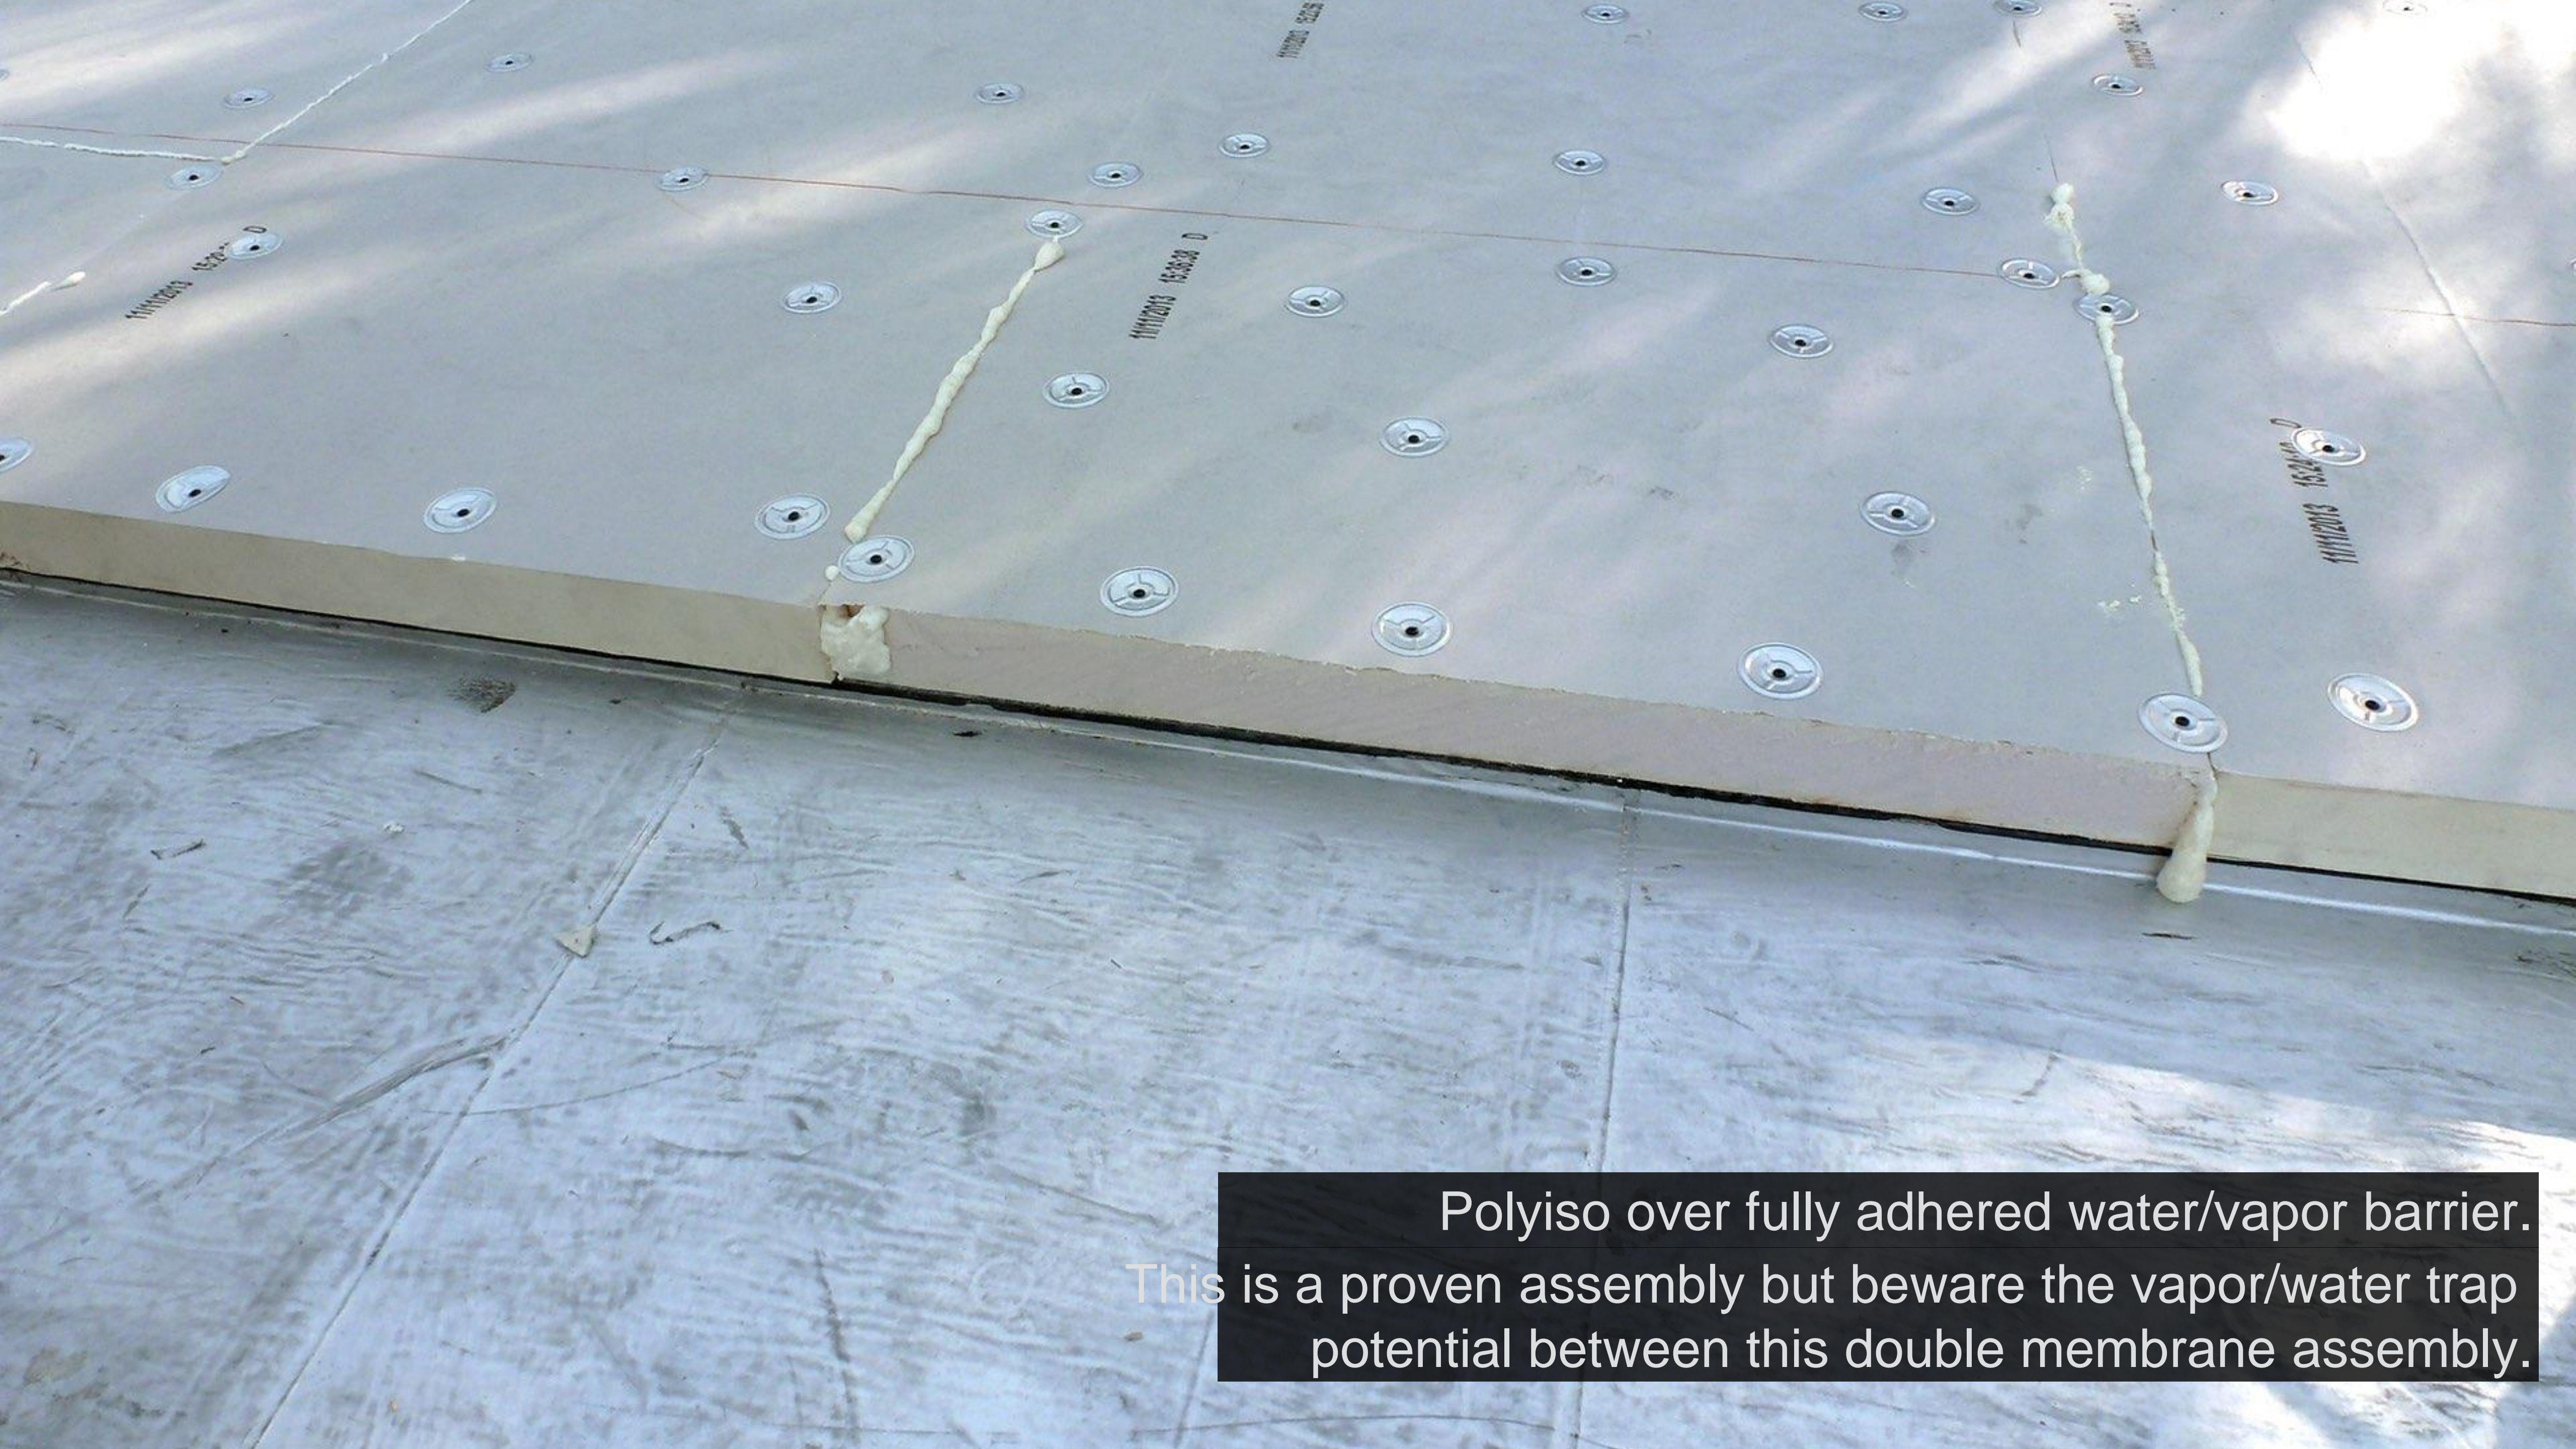
Polyiso over fully adhered water/vapor barrier. This is a proven assembly but beware the vapor/water trap potential between this double membrane assembly.

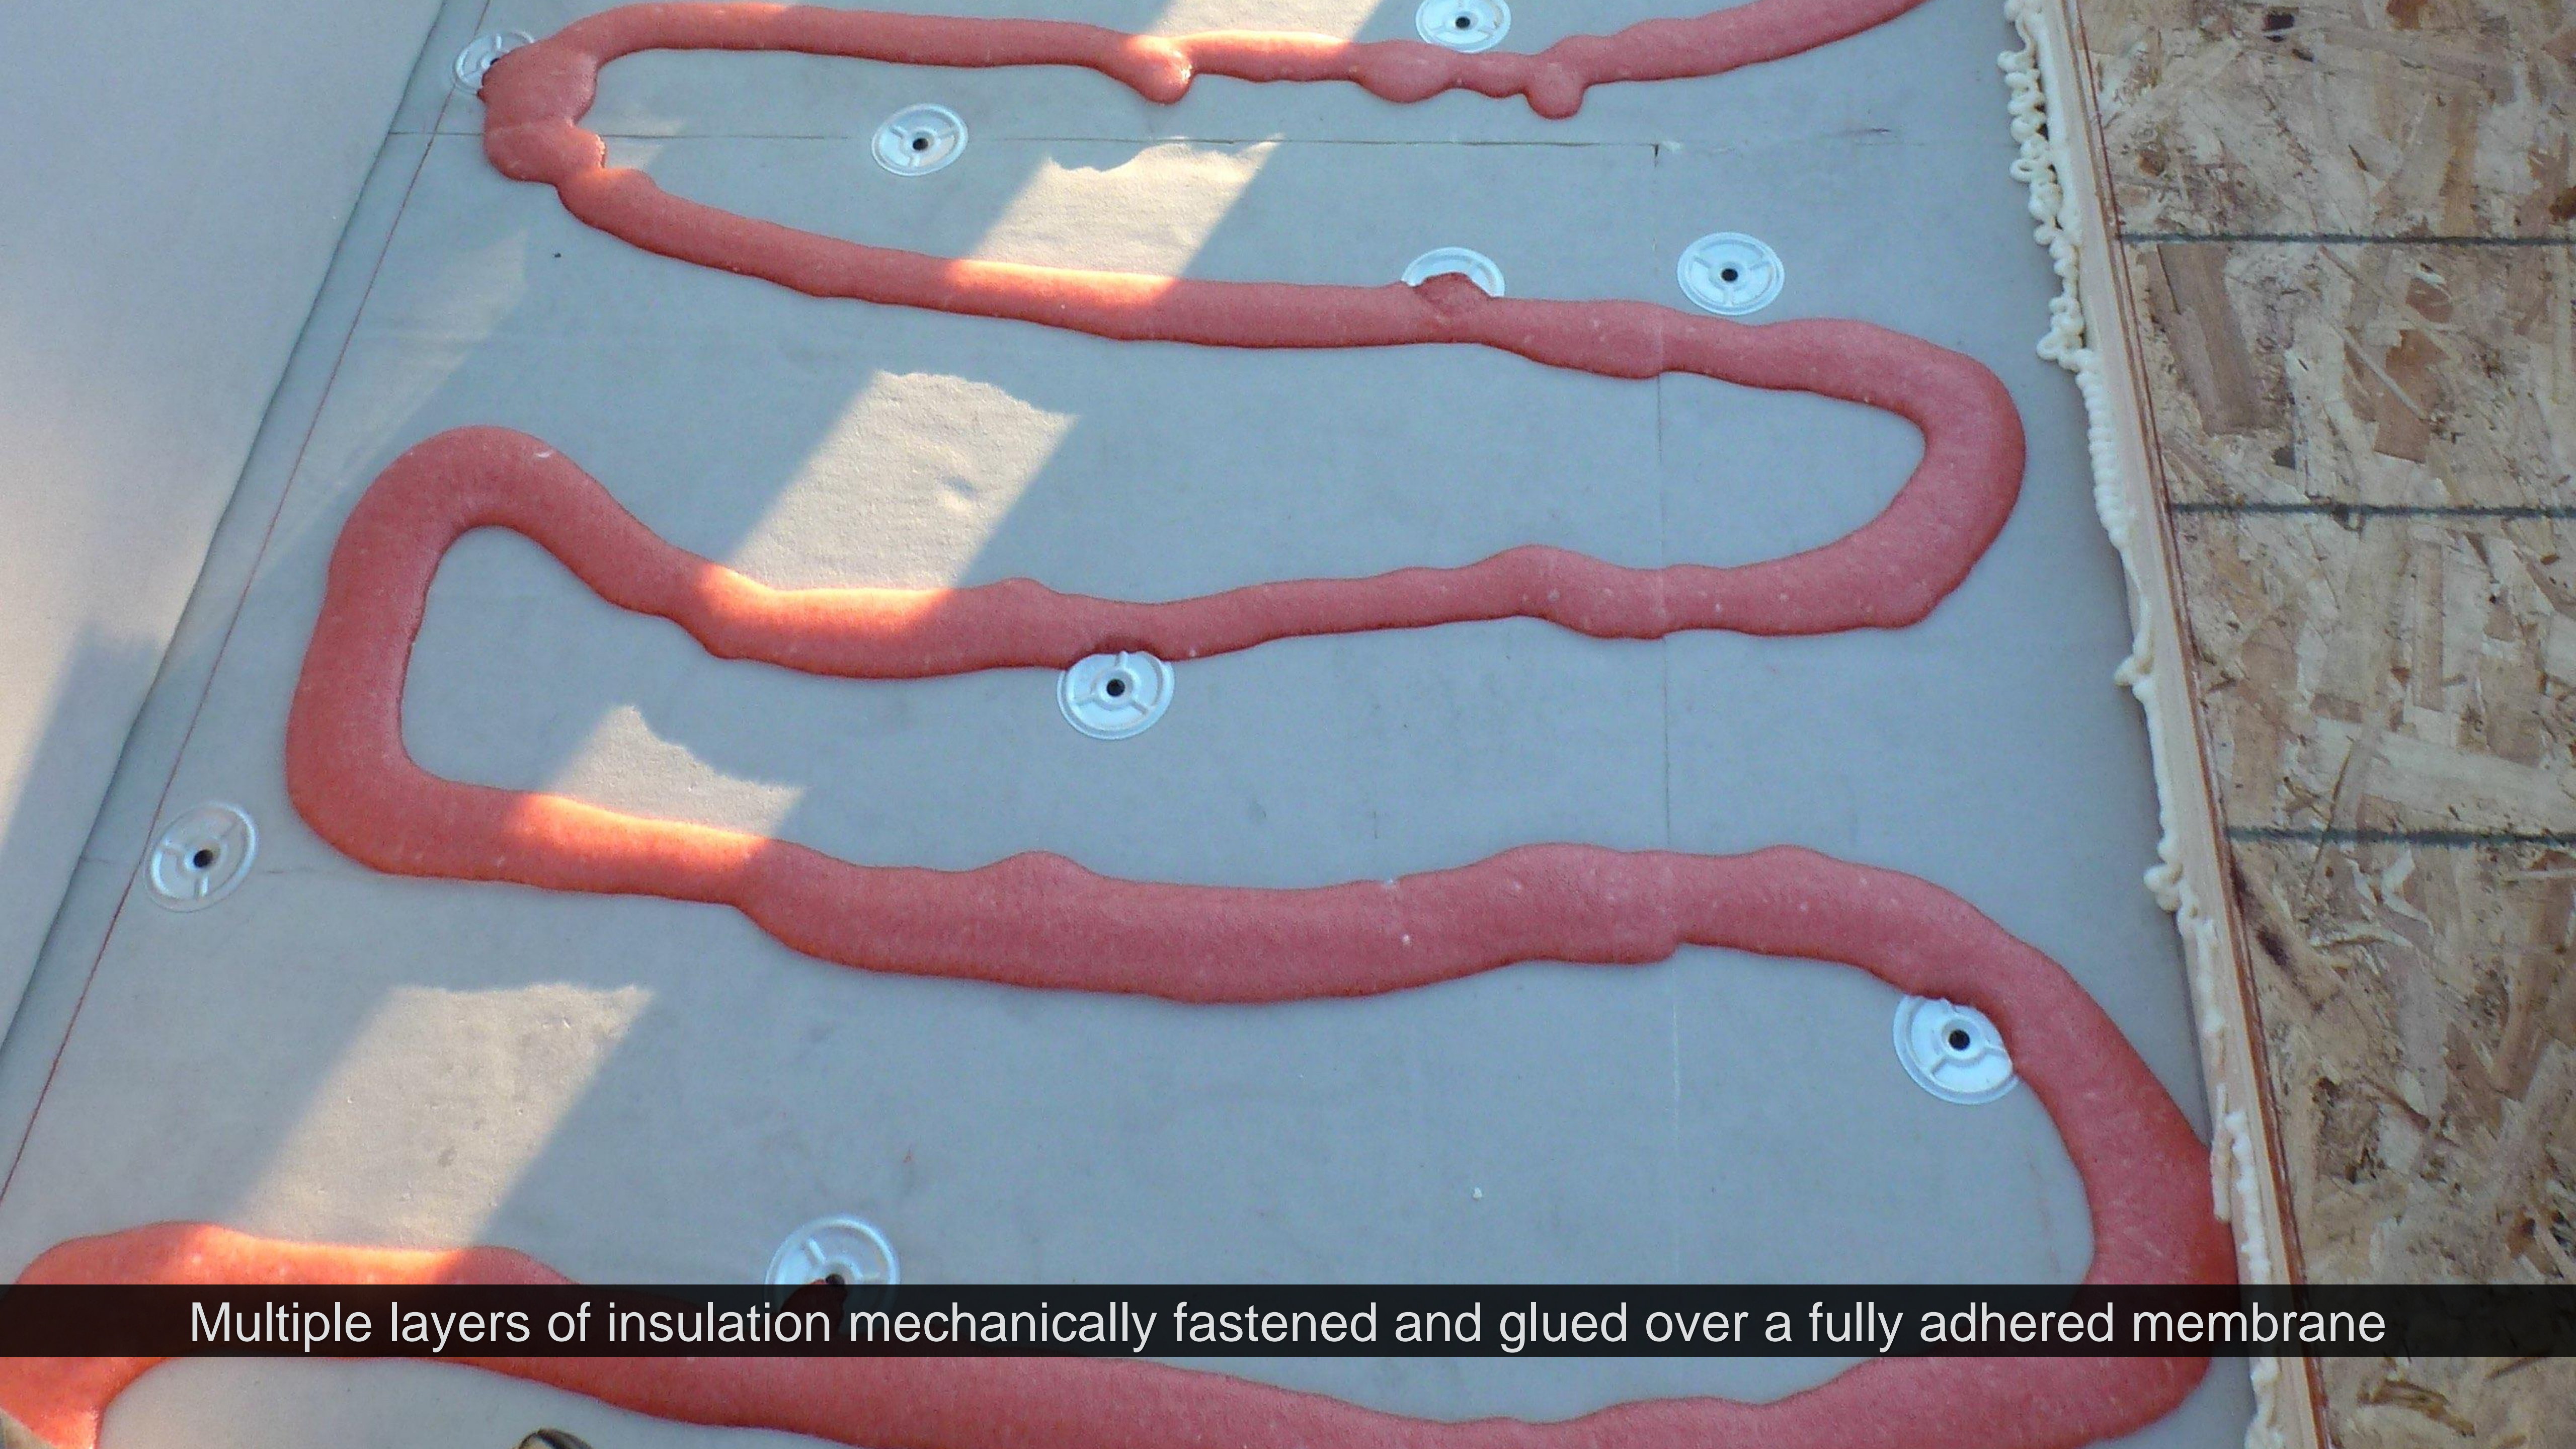
Multiple layers of insulation mechanically fastened and glued over a fully adhered membrane

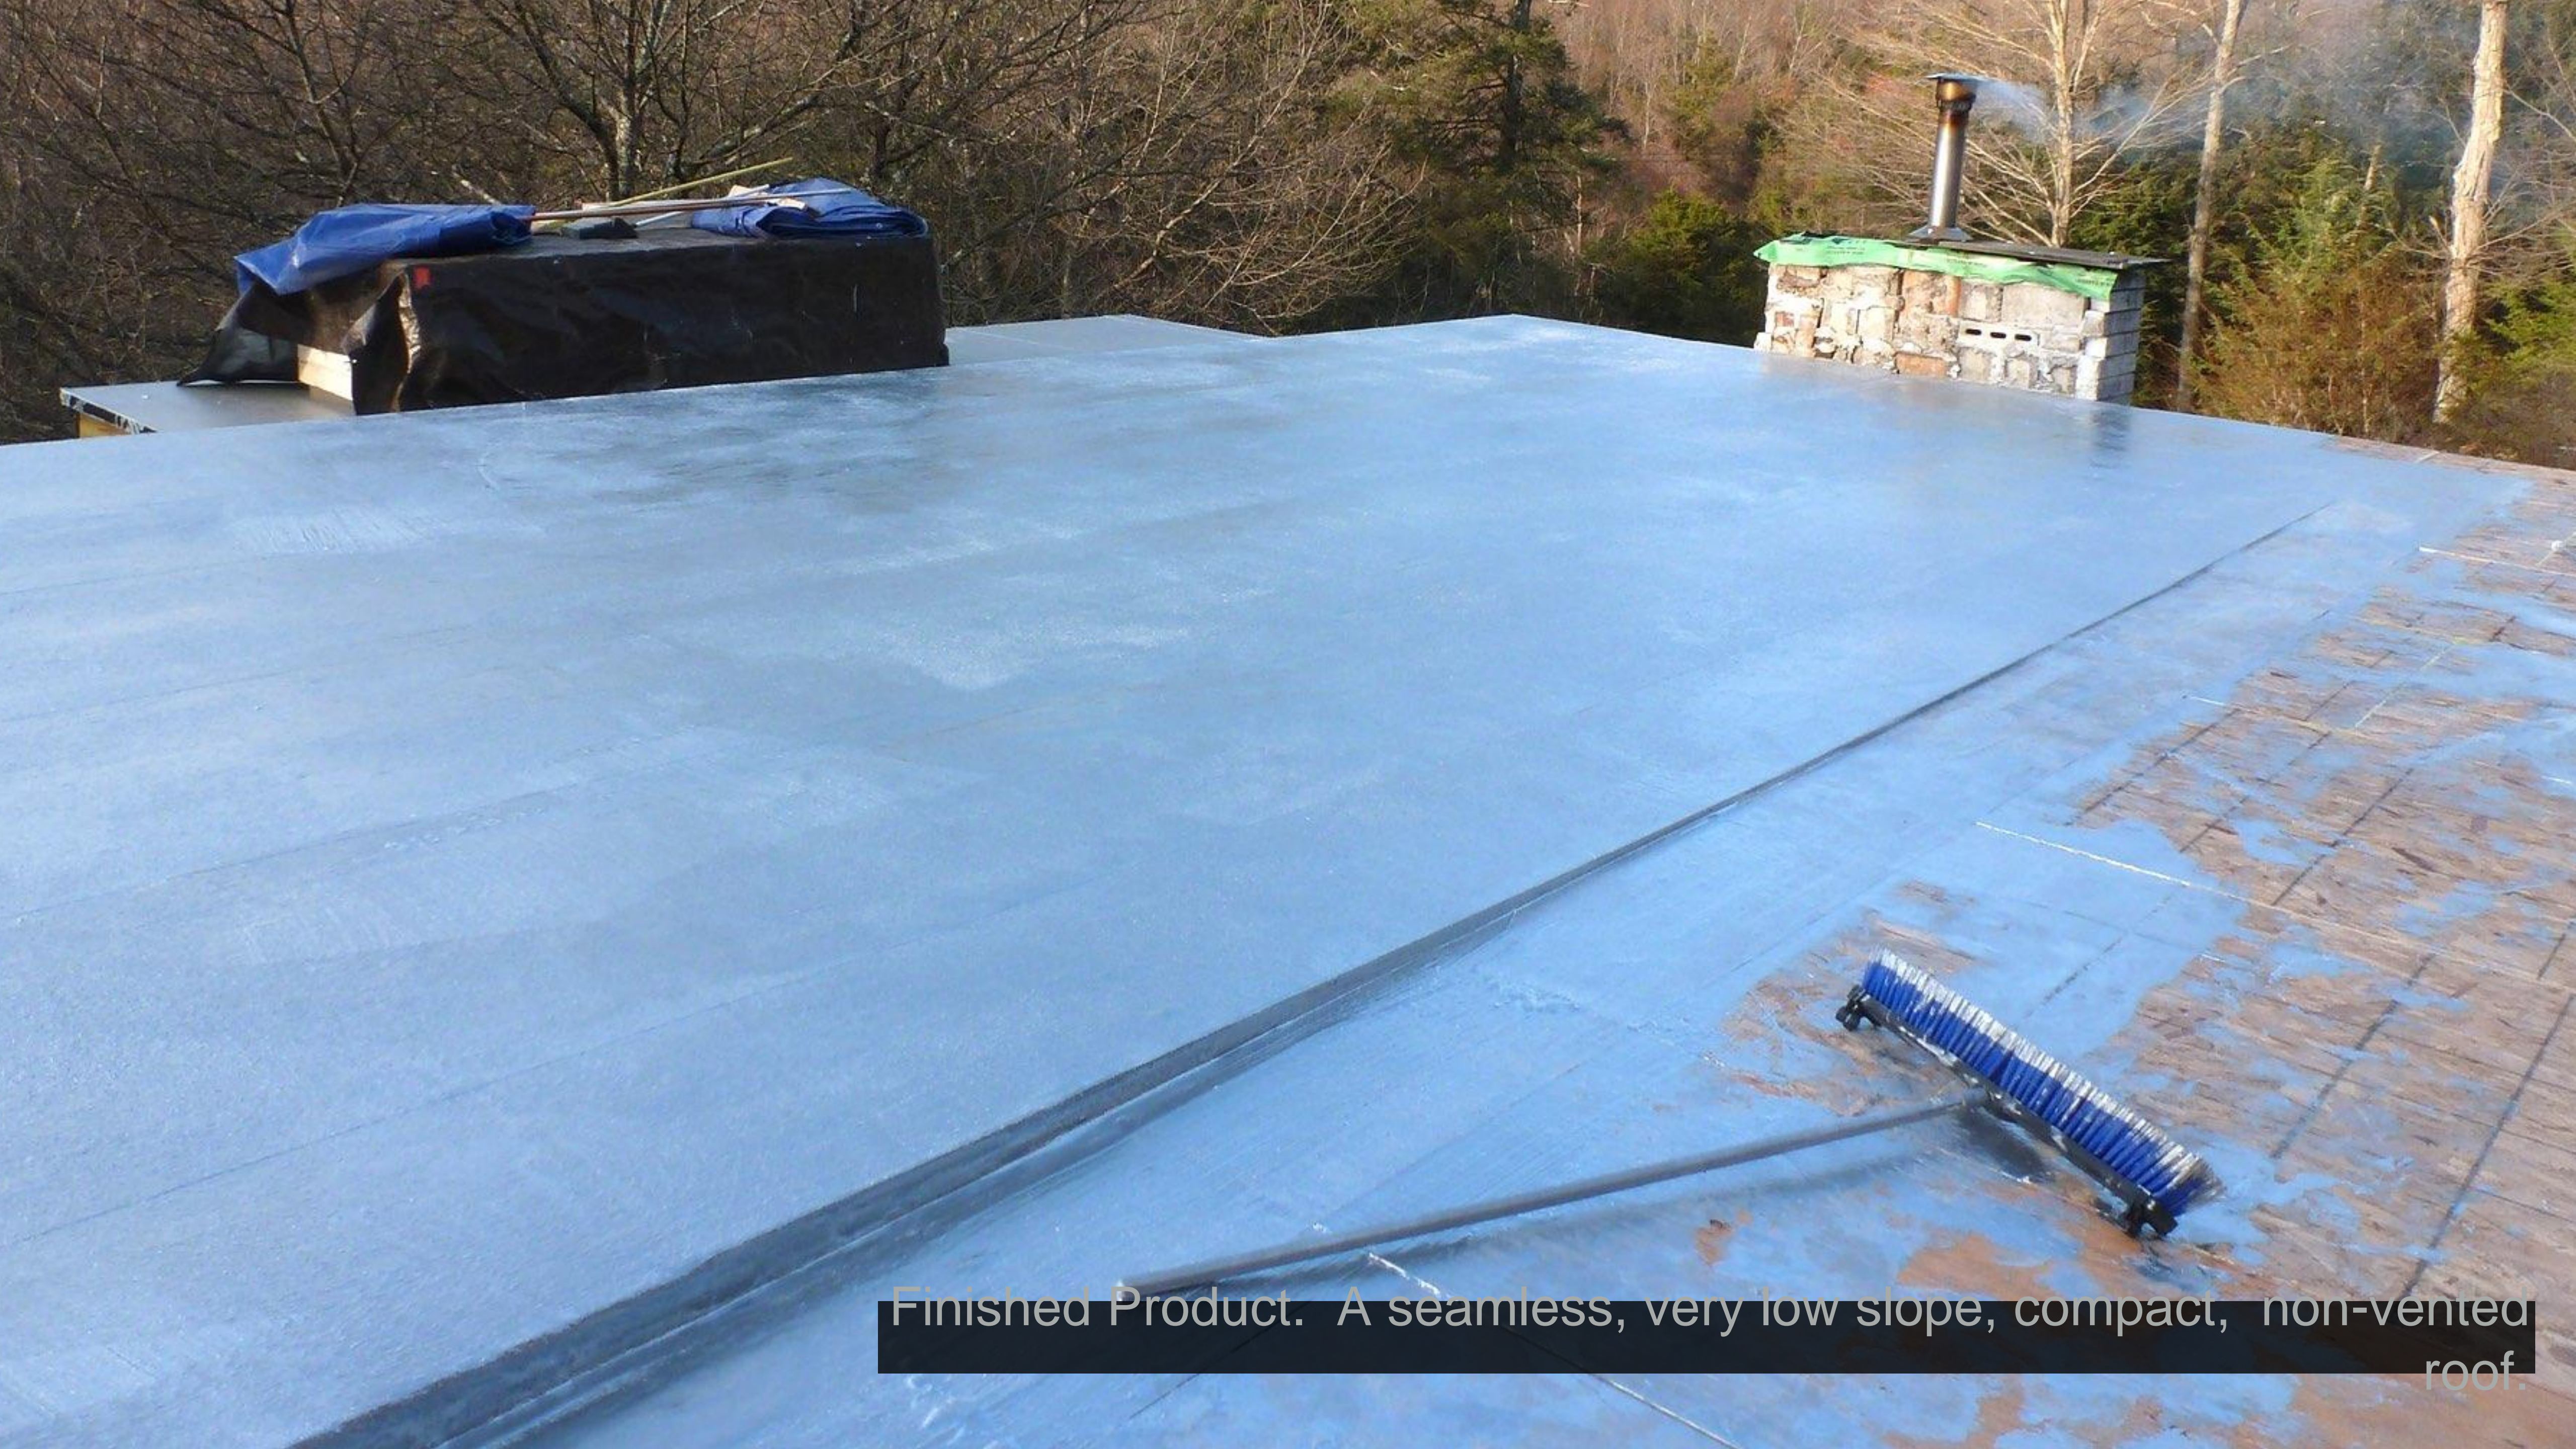
Finished Product. A seamless, very low slope, compact, non-vented roof.

A double vapor barrier roof assembly circa 1975, by Max Baker, master of roofing and building science.

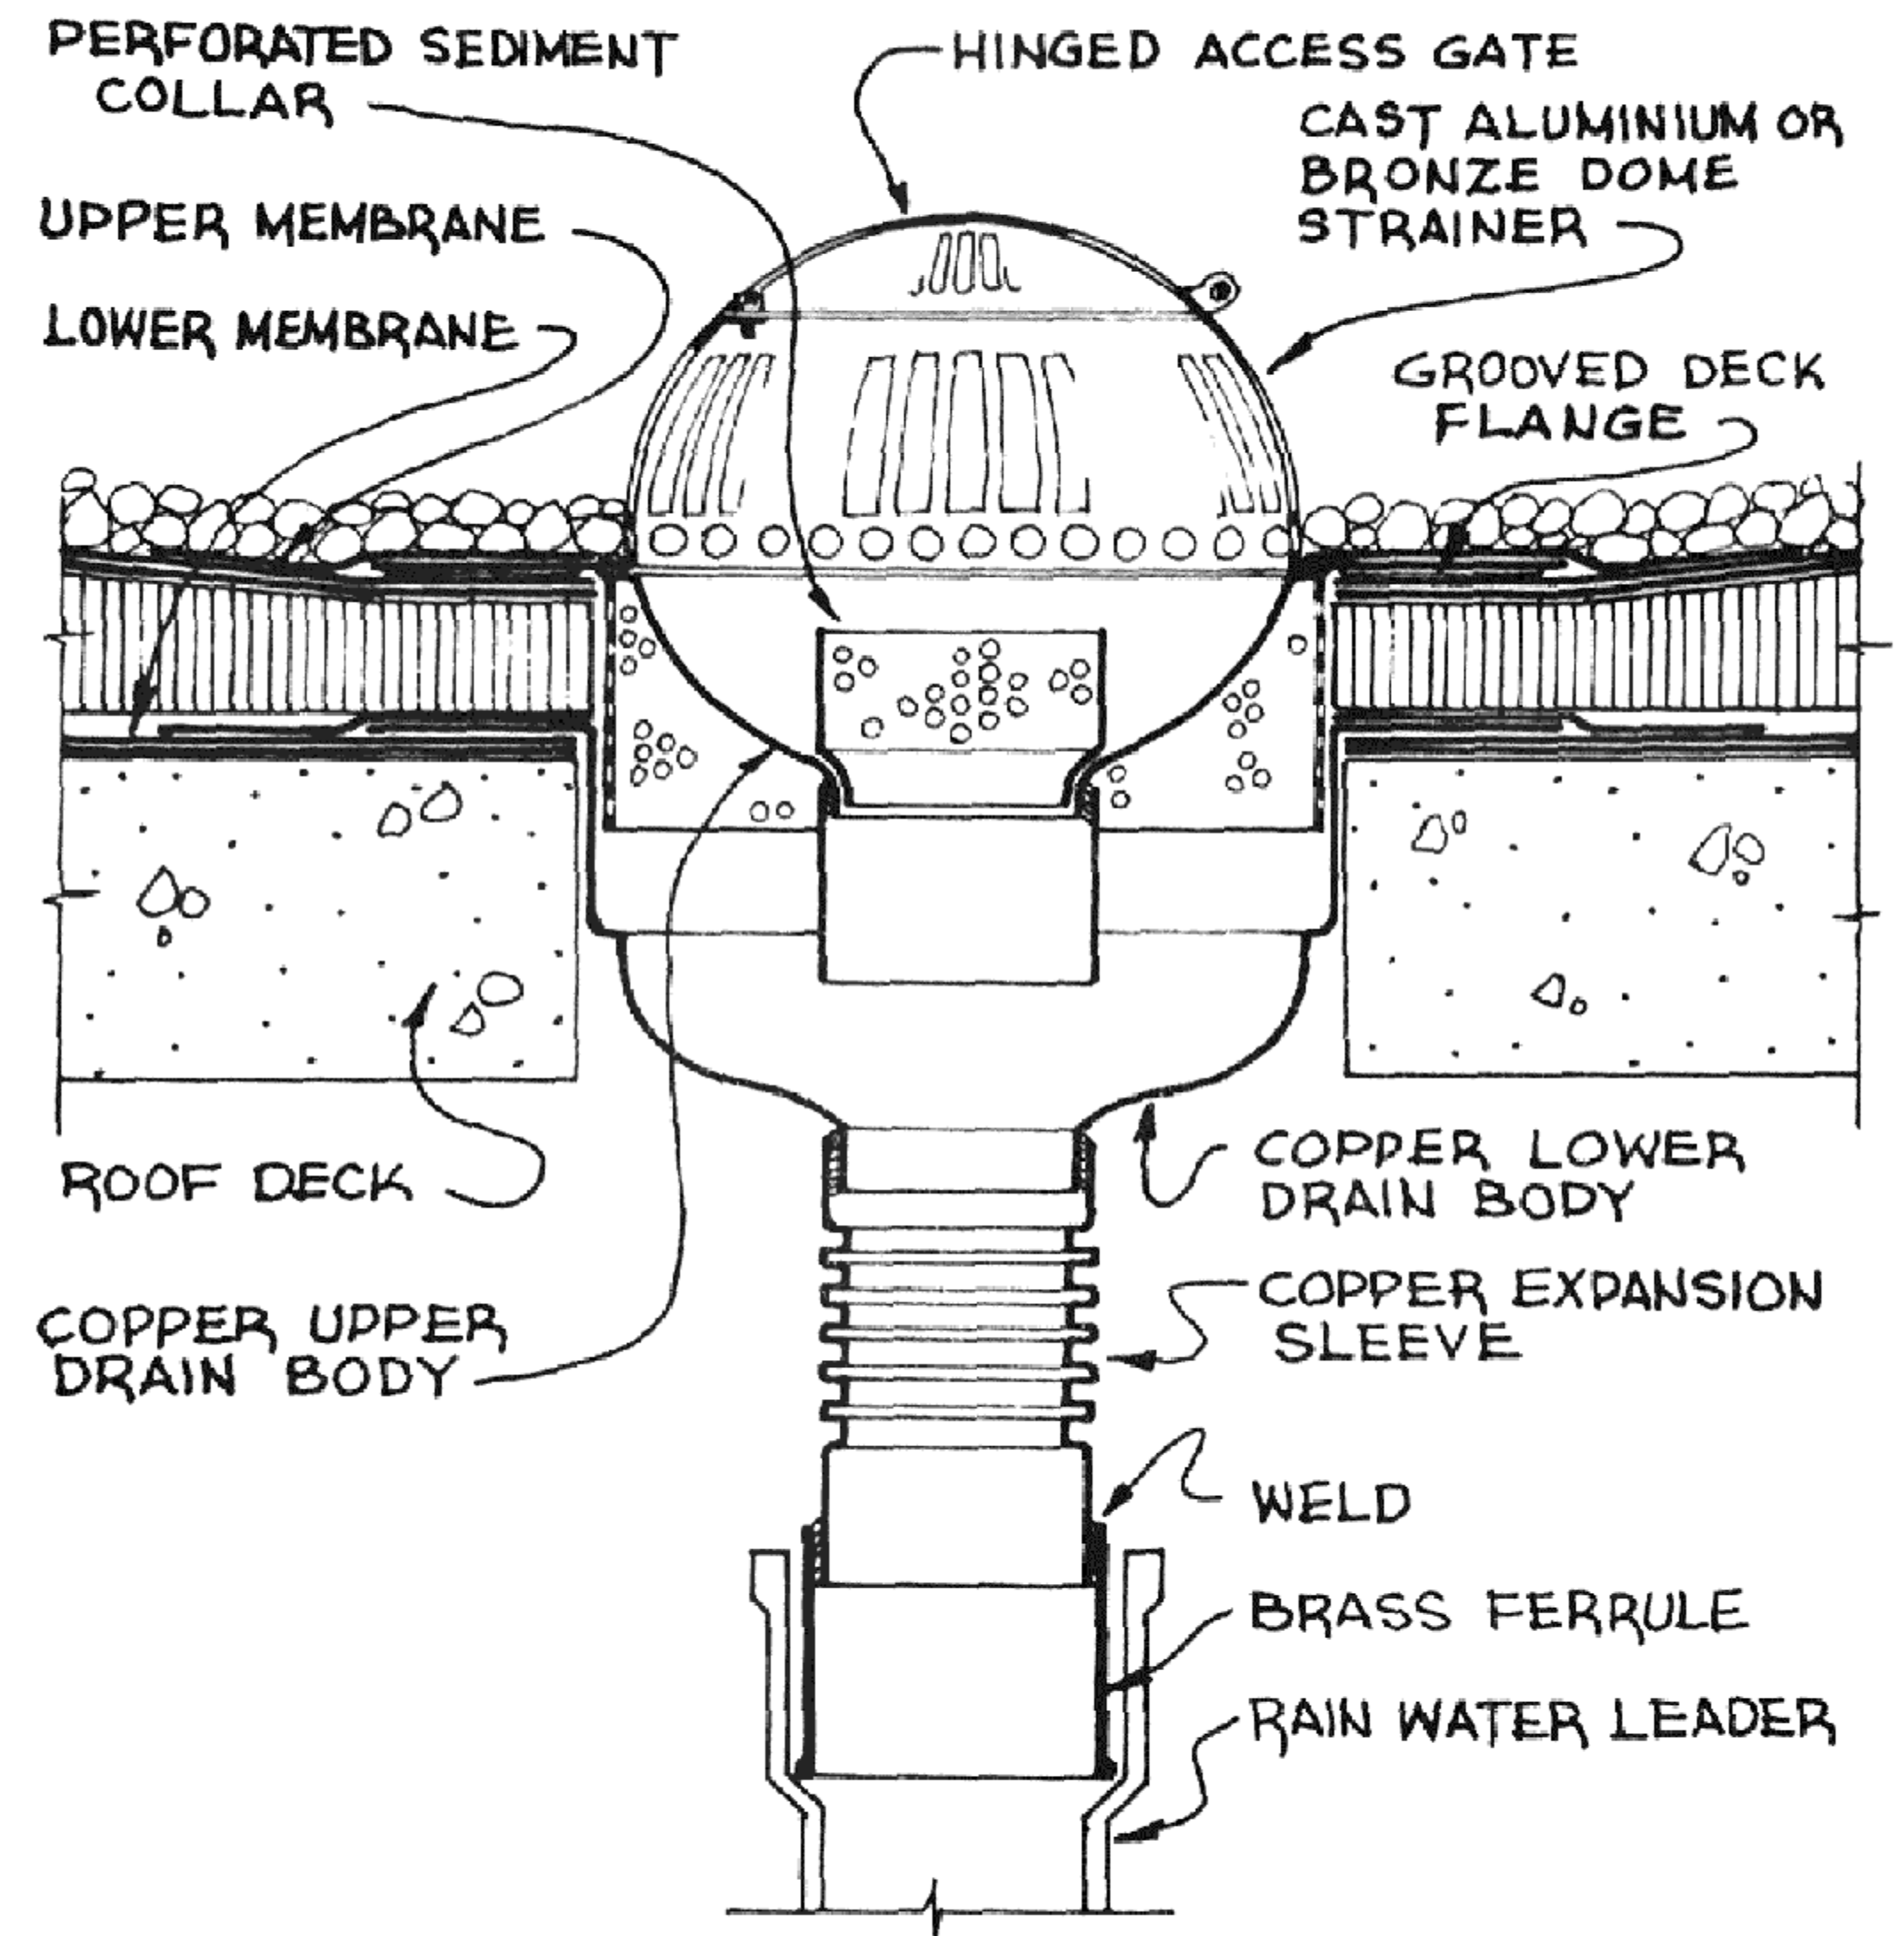
Figure 7-15. Two-part copper drain for drainage at both membranes of a double membrane roof system.
