BUILDINGENERGY NYC

Inside and Out: Insulating Our Existing Masonry Buildings

October 12, 2023

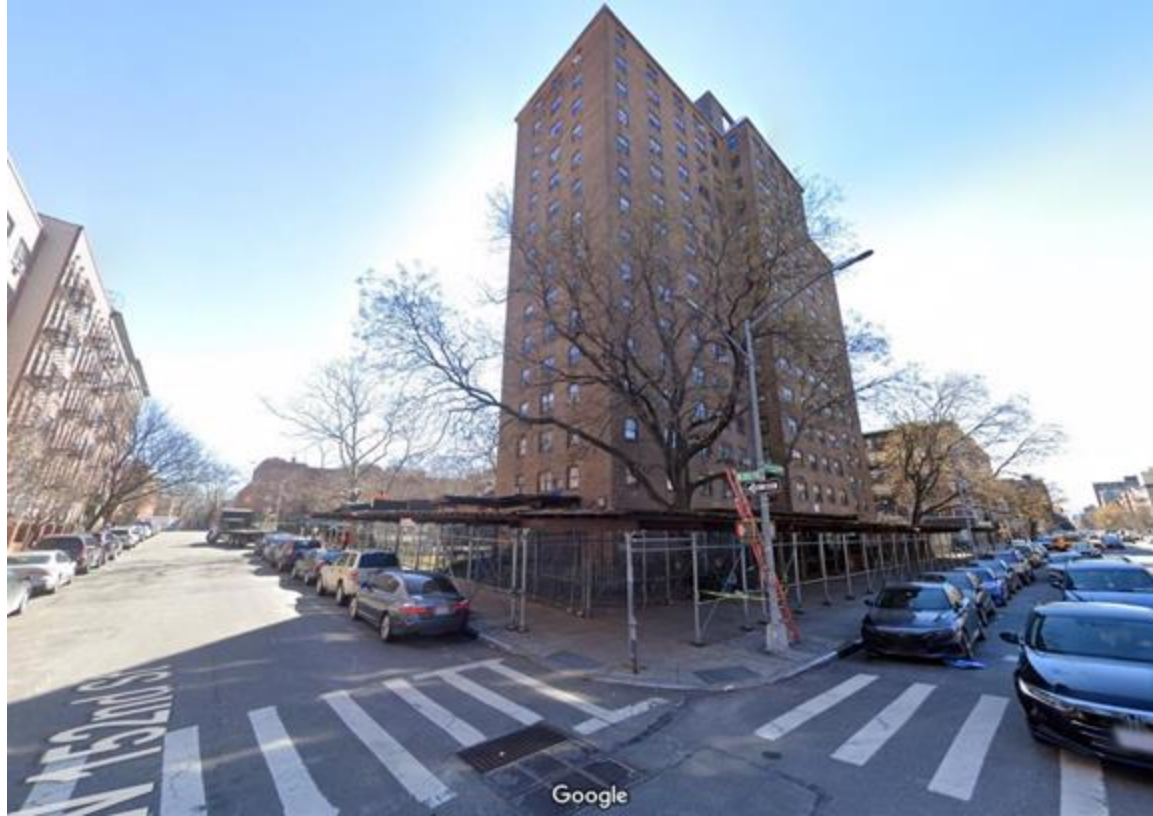
Before

Harlem River II overcladding

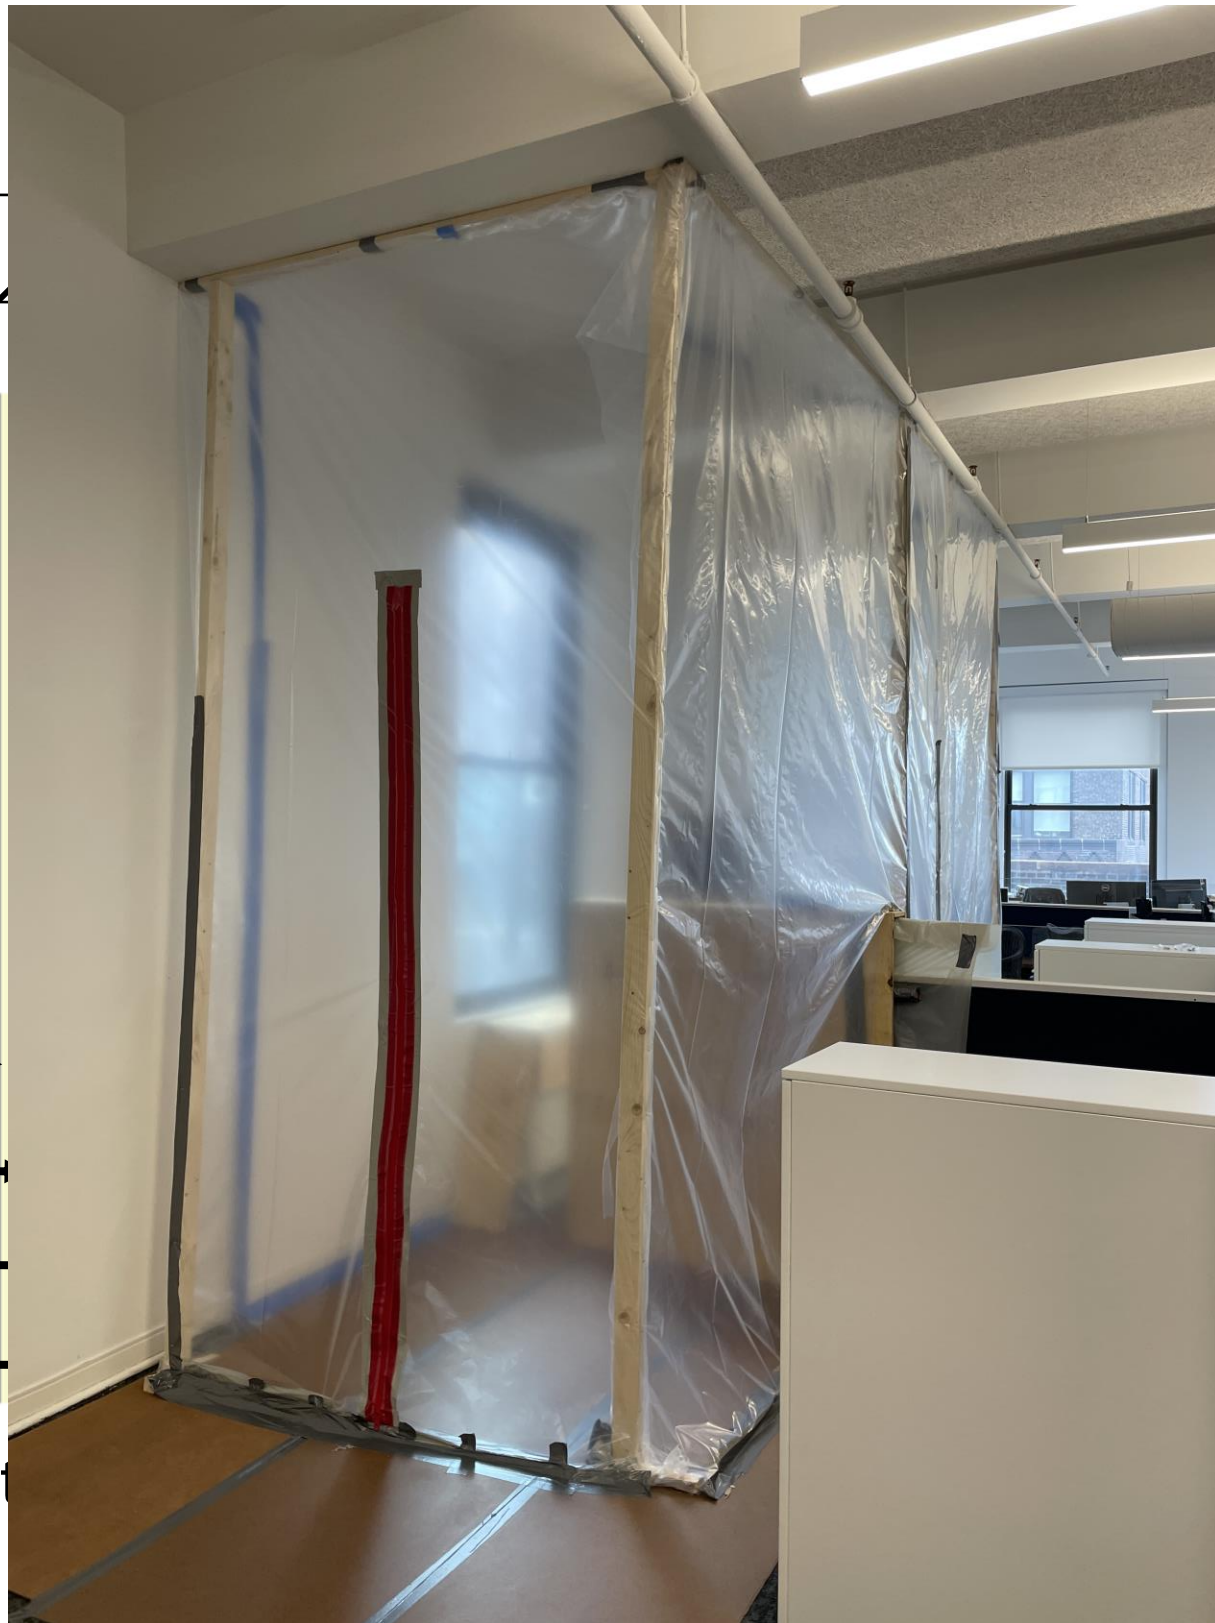
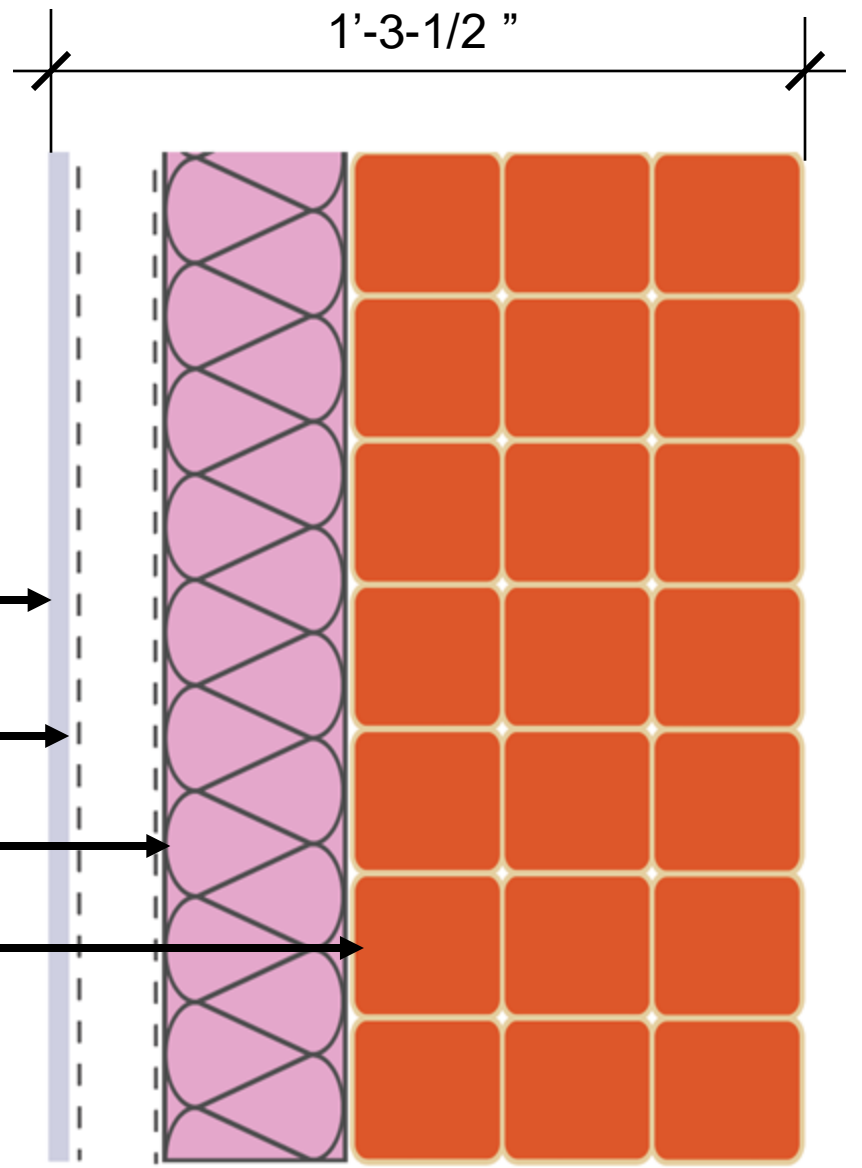
- GWB
- Finishes
- Stud Framing
- Insulation
- (E) Plaster Finishes
- (E) Terracotta Block
- (E) Air Space
- (E) Brick Masonry

Remove existing interior finishes

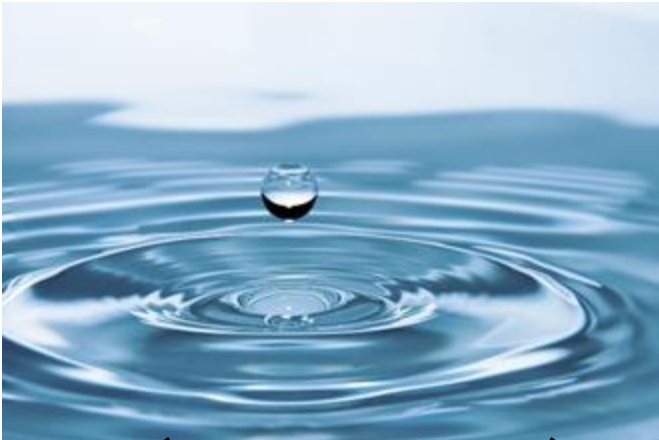
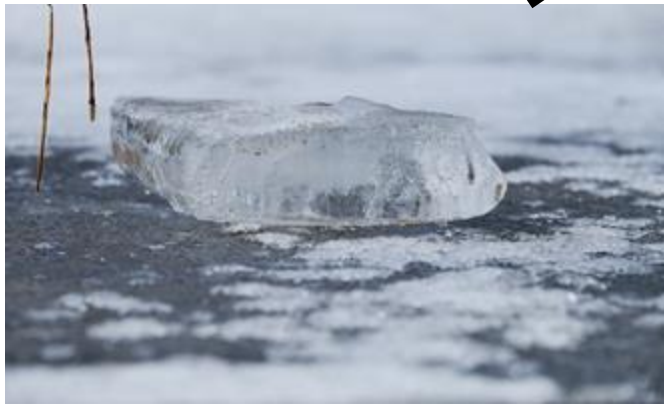
Freeze

Freeze/Thaw Damage Triangle

Water Absorption (Capillary Suction)

- Water Freezes at $\sim 32^{\circ}\text{F}$
- Water expands $\sim 9\%$ when it freezes

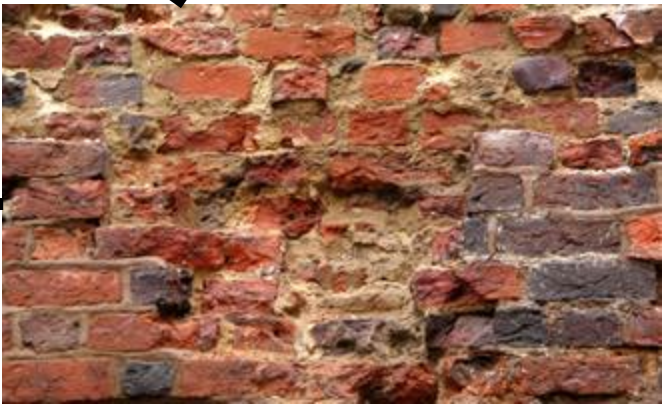
Over-stressed Condition

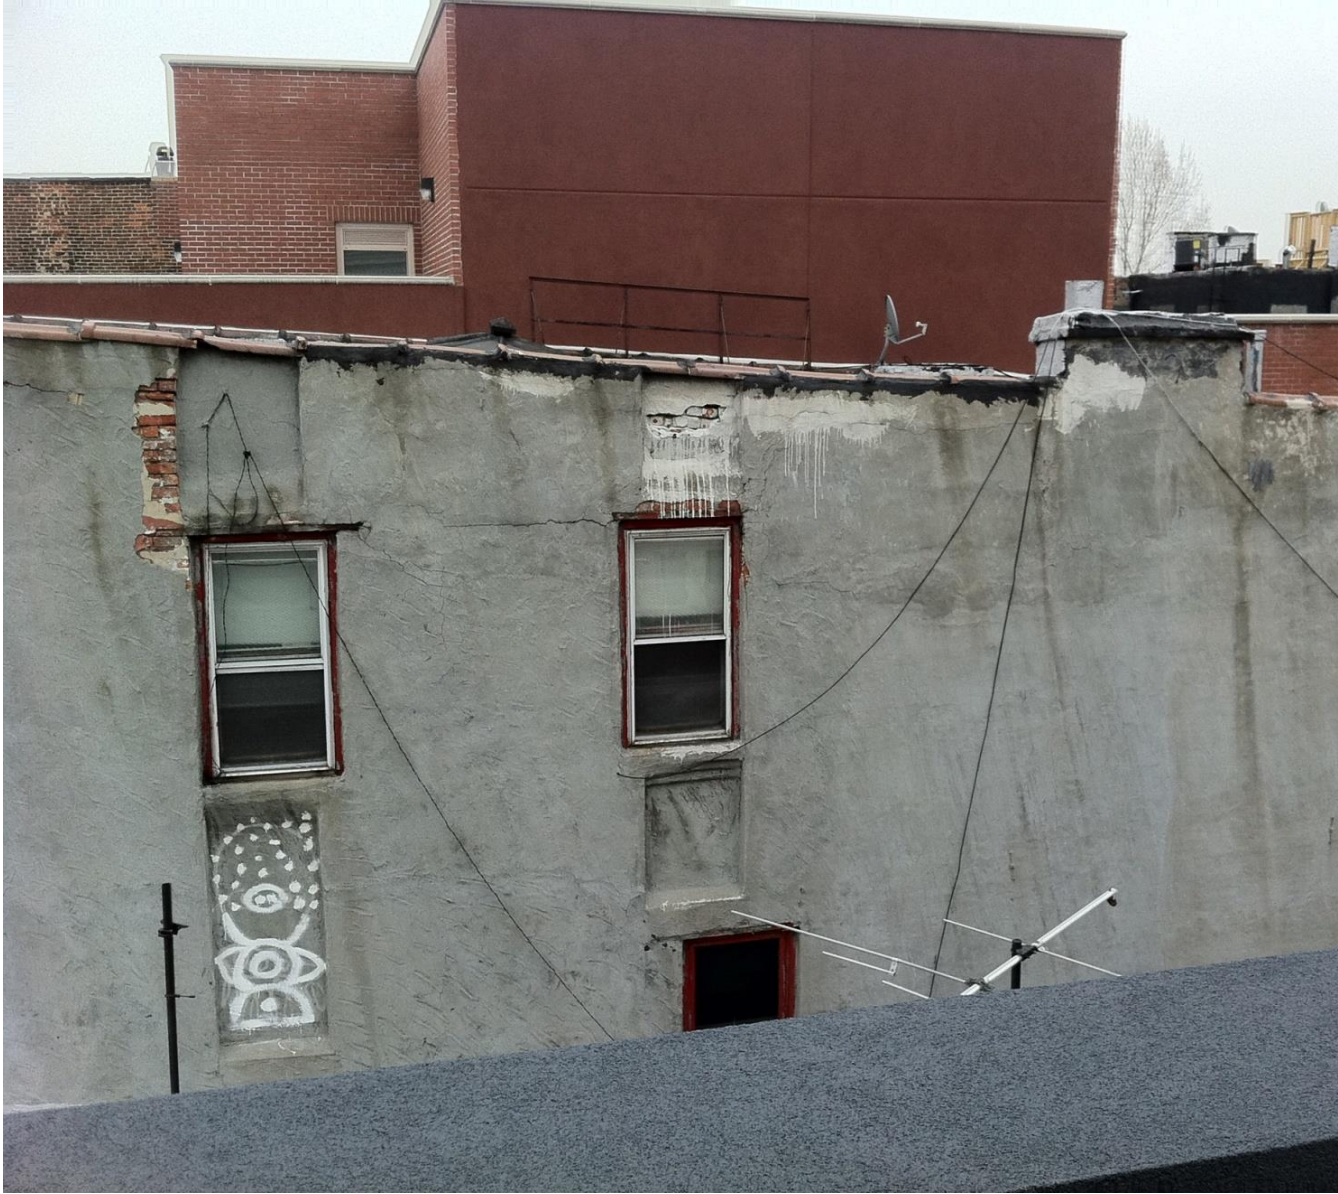
Freeze Thaw?

Yes, but not an insulation problem

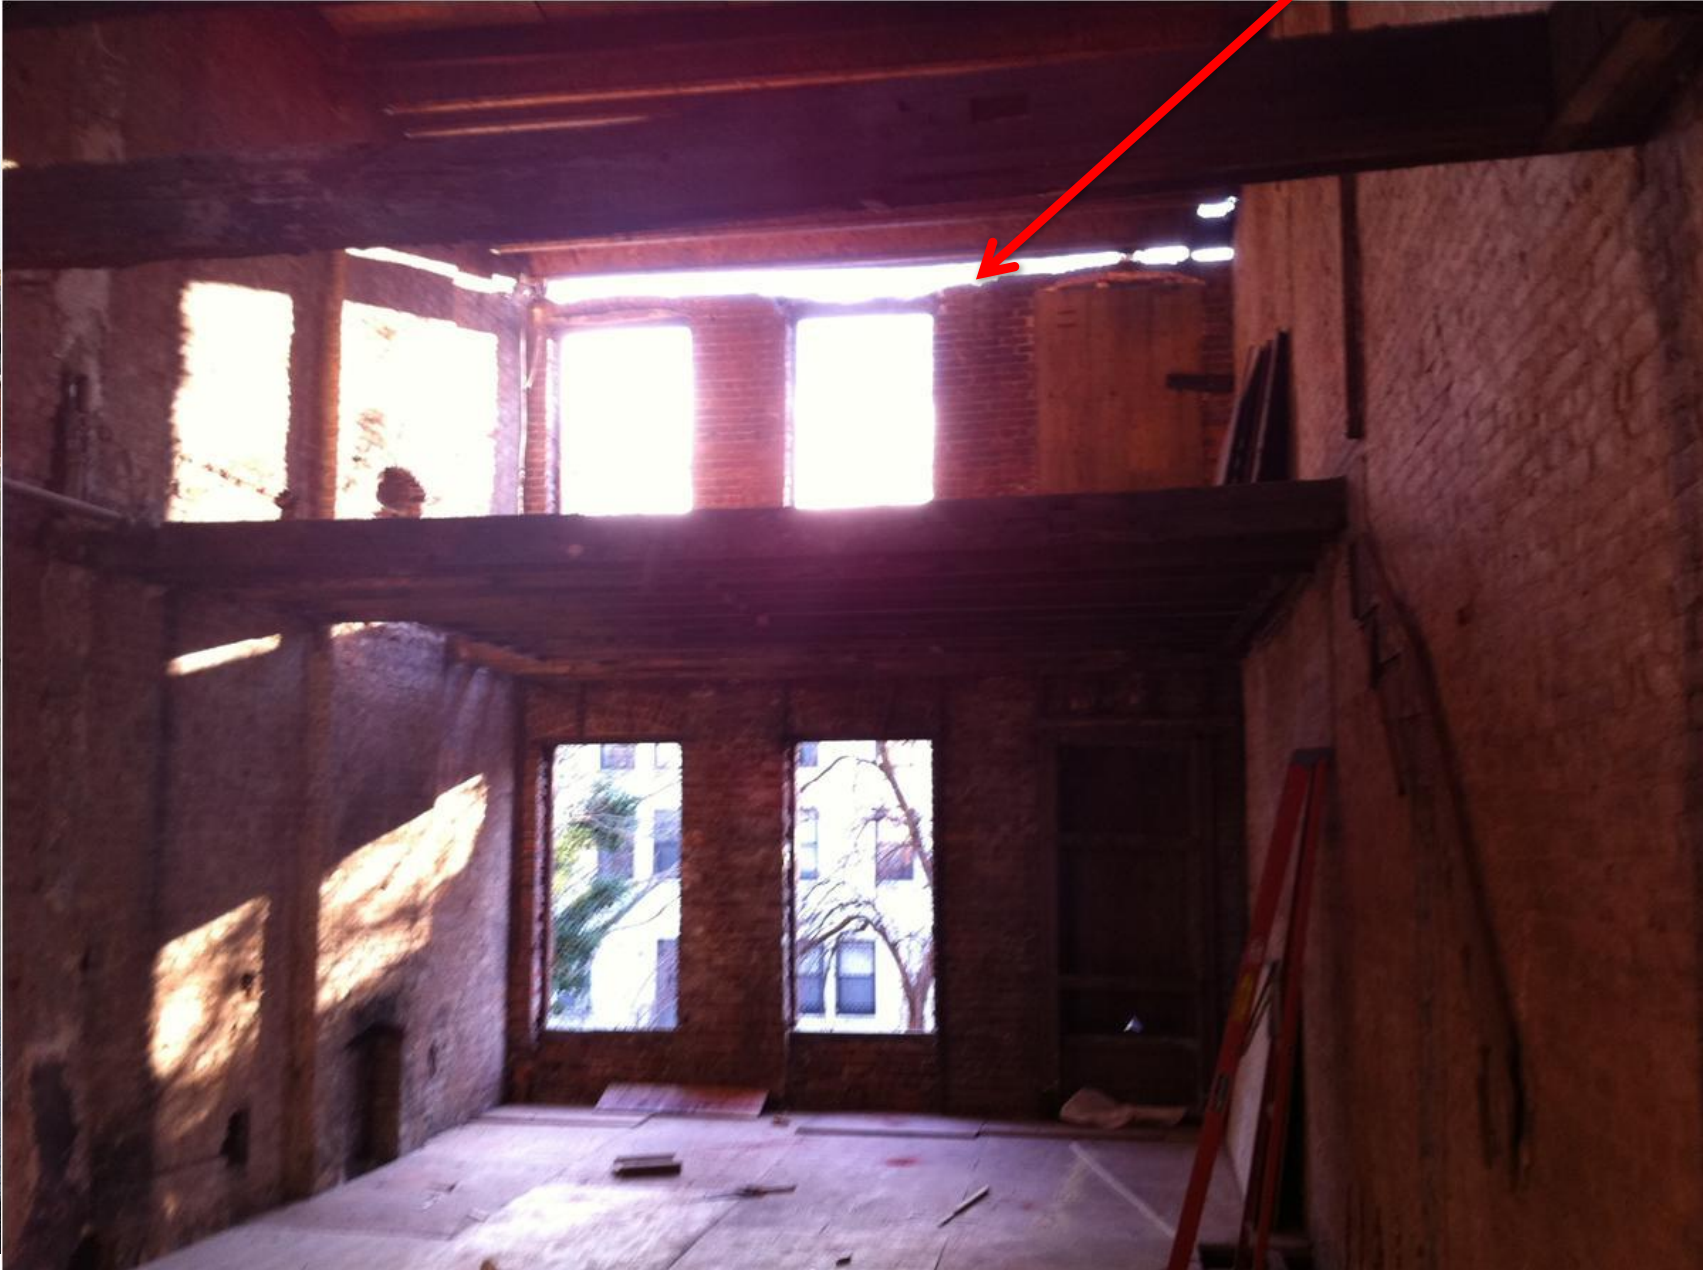
Freeze Thaw Damage – only at top of wall

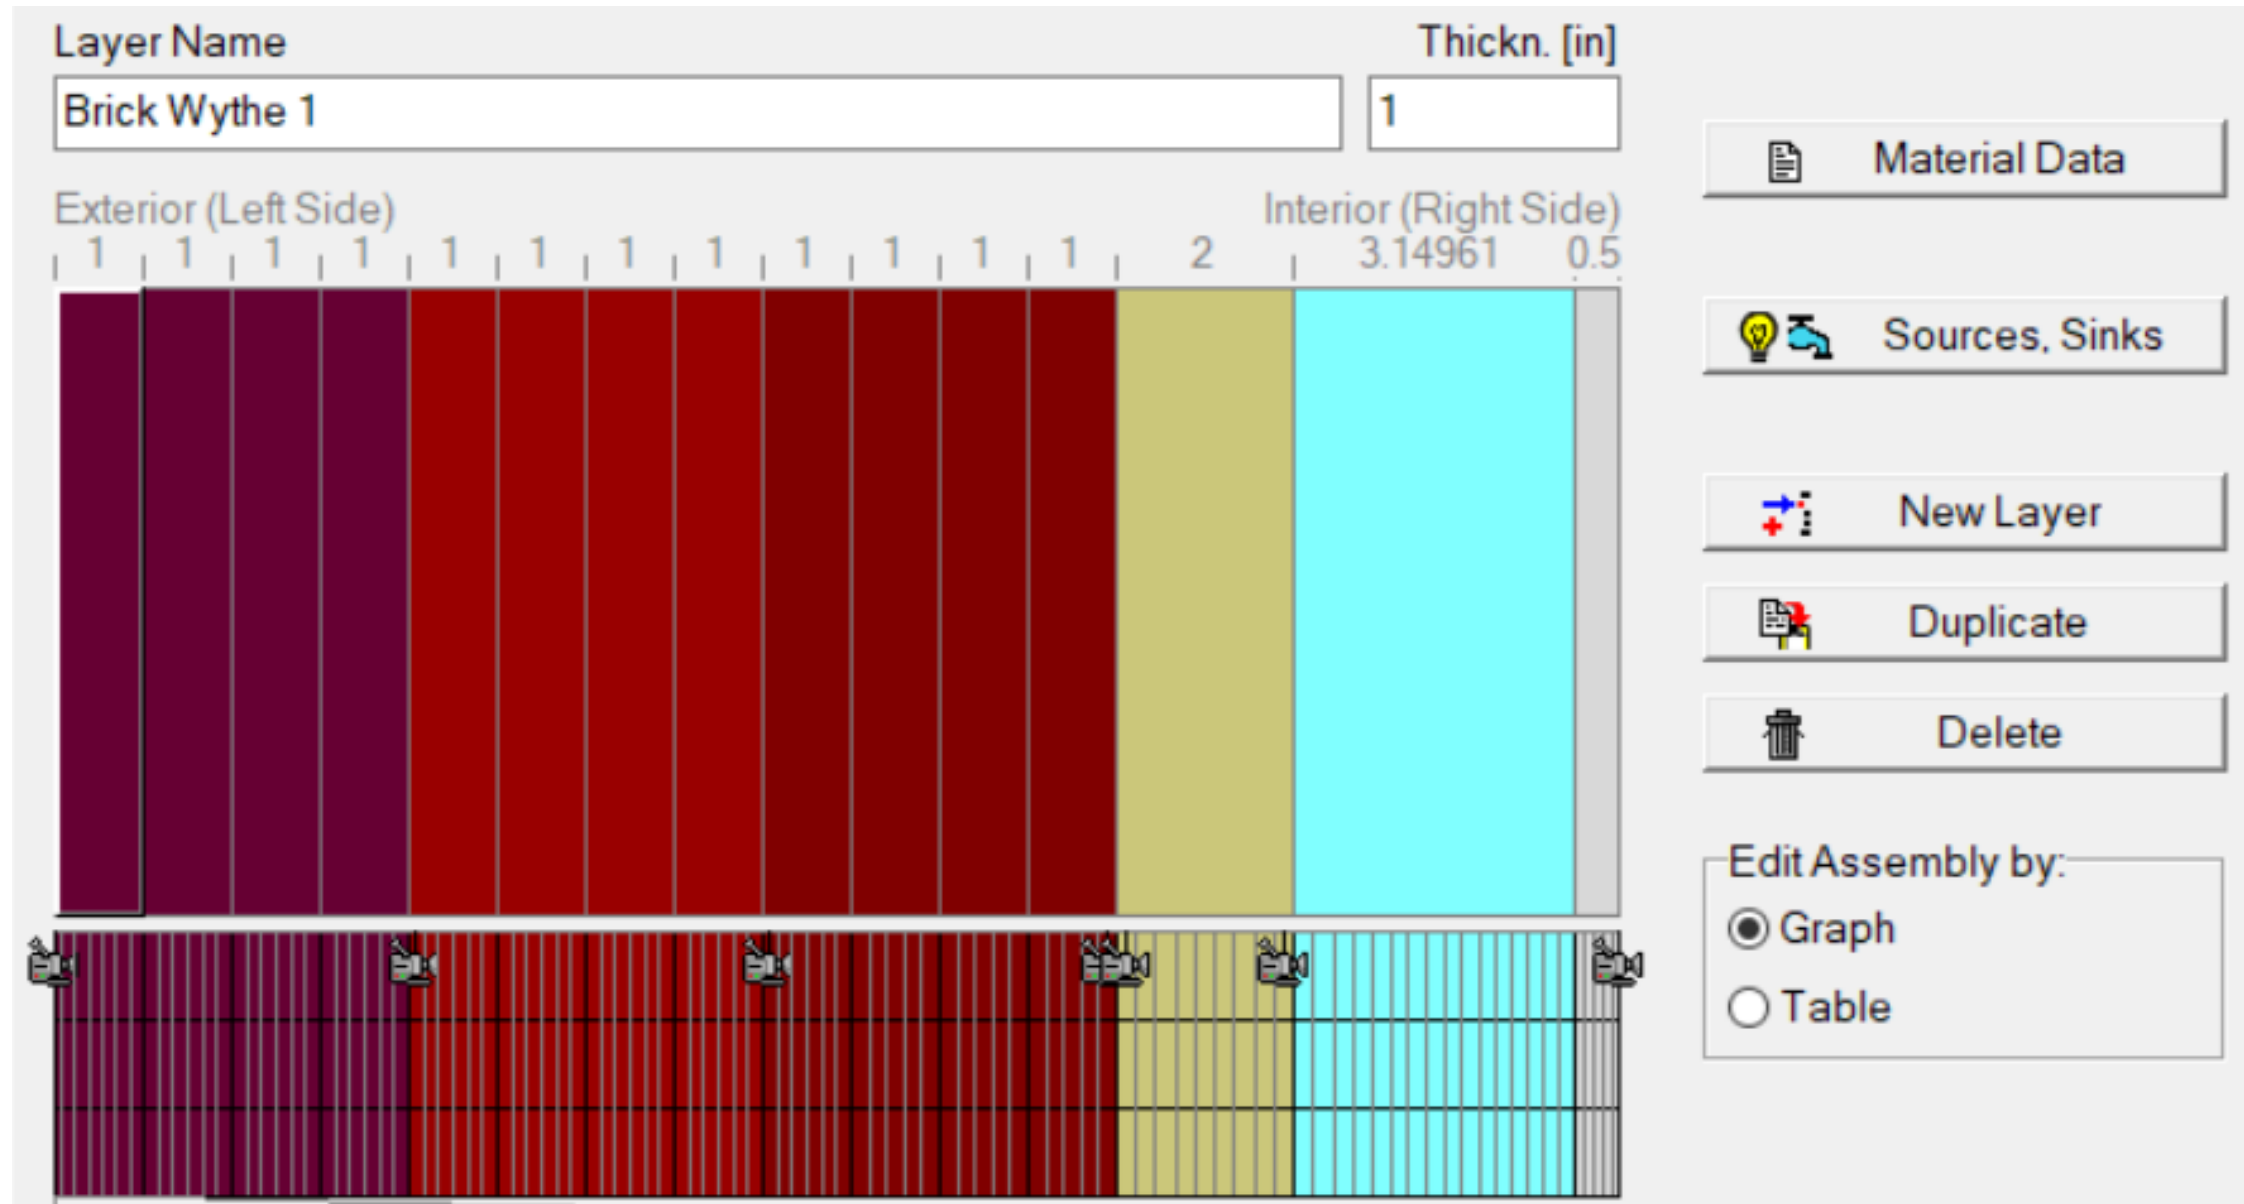
Exterior
Wythe

Middle
Wythe

Interior
Wythe

Custom Brick Properties

Bulk density [lb/ft³]: 104.3
Porosity [ft³/ft³]: 0.196

Thermal Conductivity [Btu/hft°F]: 0.23
Permeability [perm in]: 8.1

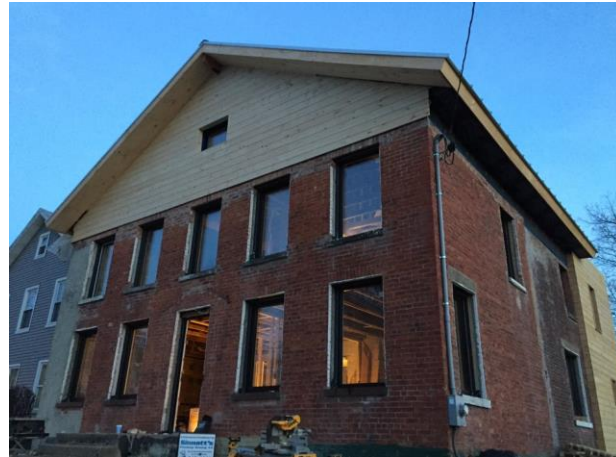
2 Whyte – Saugerties, NY – Climate zone 6 monitored masonry EnerPHit renovation

Assessment of RH % on brick/cellulose interface
(condensing surface)

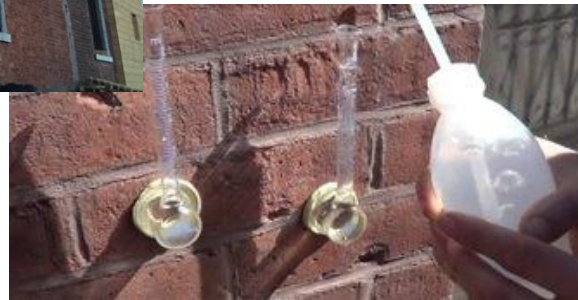
Overhangs - Keep it dry

Assessment
of masonry

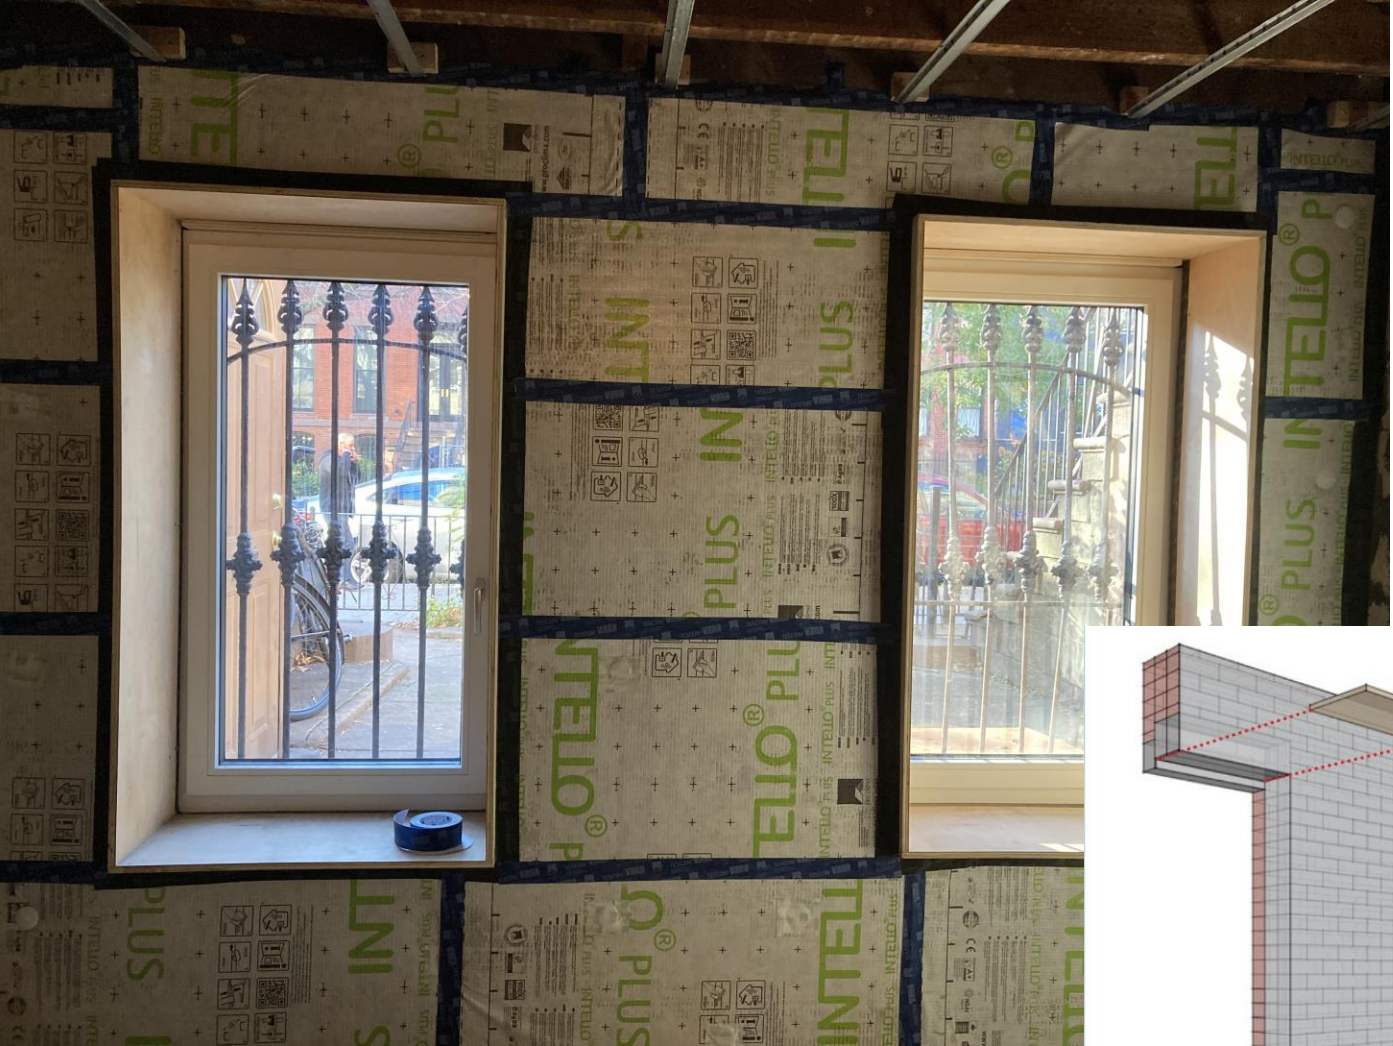
No thermal bridges, material efficient

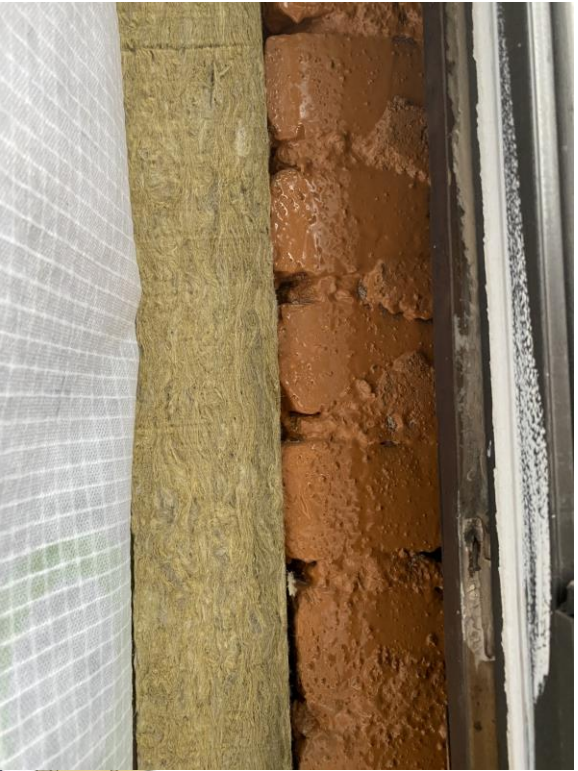
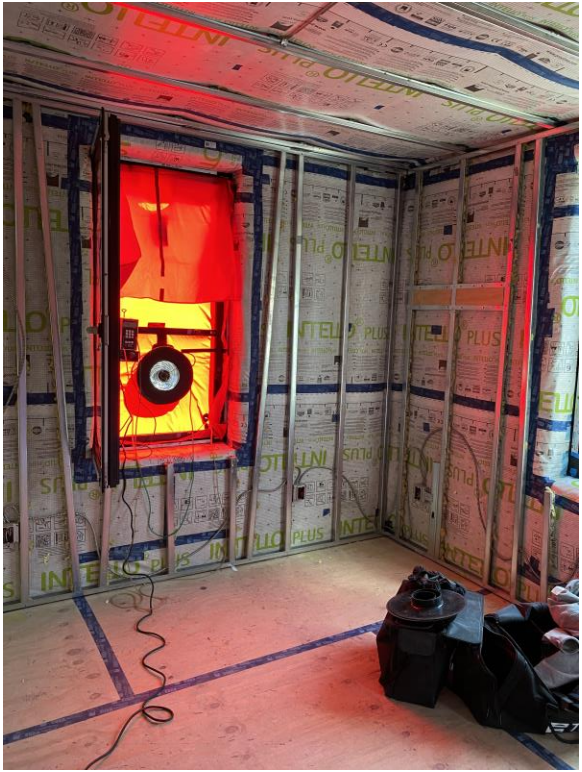
5" Mineral wool boards + INTELLO Plus (pinned) + service cavity

5" Mineral wool boards + INTELLO Plus – MONITORED

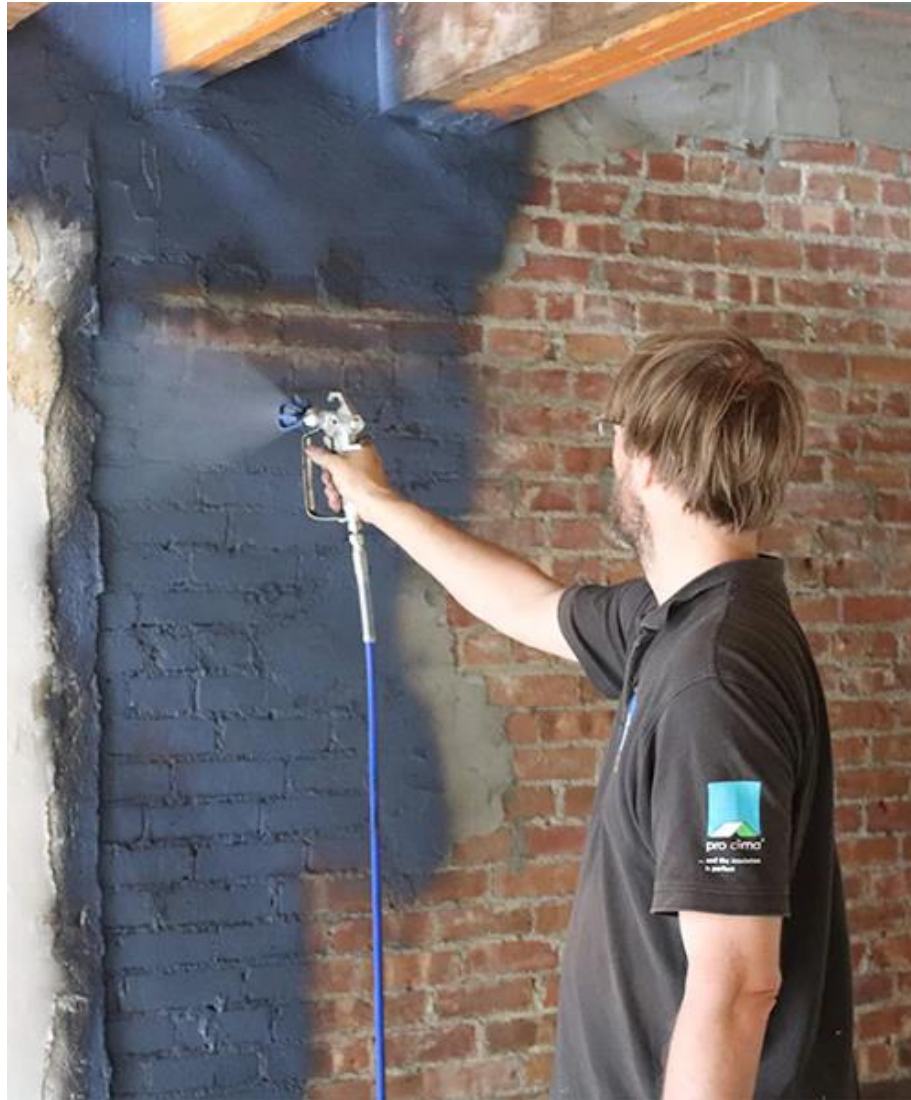
Liquid-applied air barrier

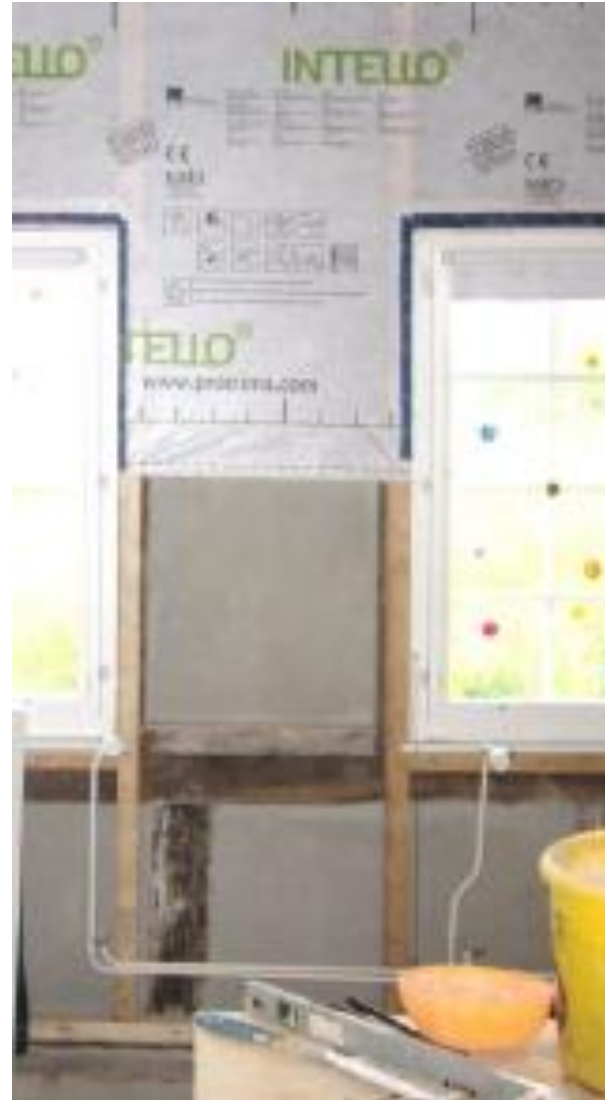
Plaster

- Existing lime plaster that is in good condition or new lime plaster can be used as a vapor-open air barrier.
- Repointing/parching might be enough.
- liquid applied air barrier is a fast and effective airseal. (cost vs speed)

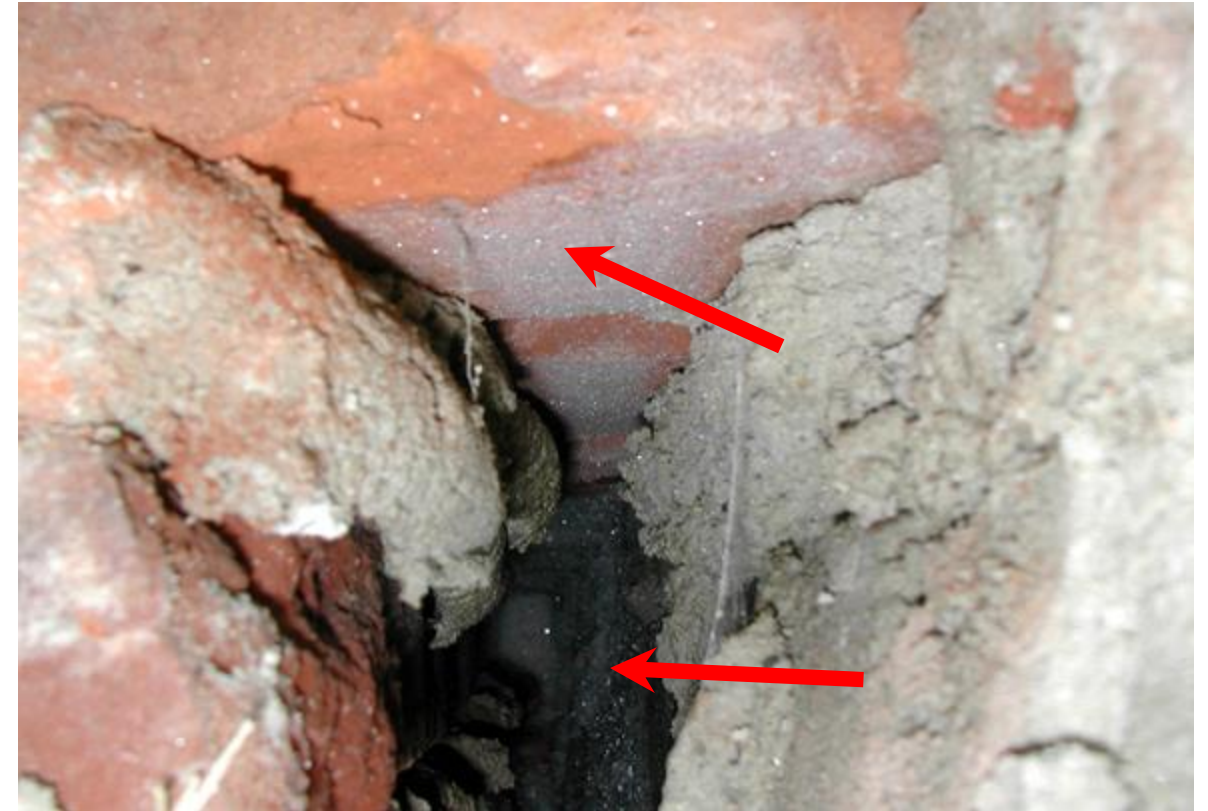
Hidden Condensation Due to Air Flow

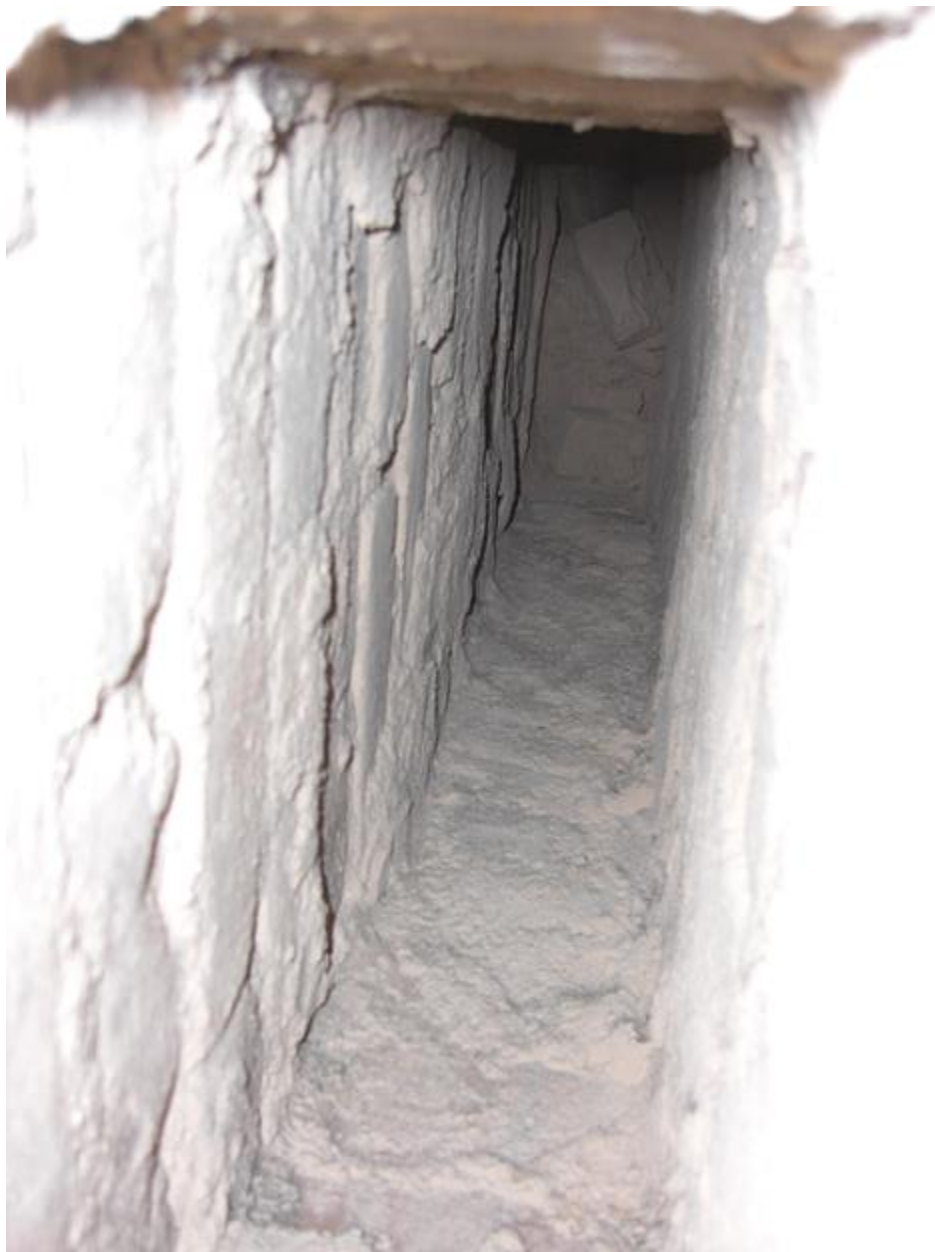
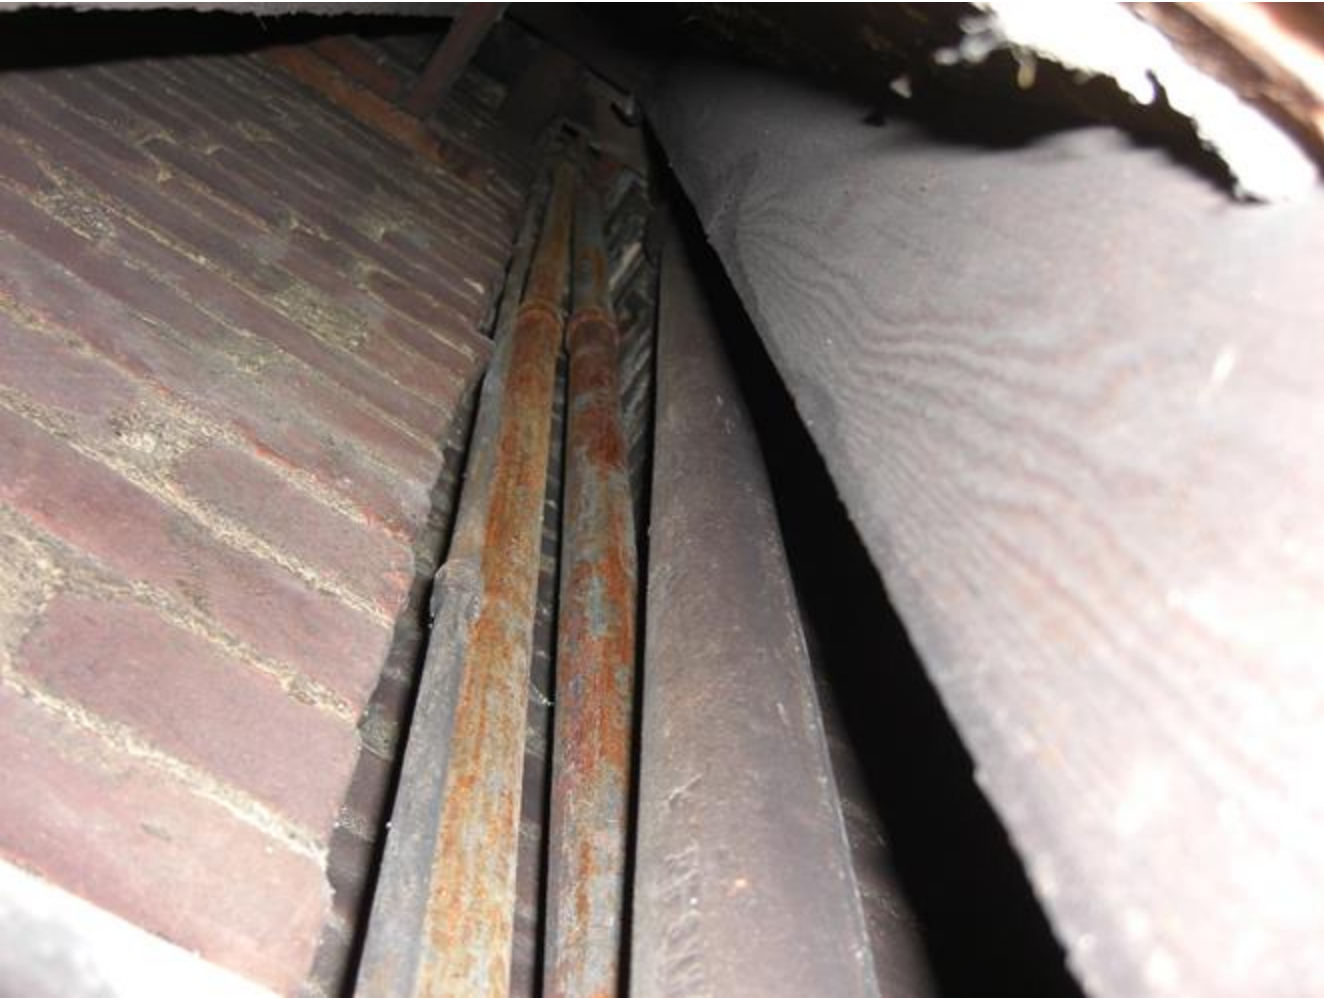
Air Leakage

Floor – Wall Connection
