Building Science Puzzles

How Heat & Moisture
Moves Through Homes

Puzzle 1 (Zone 6) – Insurance co. mitigated kitchen mold keeps coming back...

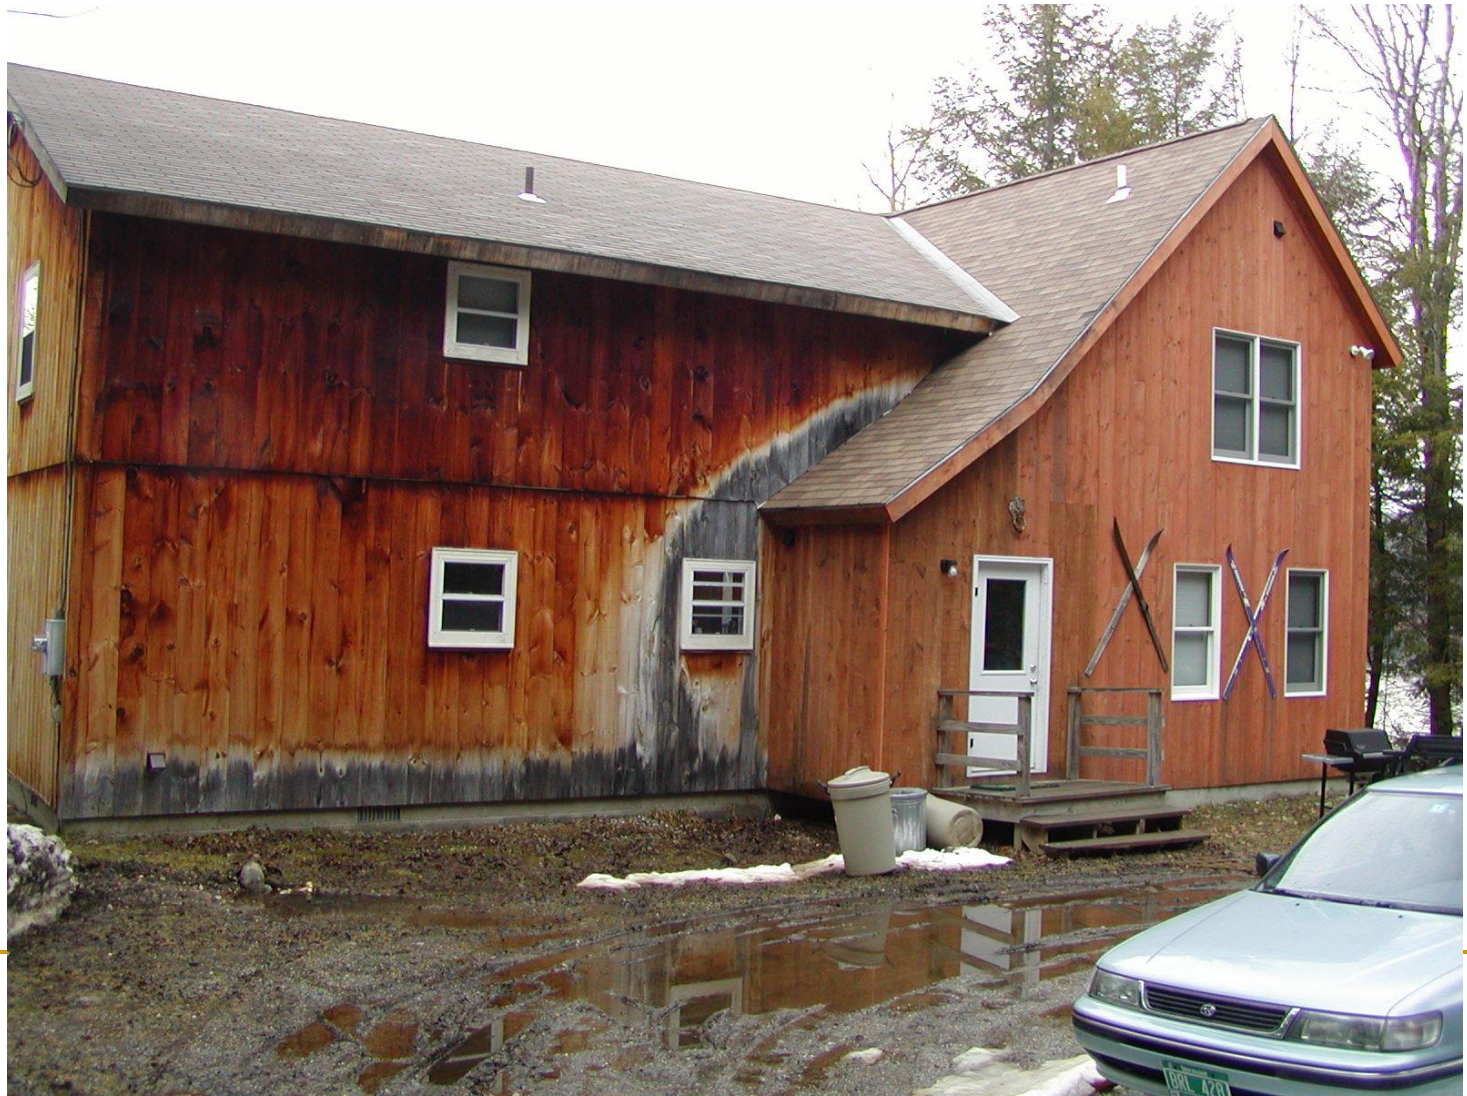
View as you drive up...

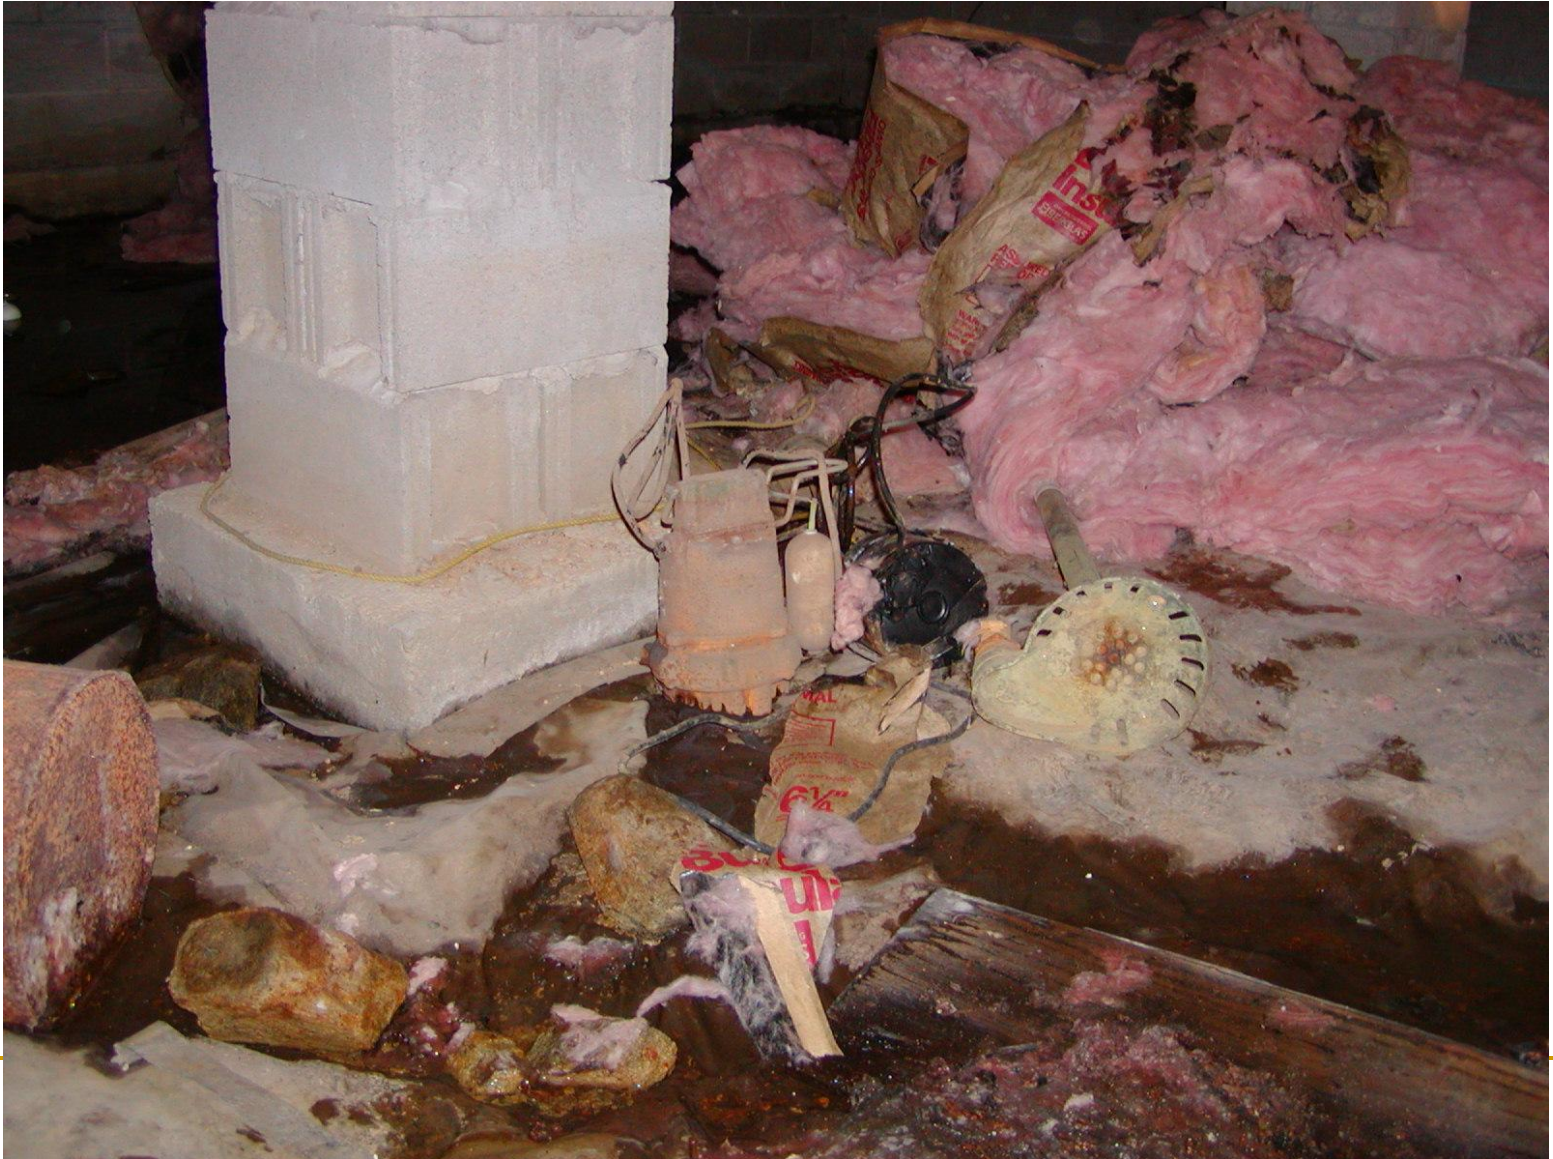
Crawlspace inspection...

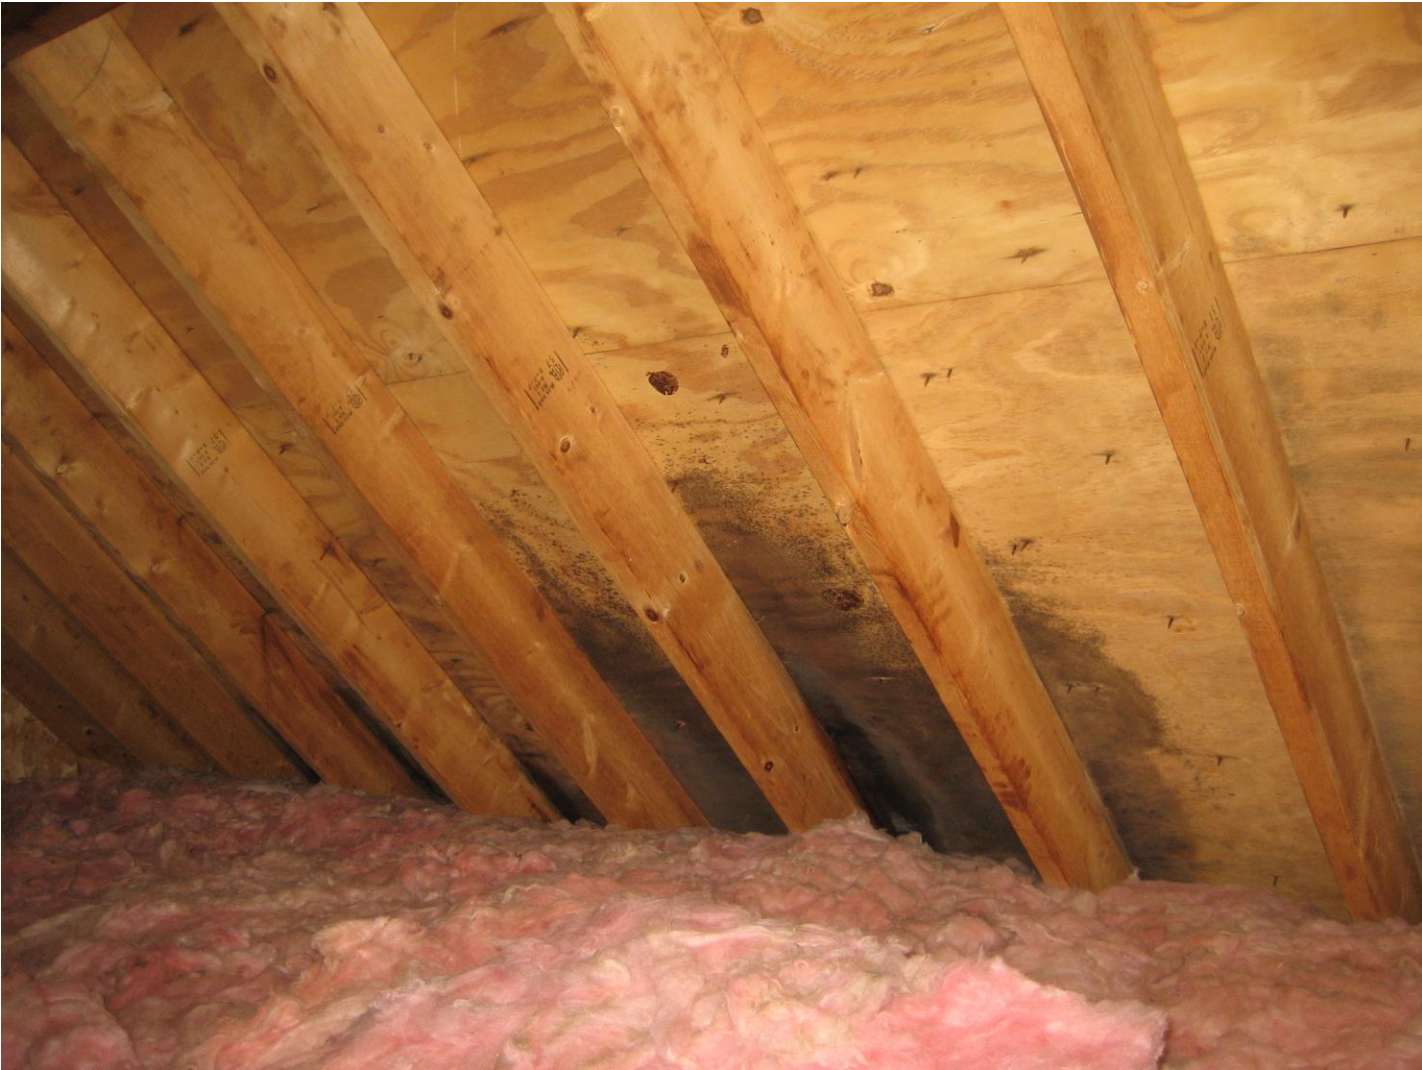
Mold in the Attic

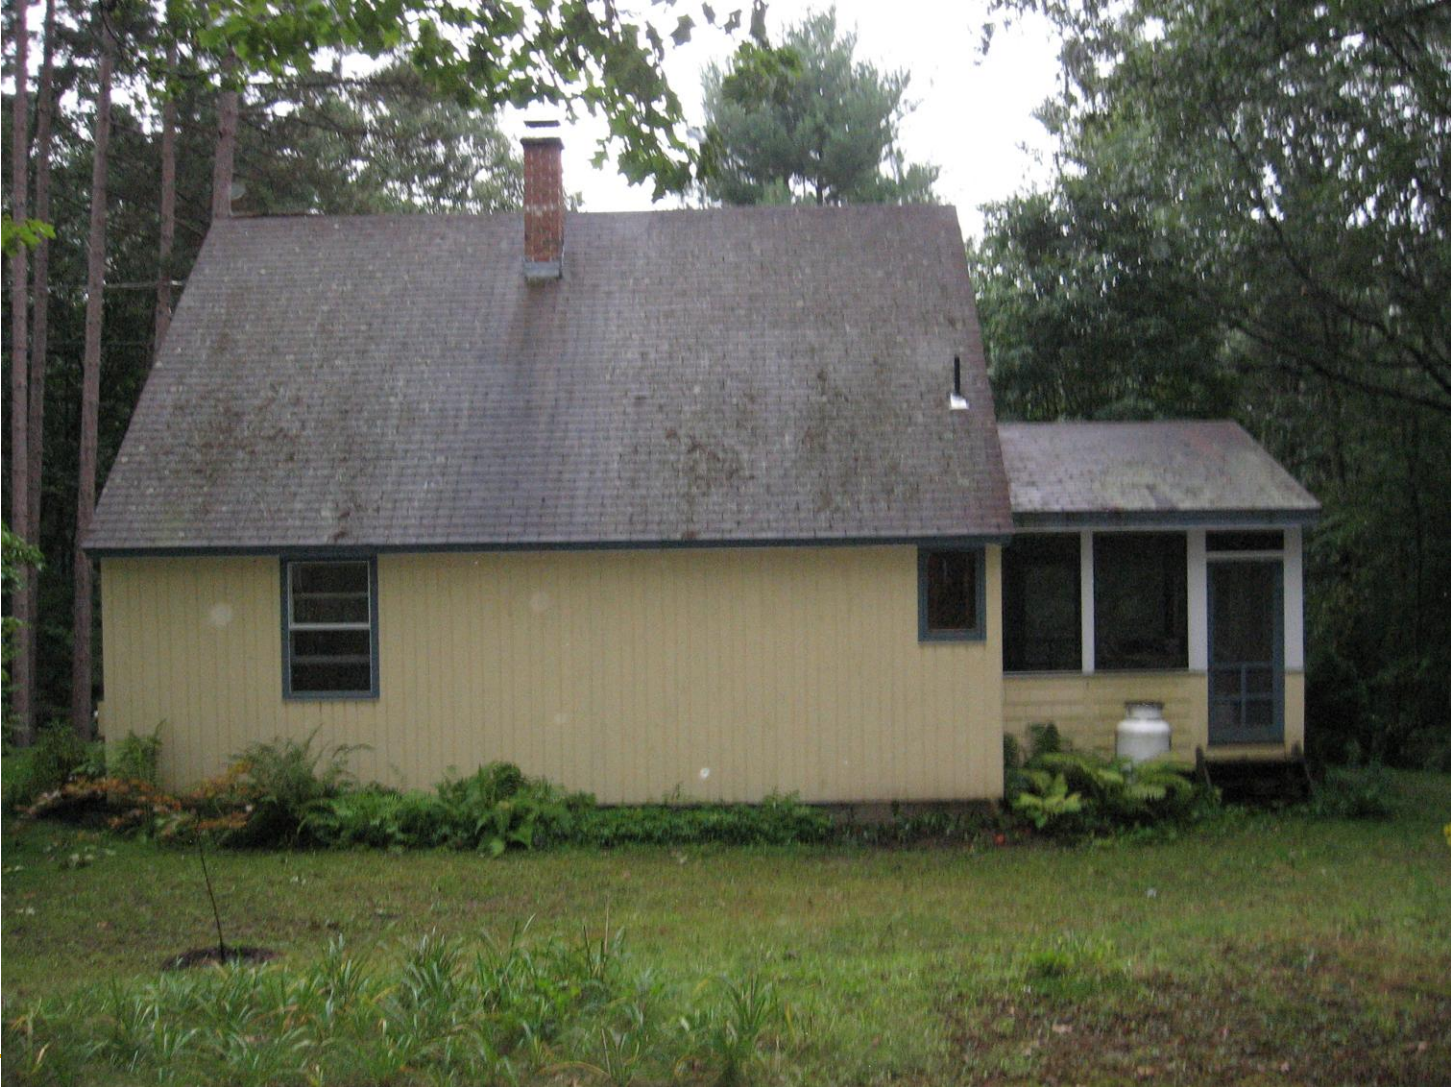
North side

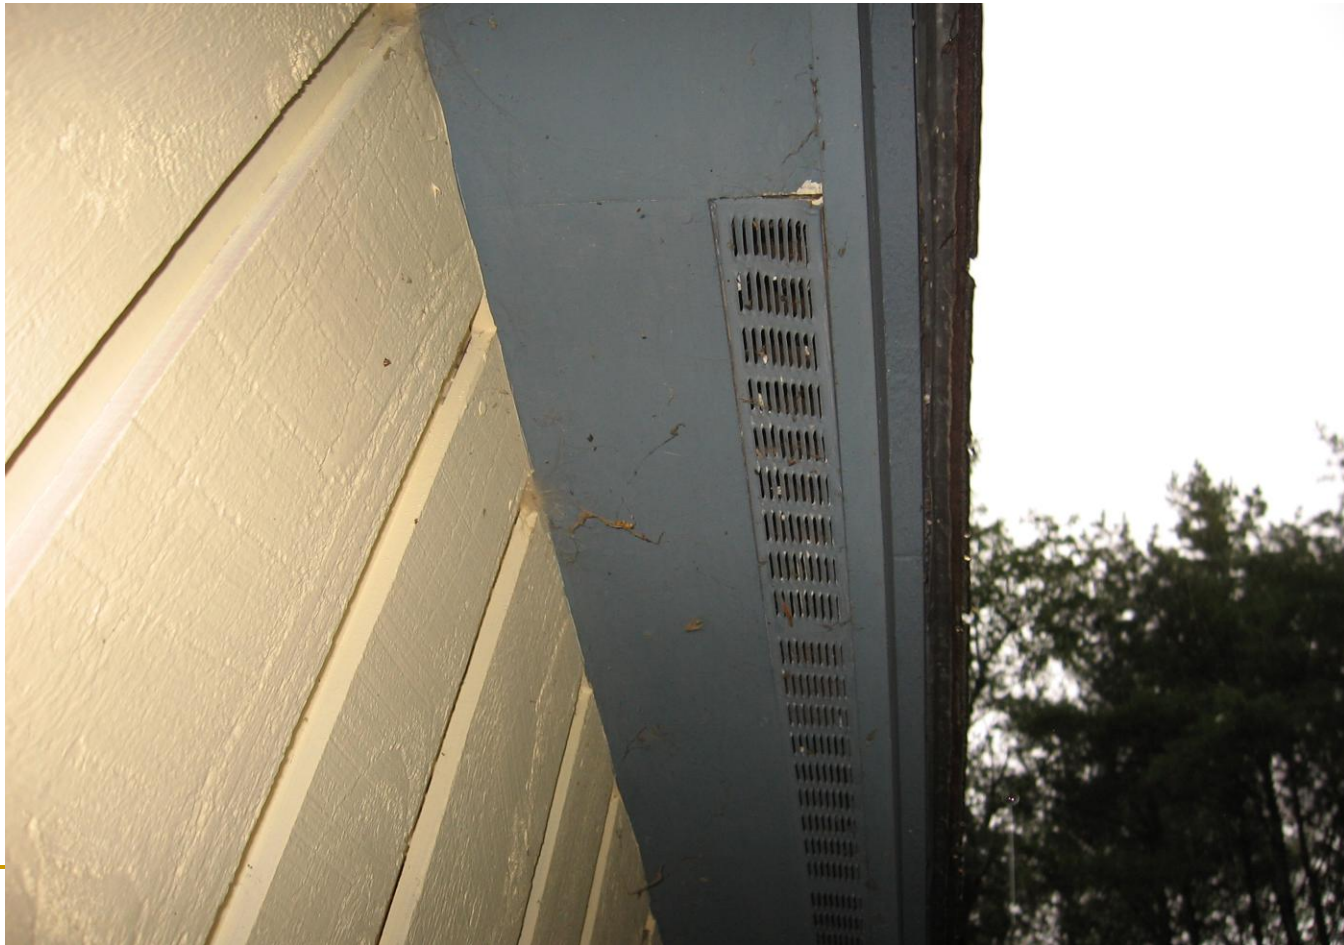
Original diagnosis: inadequate attic ventilation

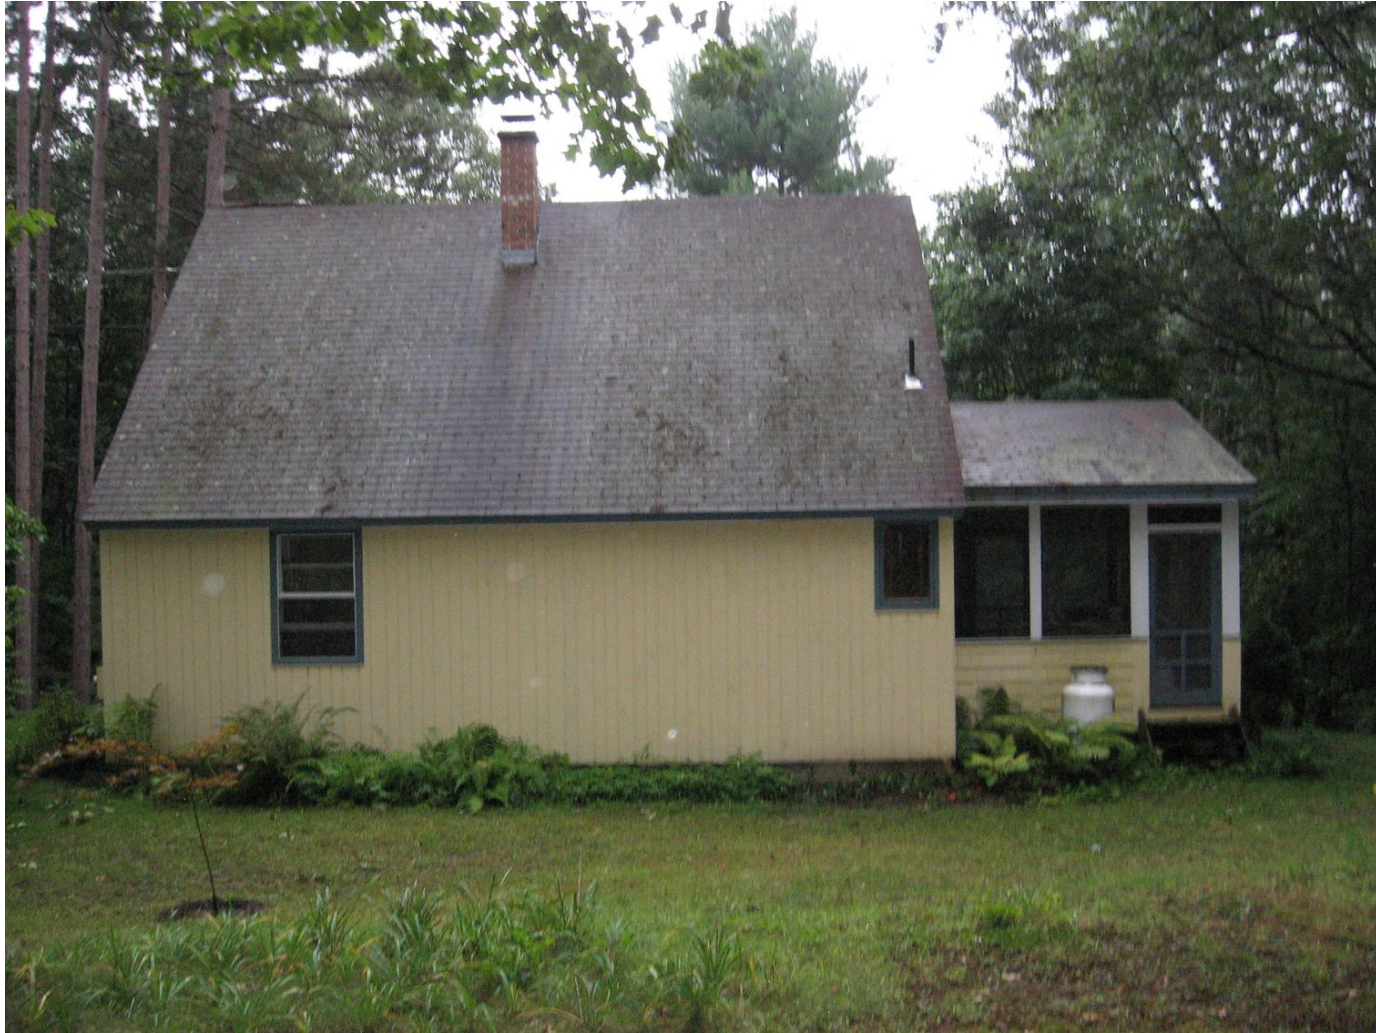
Only on the North side

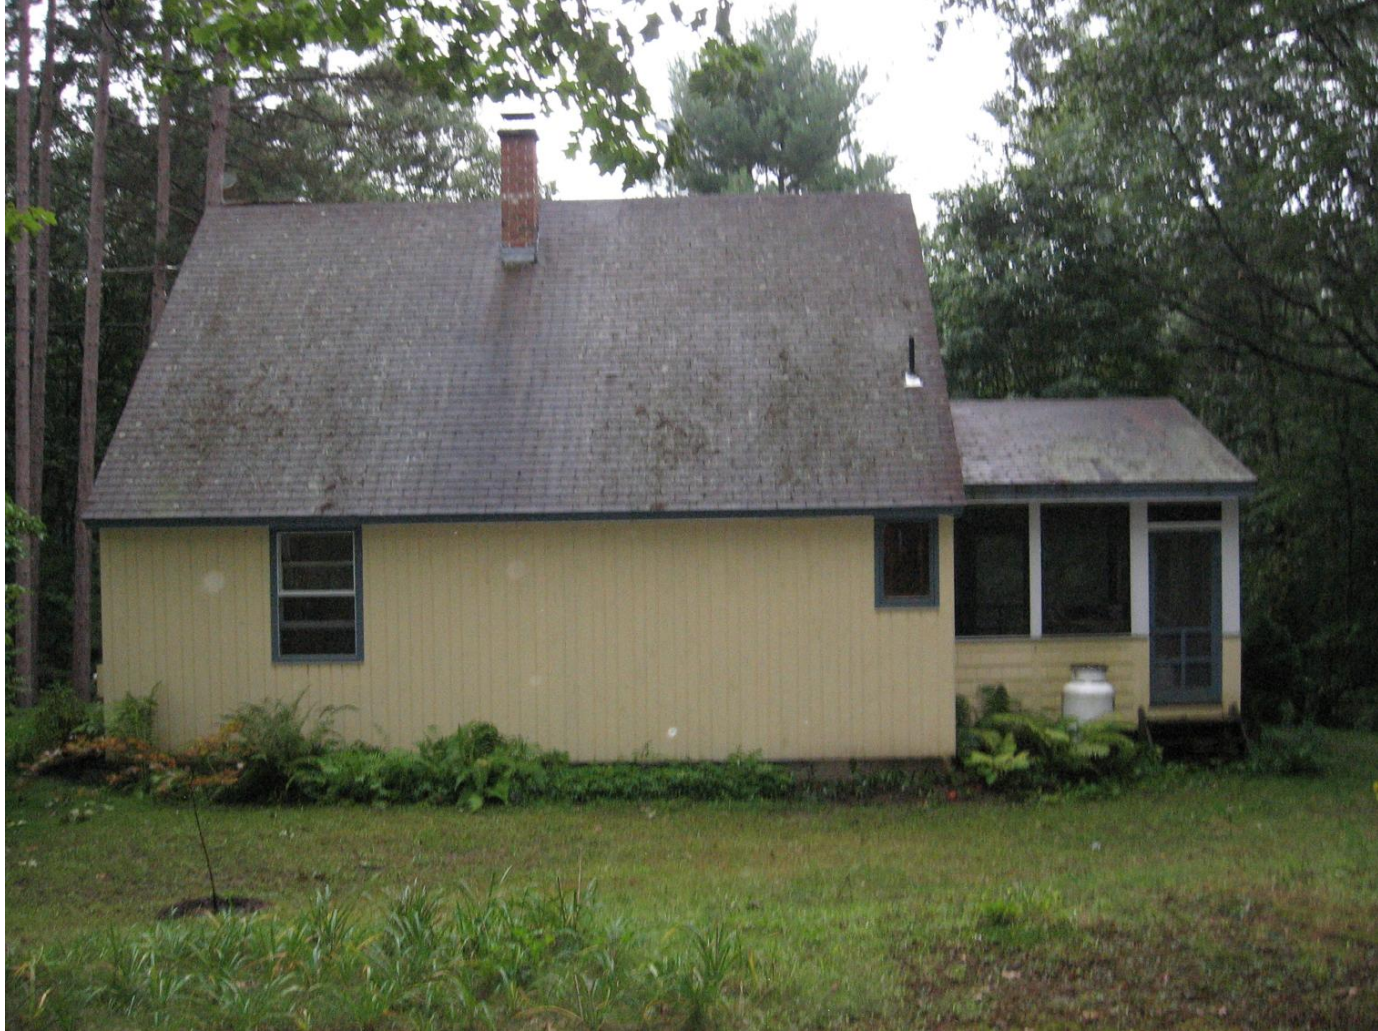
Only on the North side

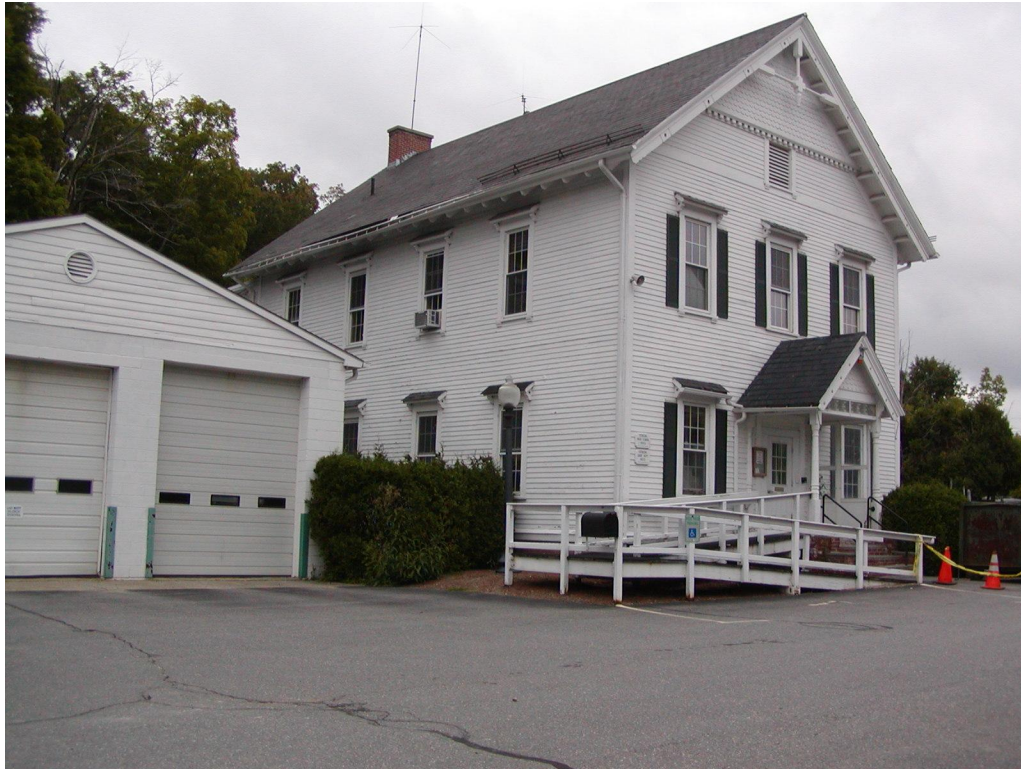
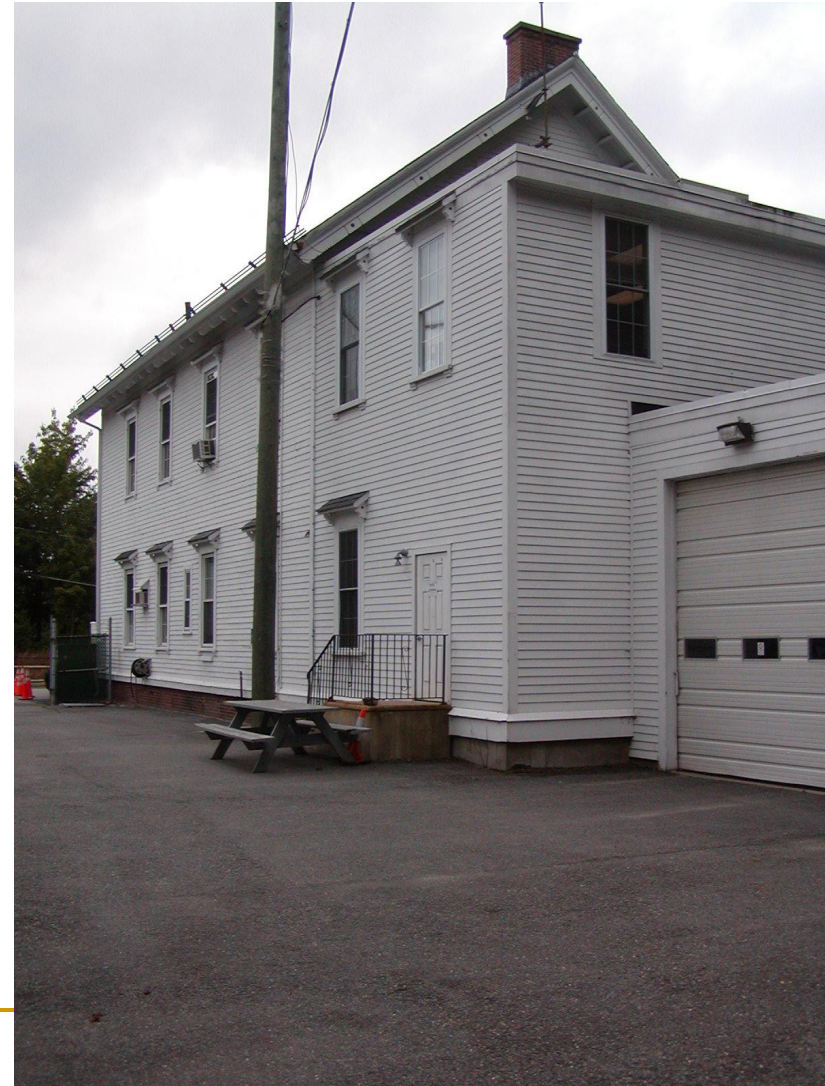
Bulk water manage 2 “spots”

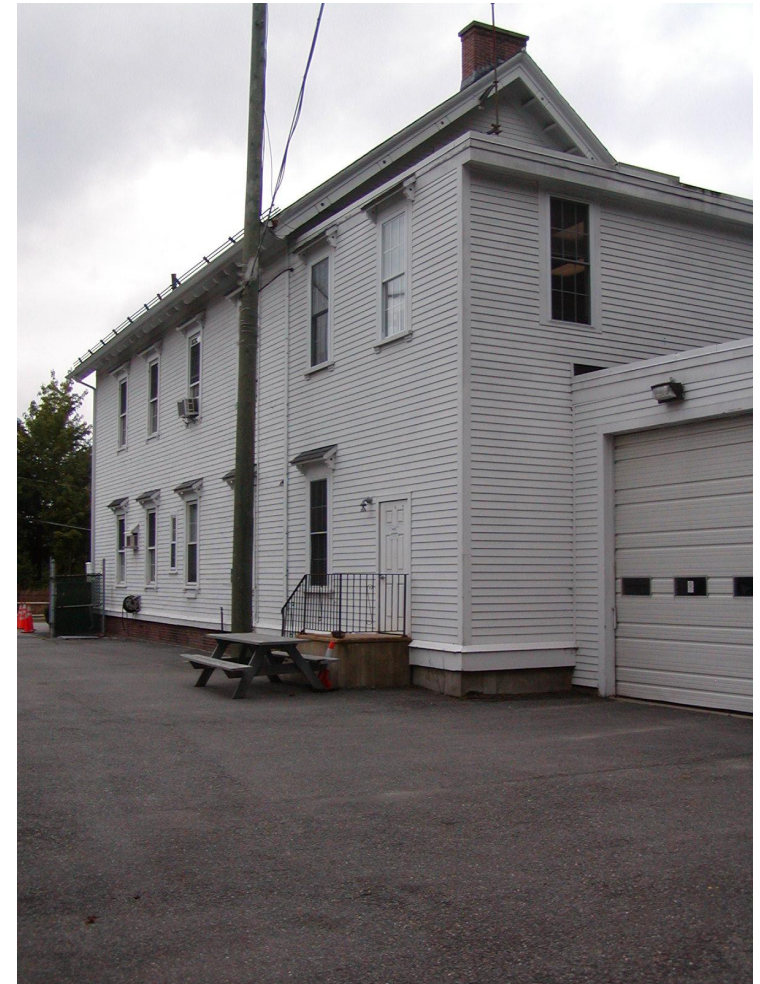
Re-building the wood siding water table with rigid insulation

Detail from Copper Development Association Inc.

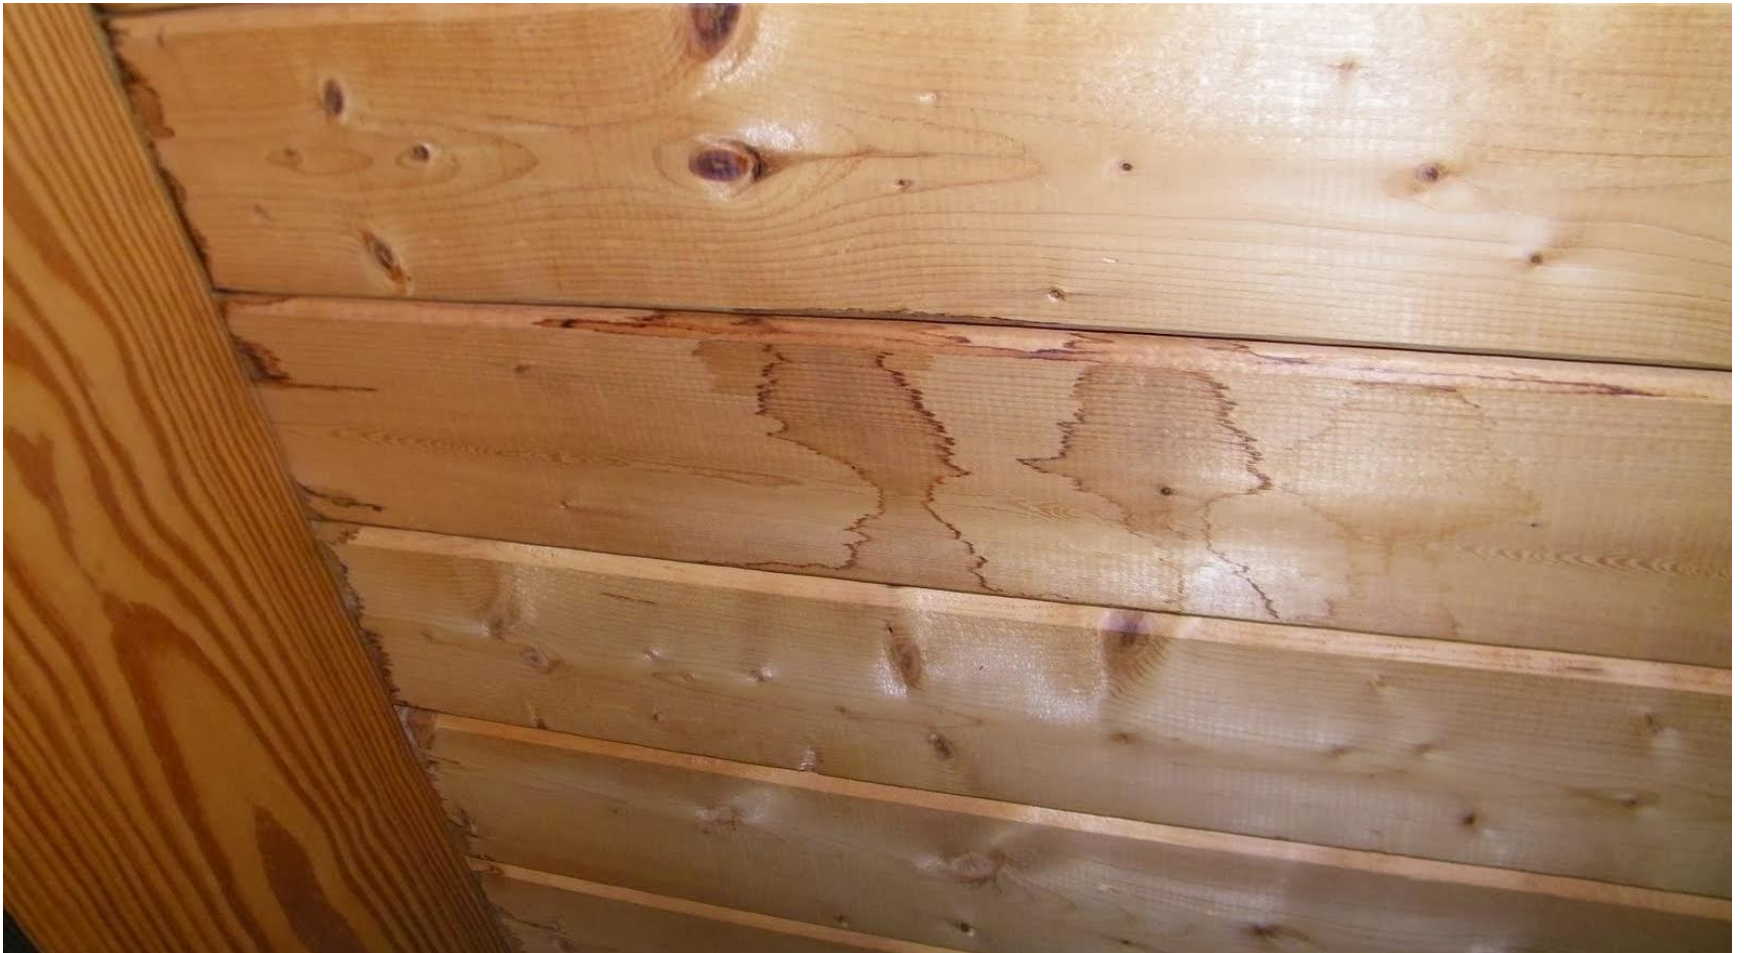
Cathedral ceiling moisture issues, inside...

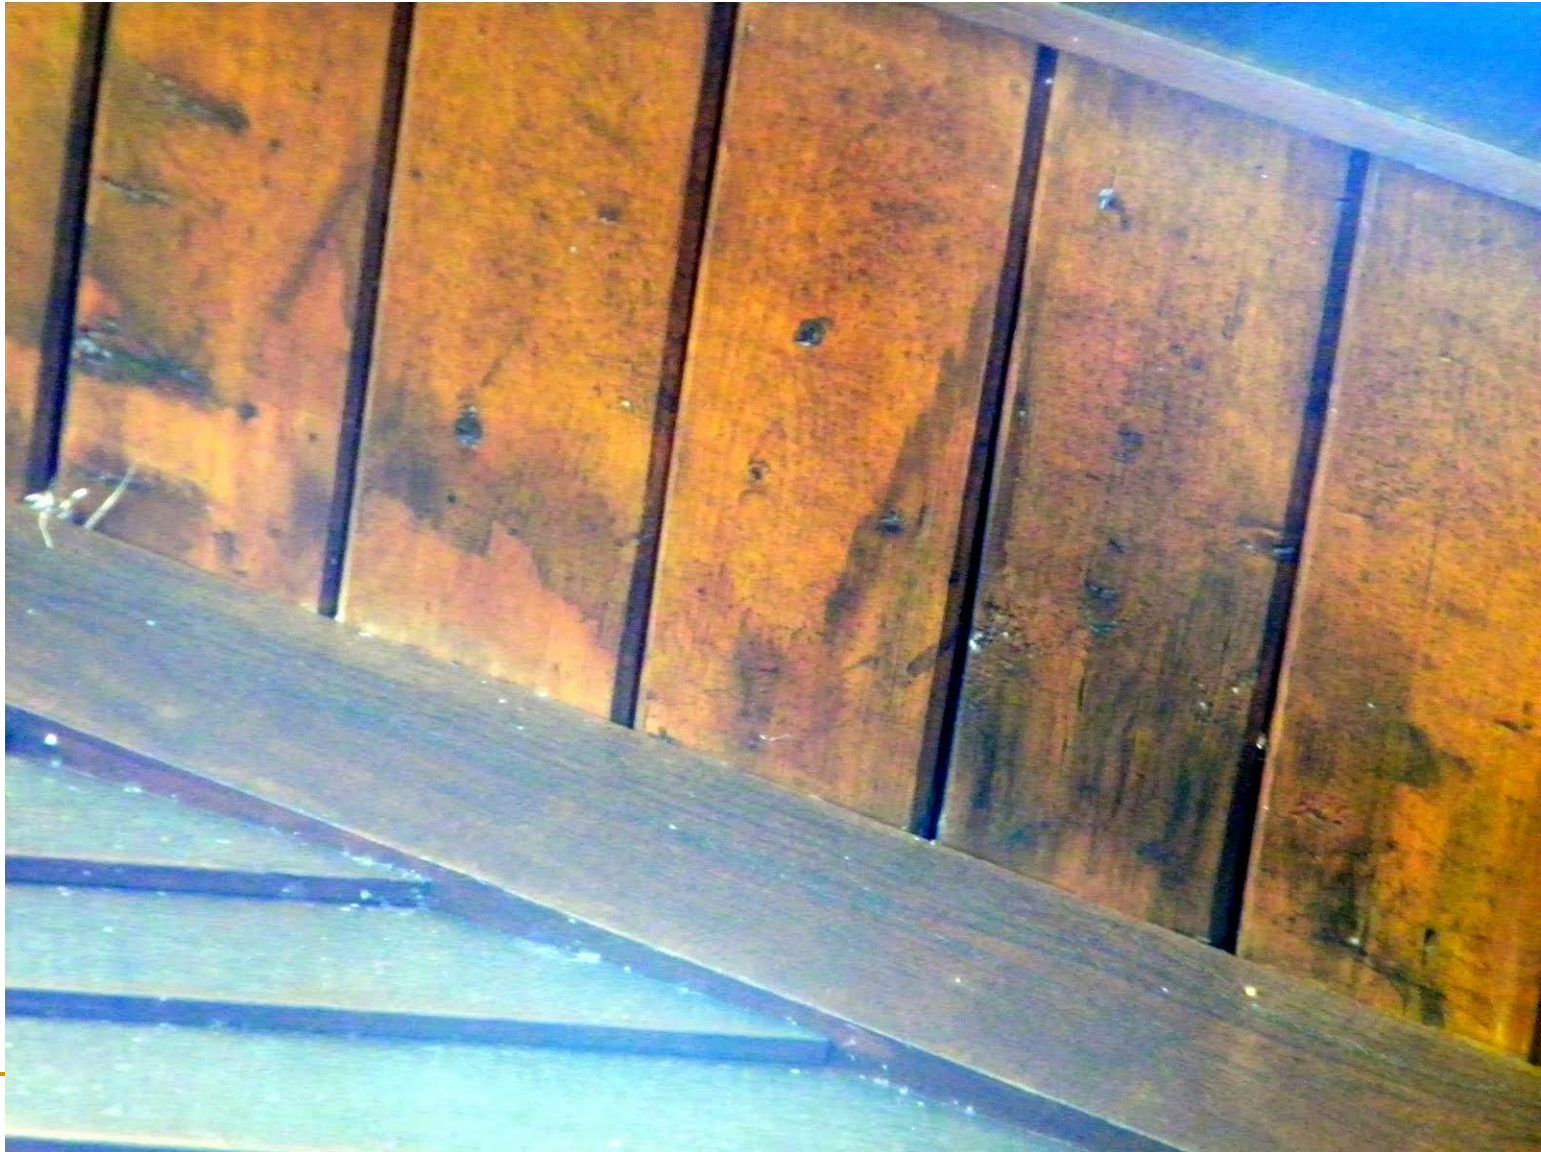
...and out..

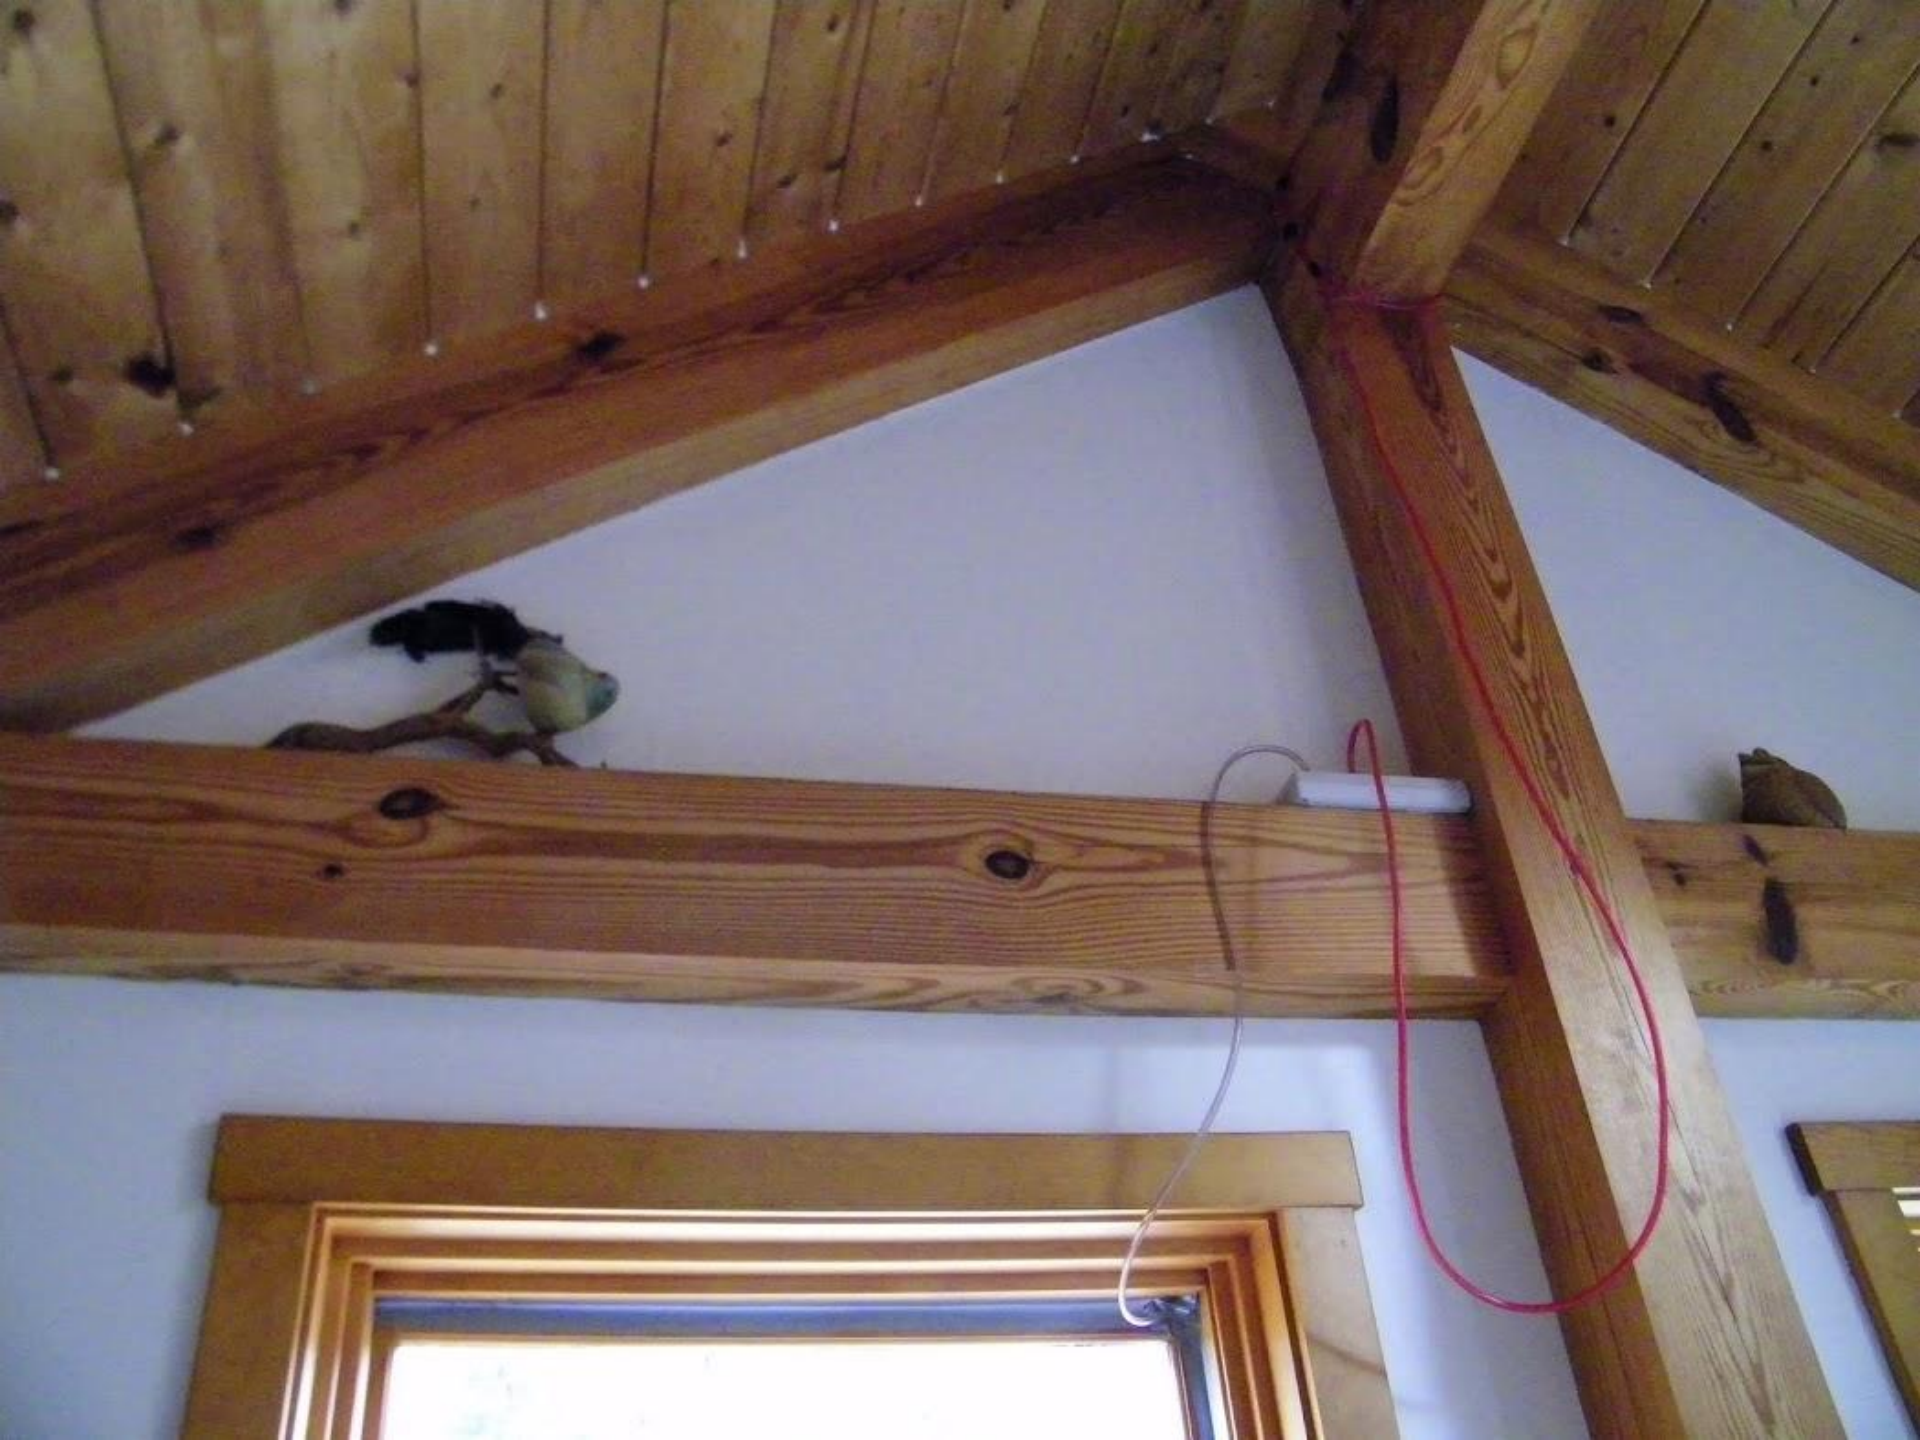
Job site data on pressures
