# UPPER WEST SIDE TOWNHOUSE FRONT STOOP DETAIL

# BROOKLYN HEIGHTS TOWNHOUSE

**FIRST CERTIFIED PASSIVE HOUSE  
IN A LANDMARKED DISTRICT**

BAXT | INGUI  
Architects PC

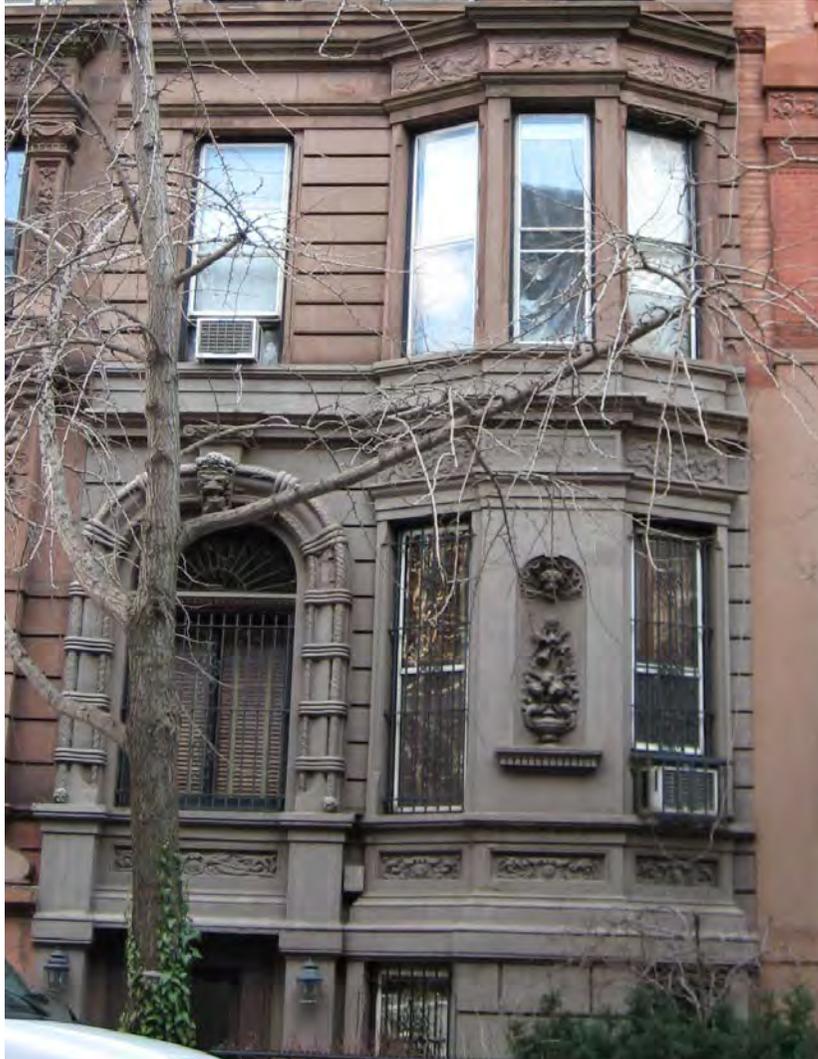
**BEFORE**

**THE ORIGINAL FACADE THAT WAS REMOVED IN THE 1940'S WAS REINSTALLED, ALONG WITH A NEW STOOP MATCHING THE NEIGHBORING BUILDINGS IN THE SAME ROW. THIS WAS POSSIBLE BY INSTALLING ALL PASSIVE DETAILS ON THE INTERIOR.**

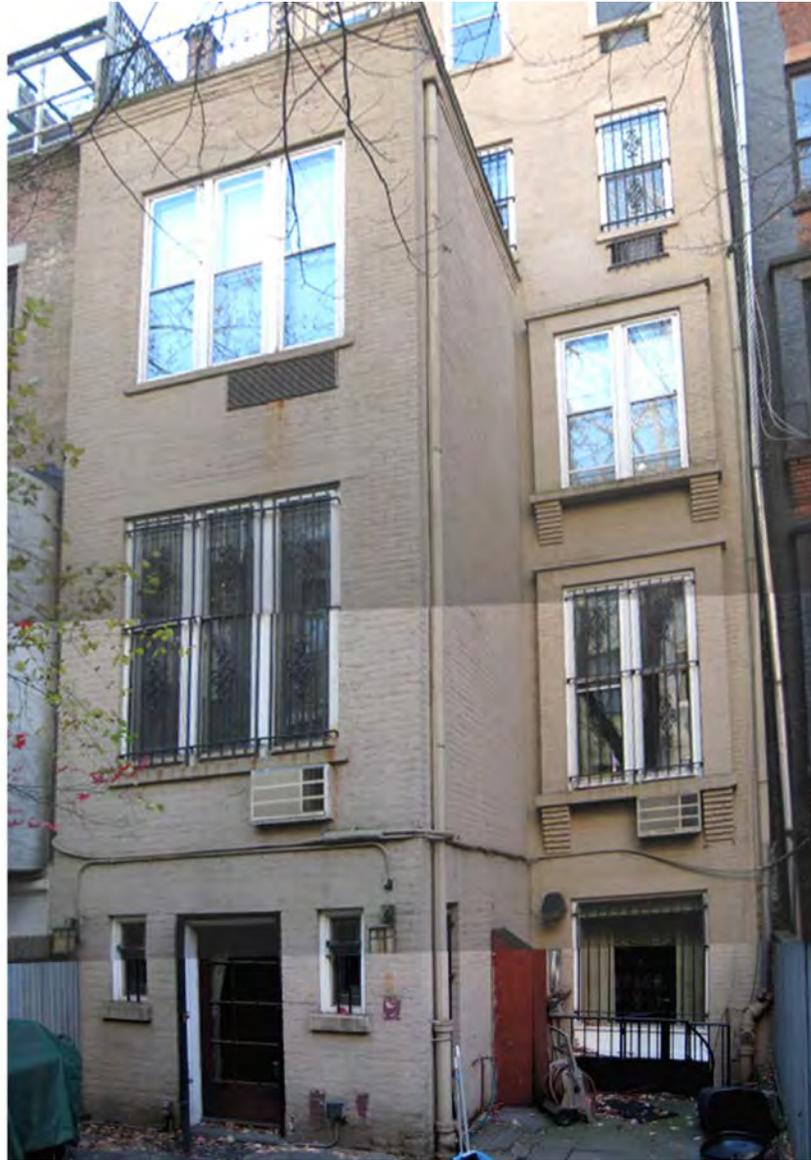
**BEFORE**

**THE EXISTING  
PAINTED REAR  
BRICK FACADE  
WAS STRIPPED,  
RESTORED AND  
EXPANDED WITH  
CORNER OPENINGS  
AND A NEW  
ADDITION.**

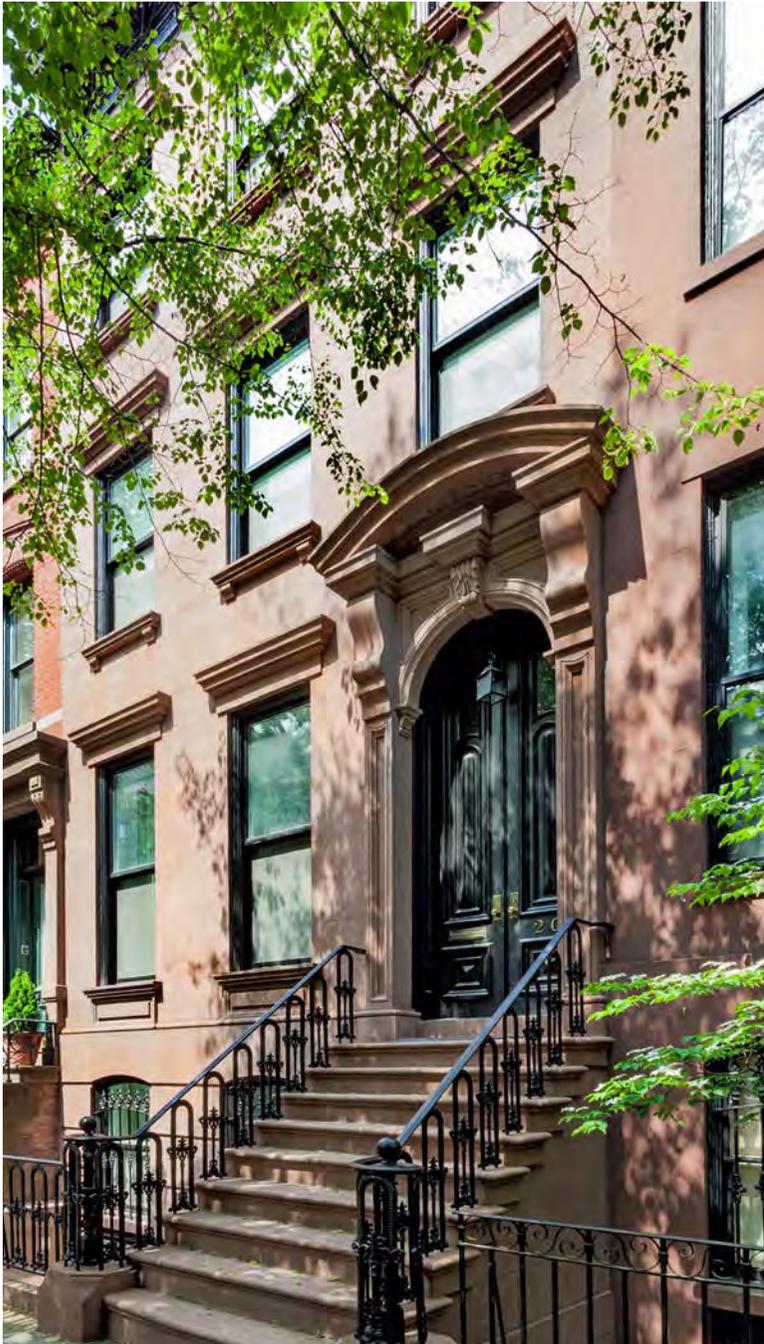
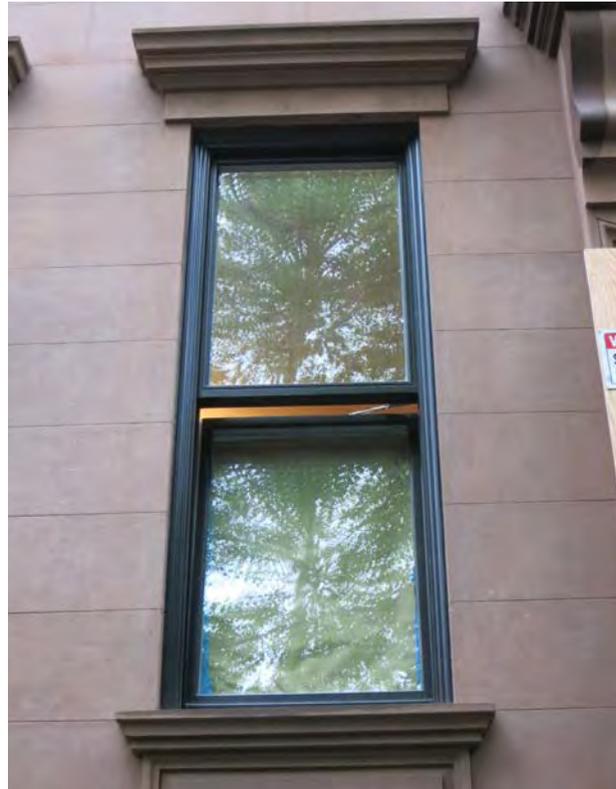
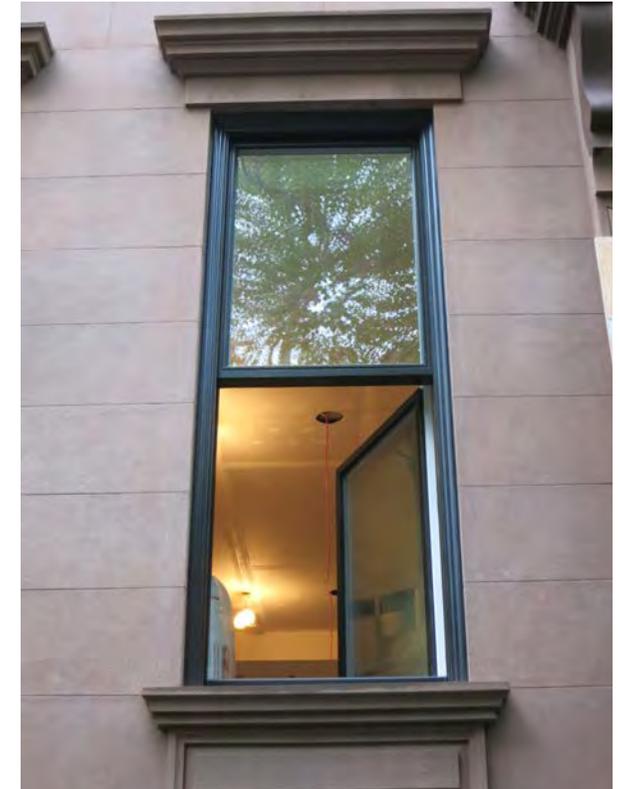
# BROOKLYN HEIGHTS TOWNHOUSE FRONT FACADE

**THE EXISTING BROWNSTONE FACADE WAS IN GREAT SHAPE AND REMAINED, HOWEVER THE STOOP AND ORIGINAL FRONT DOORS WERE RESTORED, AND NEW HISTORIC RAILINGS REPLACED EXISTING.**

**ALL WINDOWS WERE REPLACED WITH ZOLA TRIPLE GLAZED TILT/TURN SIMULATED DOUBLE HUNG UNITS, WHICH WERE APPROVED THROUGH LPC PUBLIC HEARING.**

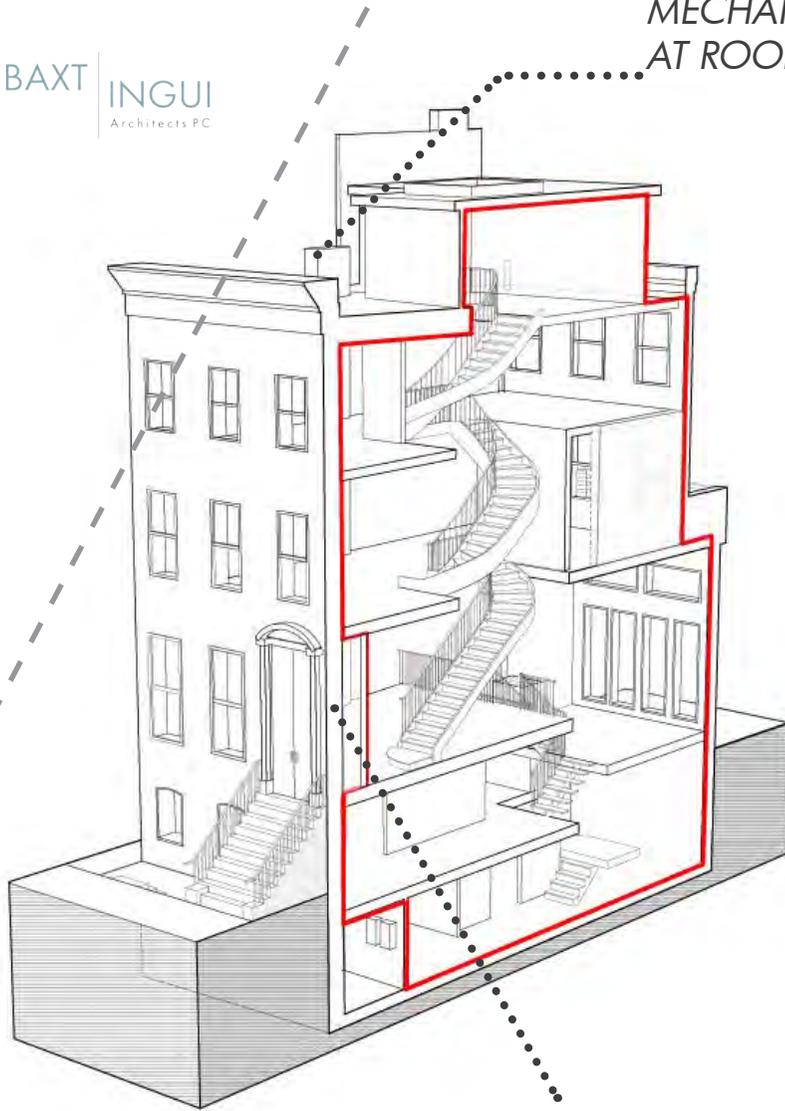
MINIMAL  
MECHANICALS  
AT ROOF

ROOF ADDITION  
AND MECHANICALS  
NOT VISIBLE FROM  
THE STREET

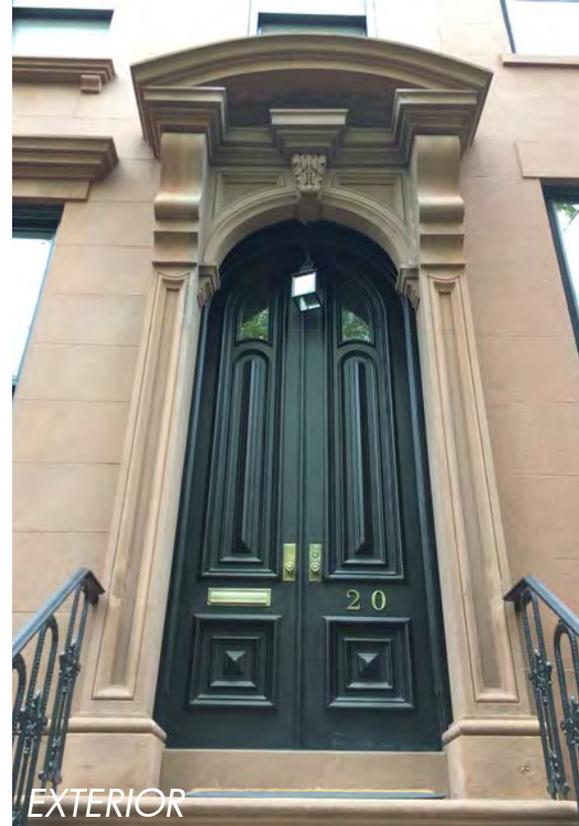
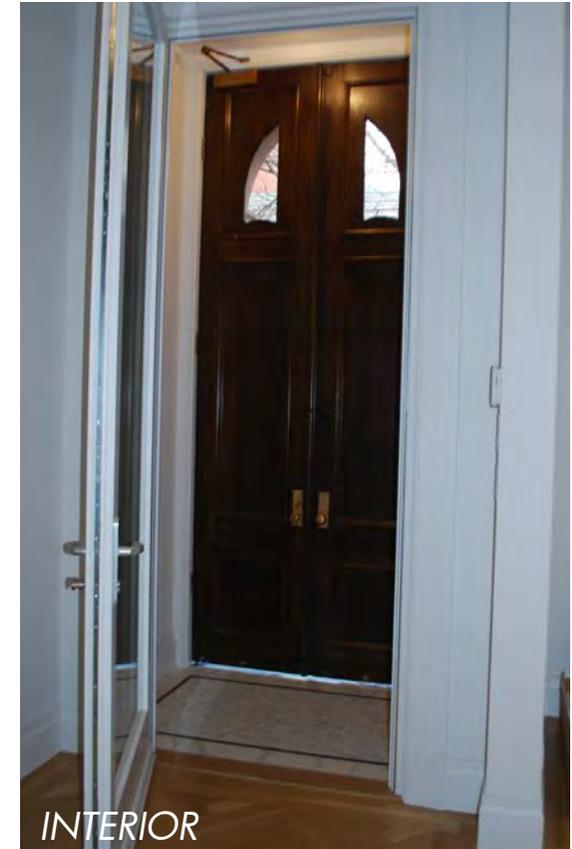
PASSIVE ENVELOPE  
WRAPS BACK  
TO VESTIBULE DOOR

RESTORED ORIGINAL DOORS

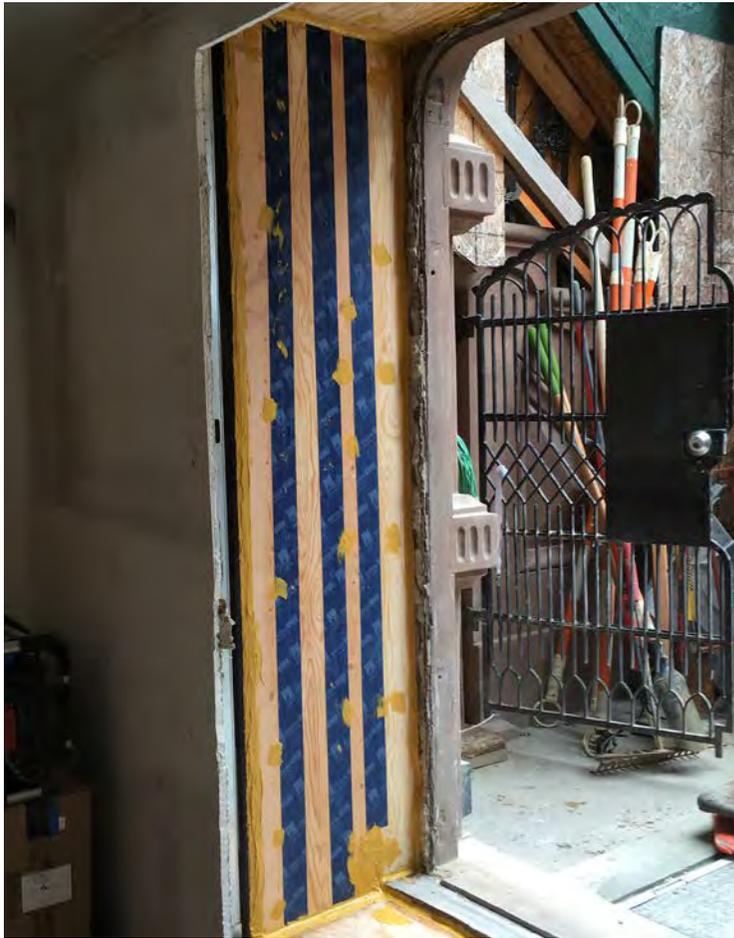
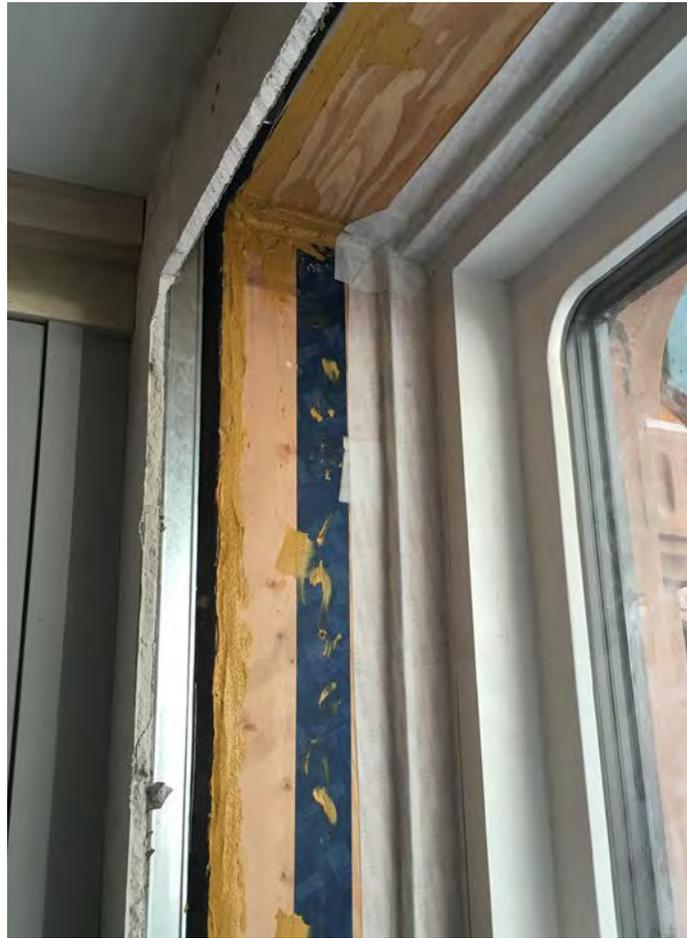
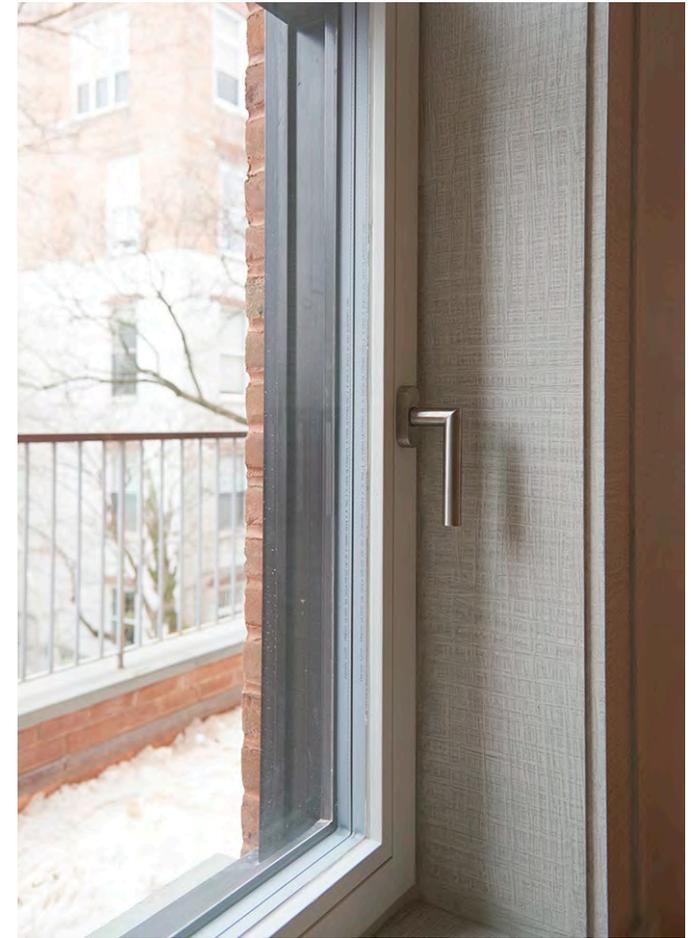
# WINDOW INSTALLATION

**PASSIVE WALL DETAILING ON THE INTERIOR, LEAVING ORIGINAL BROWNSTONE FACADE INTACT.**

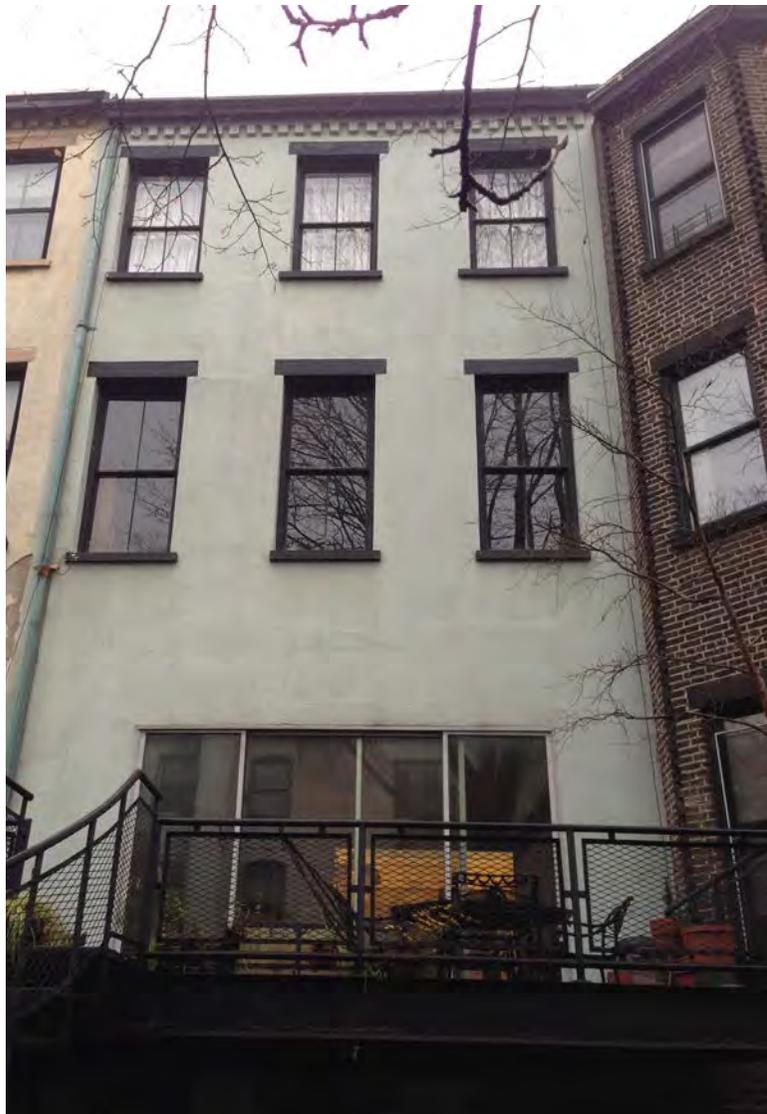
**BEFORE**

**EXISTING STUCCO BRICK FACADE WAS STRIPPED AND RESTORED AND A 6 FT ADDITION WHICH WAS ANGLED TO MIRROR THE ADJACENT NEIGHBORS ANGLED BAY WINDOW.**

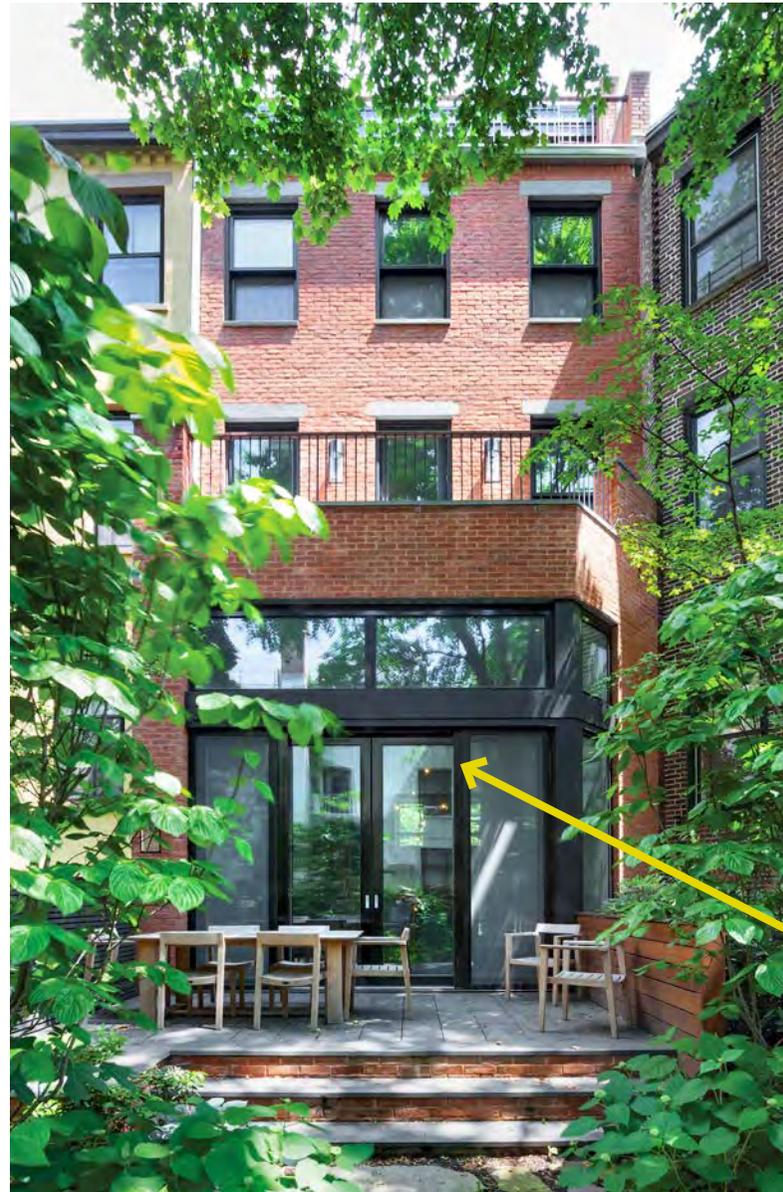
**AFTER**

**TRIPLE PANE 15 FT TALL x 15 FT WIDE DOOR AND TRANSOM UNIT (TREES PROVIDE ADEQUATE SHADE)**
