Certified Building Analysis LLC

Residential performance testing

Methods and techniques for testing
envelope air tightness, Duct testing
and ventilation .

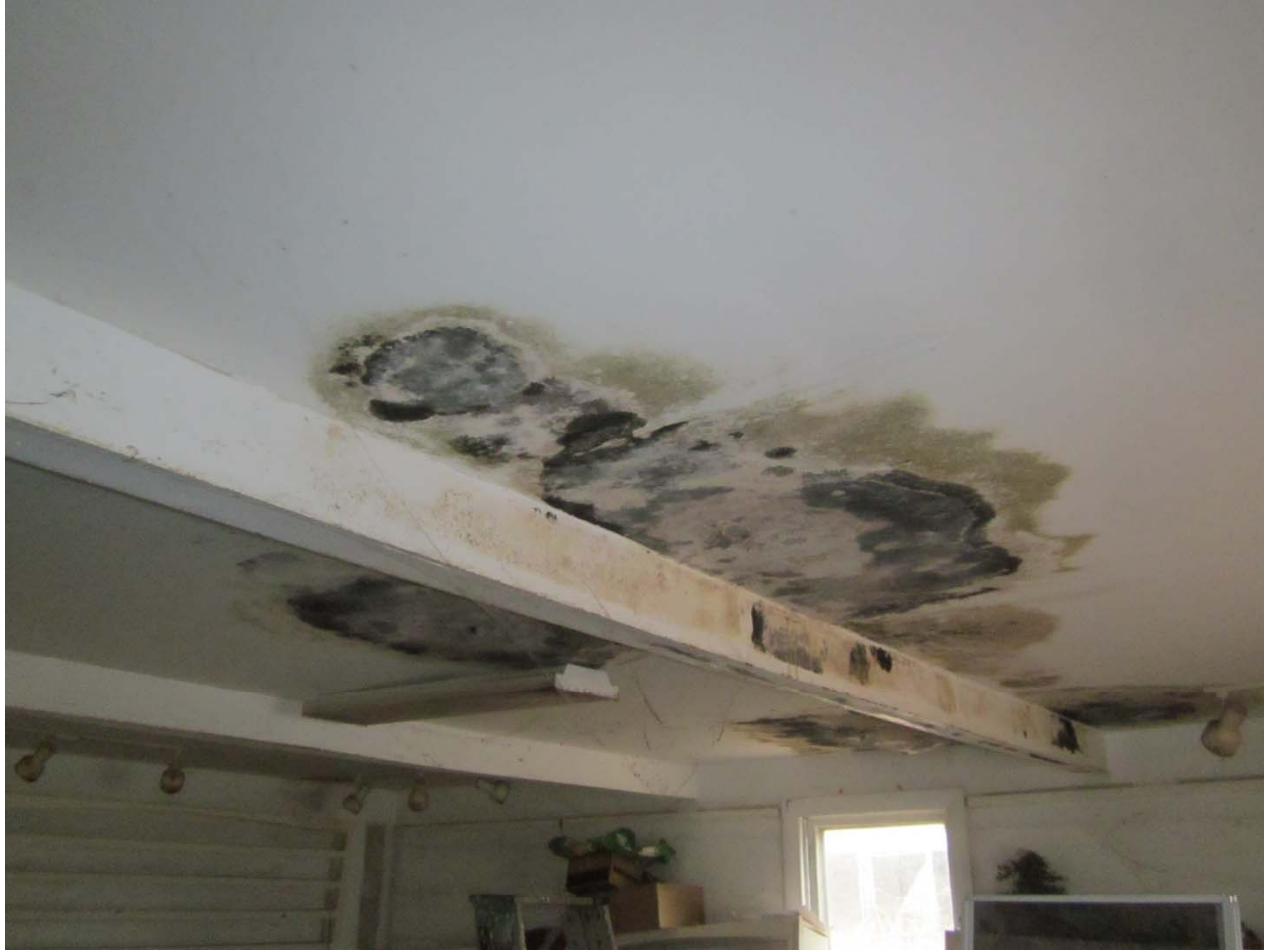
Possibility of mold caused by water damage?

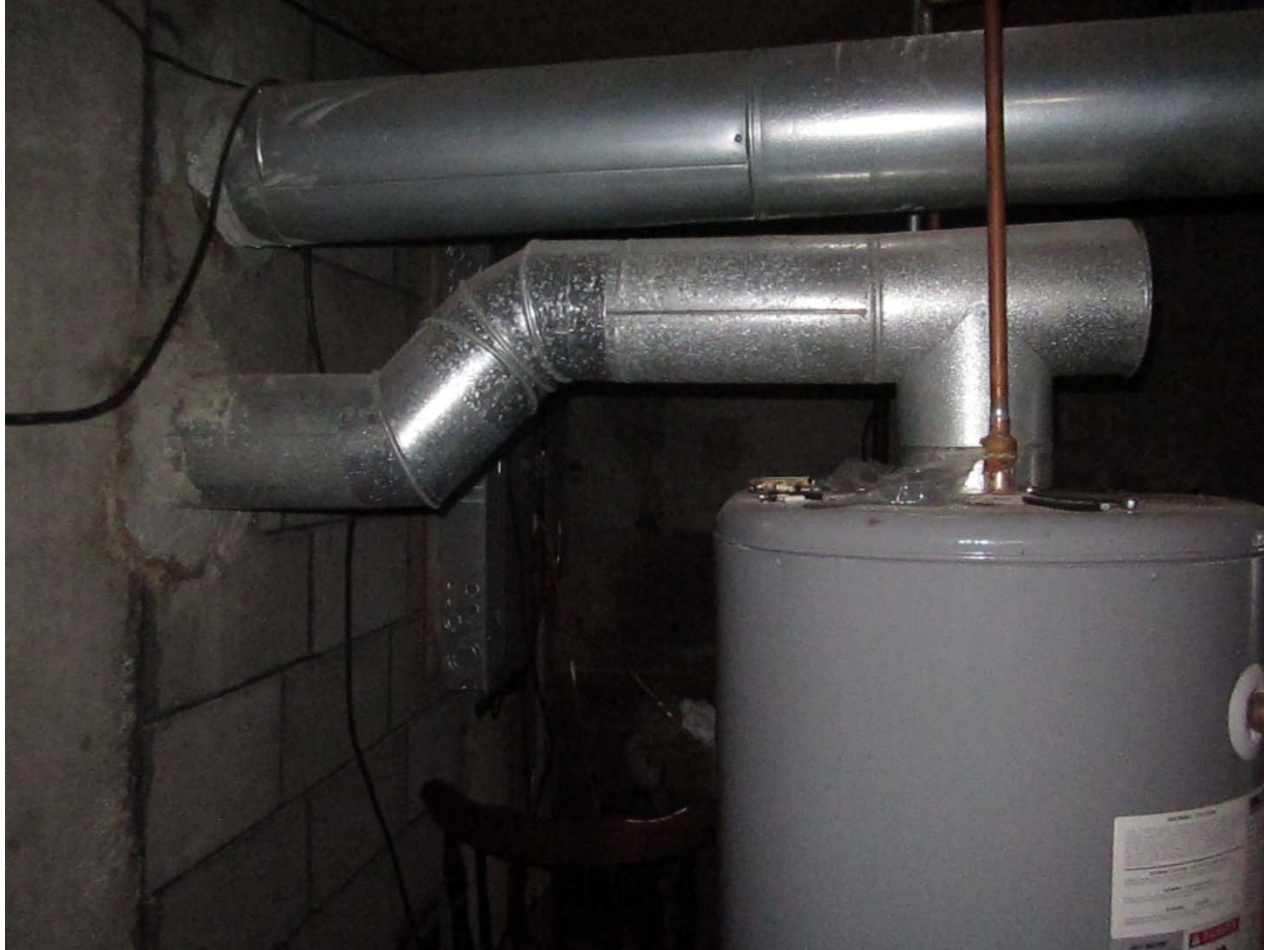
Improper venting of hot water heater.

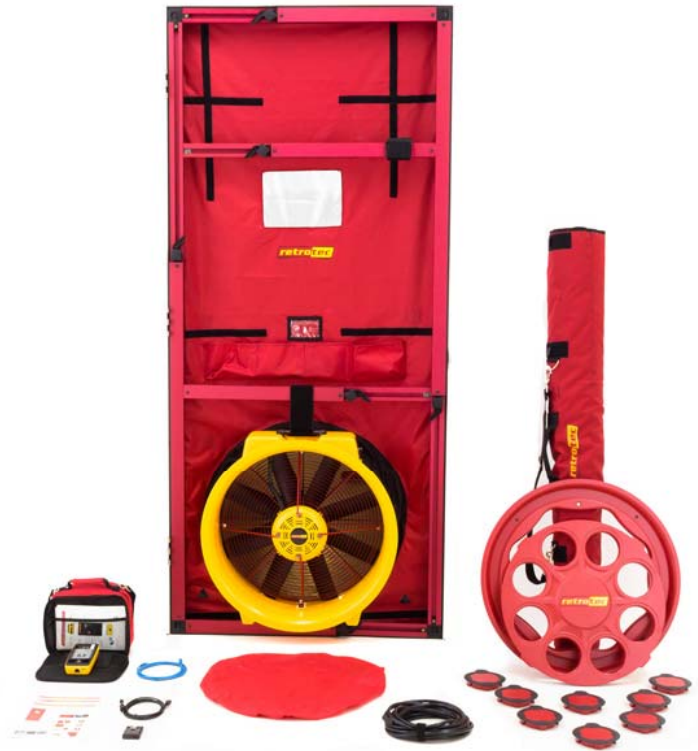
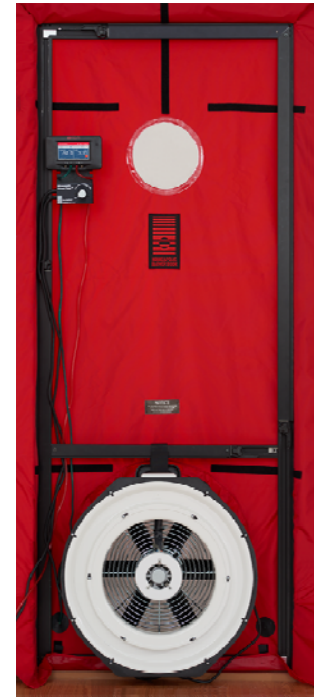
Blower doors and components

On the left is the Retrotec 5000 series ,

On the right is the Minneapolis Model 3

- Blower door testing is done at a pressure of 50 Pa.
- Select an exterior door to install blower door and frame into. Should have unobstructed path to outside.
- There are several manufactures of this test equipment.
- Next slide shows two manufacturers types of blower doors.

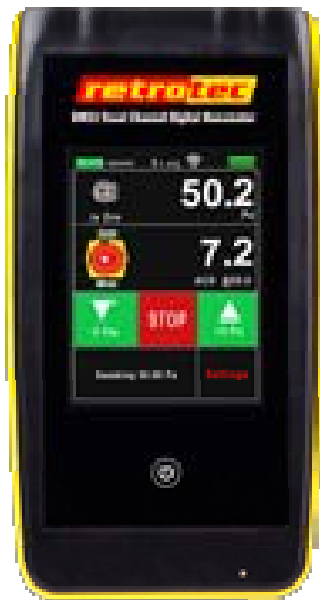
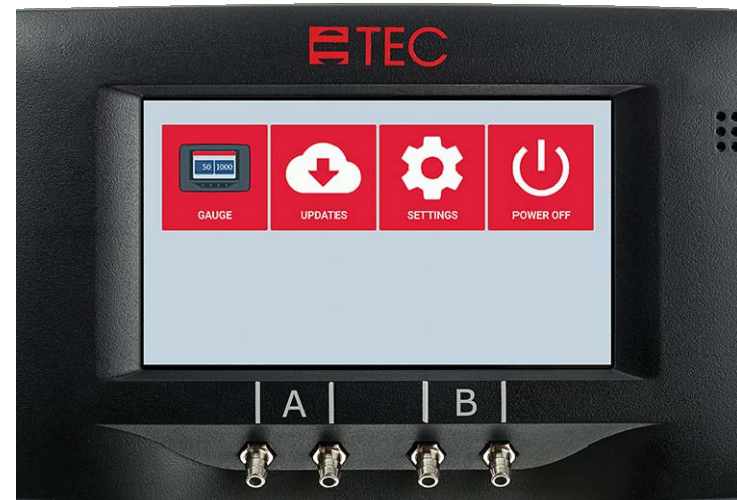
dual channel Micro Menometers

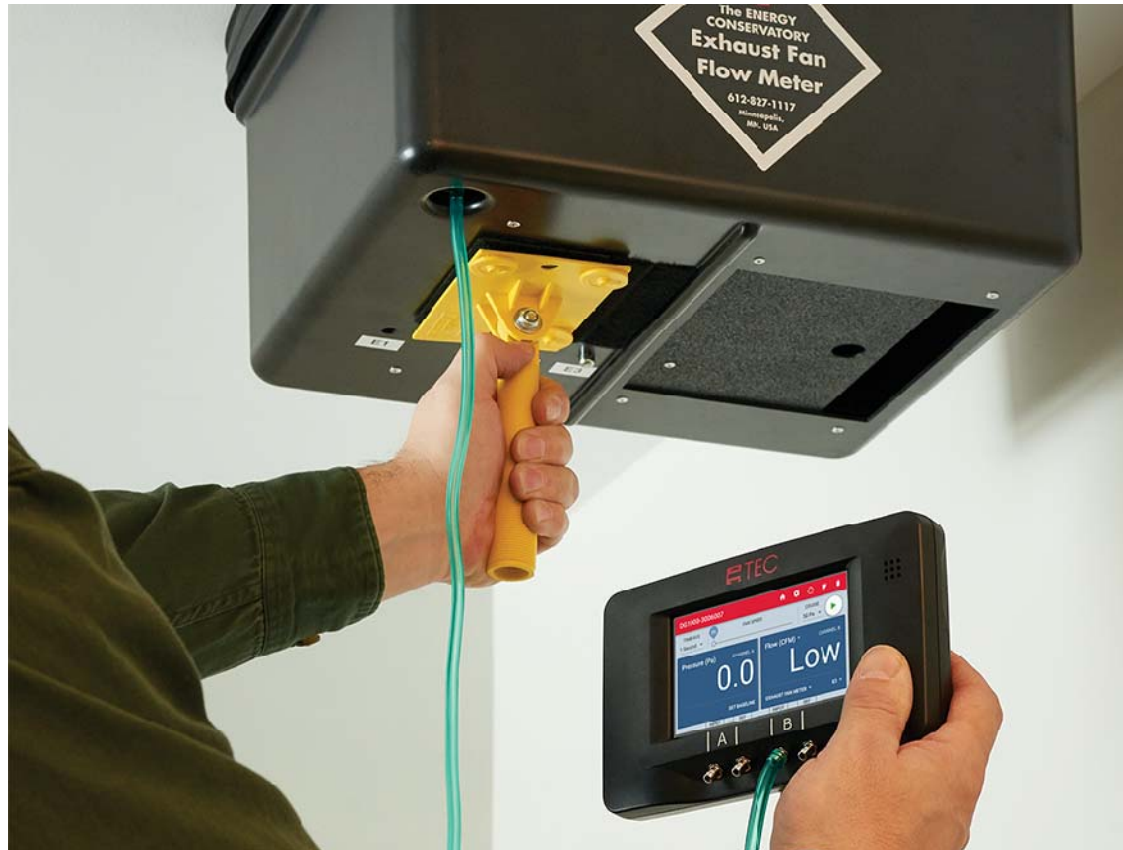
Exhaust Fan Flow meter

This is used for testing exhaust fans for flow . The CFM readings are used in conjunction with blower door results for computing ASHREA 62.2-2013-16 compliance.

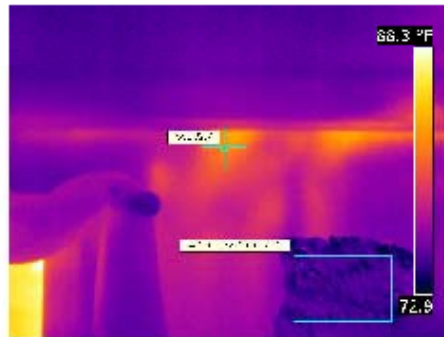
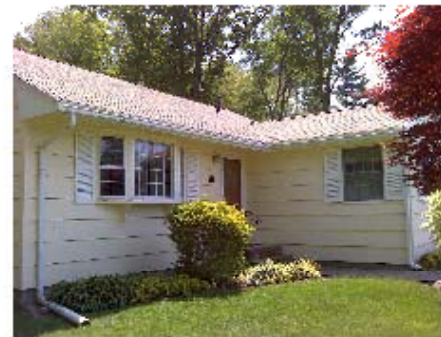
Camera Model	FLIR B200
Image Date	5/26/2010 2:48:31 PM
Image Name	IR_0039.jpg
Emissivity	0.93
Reflected apparent temperature	75.4 °F
Object Distance	3.3 ft

North facing exterior wall at intersection of ceiling and wall, 18 Greenfield St, South Easton, Ma 02375. Interior conditions consisted of blower door operation at 50 pa, CFM 50 @1474. Volume of dwelling 15337 cubic feet. ext. temp 88F /RH 64

Left side of bay window upper corner location of interior thermogram

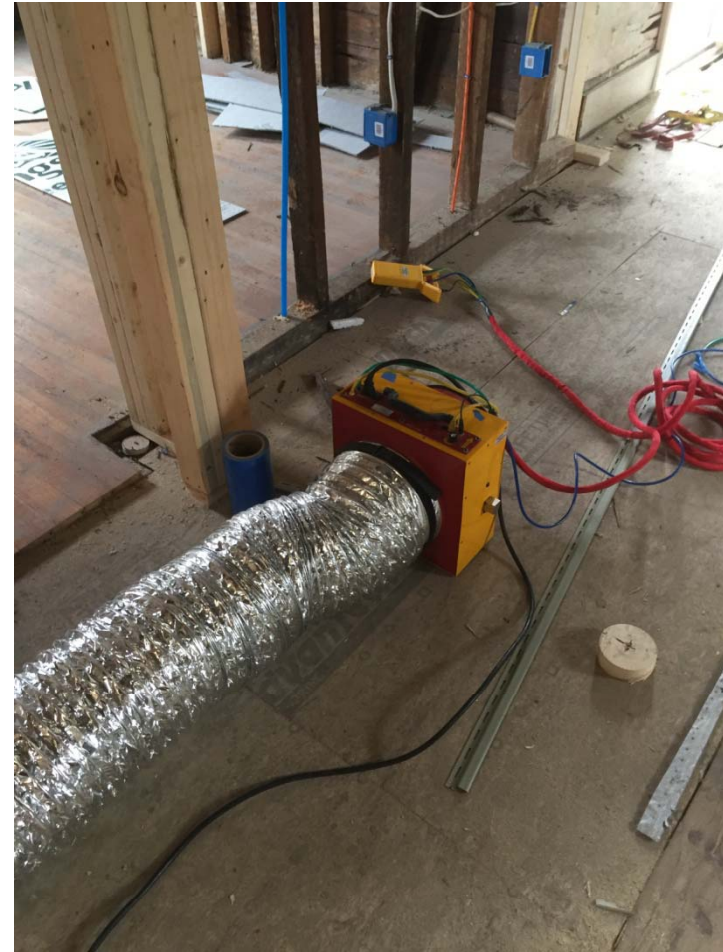
Duct tester installed

- Remove filter
- Seal all vent and return grills
- Attach duct tester to air handler if possible
- Insert pressure probe in to a supply nearest to air handler
- Allowable total leakage is based on $CFA \times .04$
- Leakage to outside will be lower to outside, this measure shows how much leakage is occurring in unconditioned spaces.

- Set up for duct testing
- For total leakage at least one exterior door or window must be left open.
- For leakage to outside all doors and windows must be closed except for door that blower door is installed in. Duct tester and blower door are run at same time.
- This test is done at 25 Pa

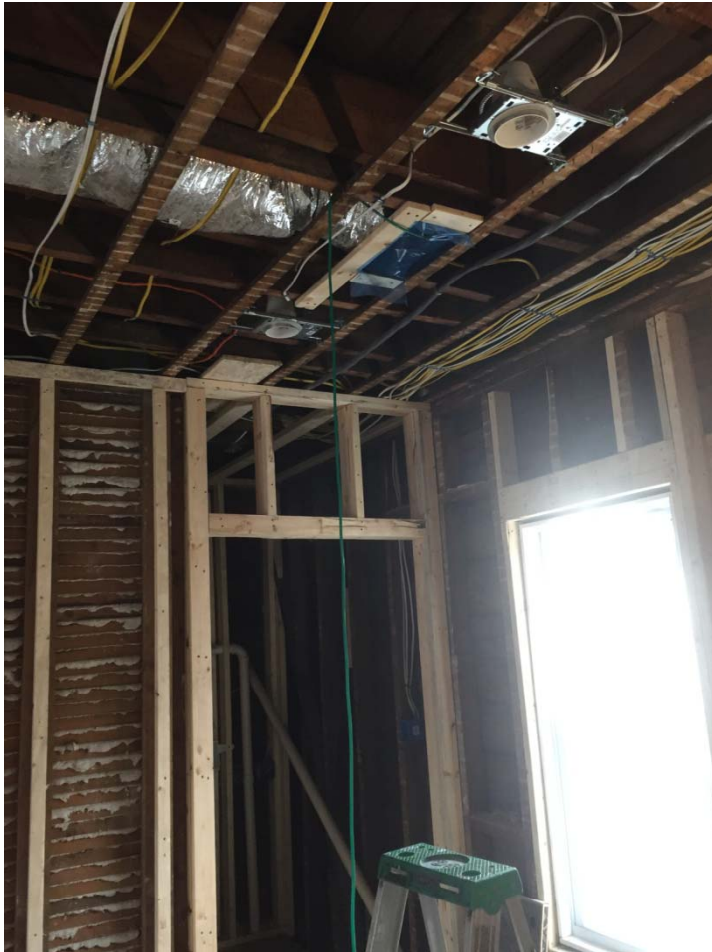
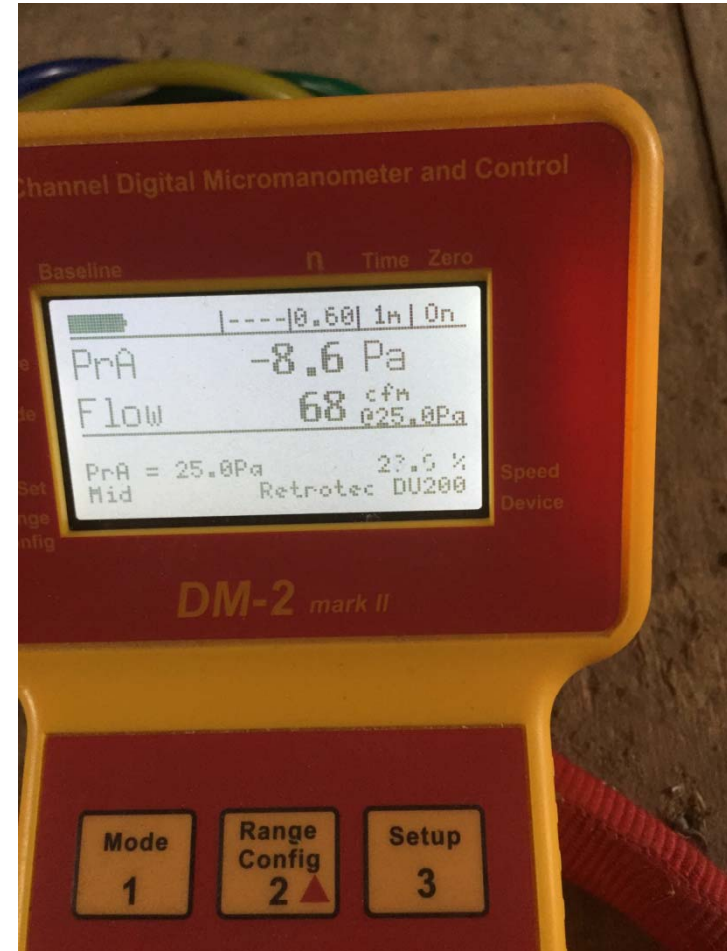
Pressure probe on right Results on left

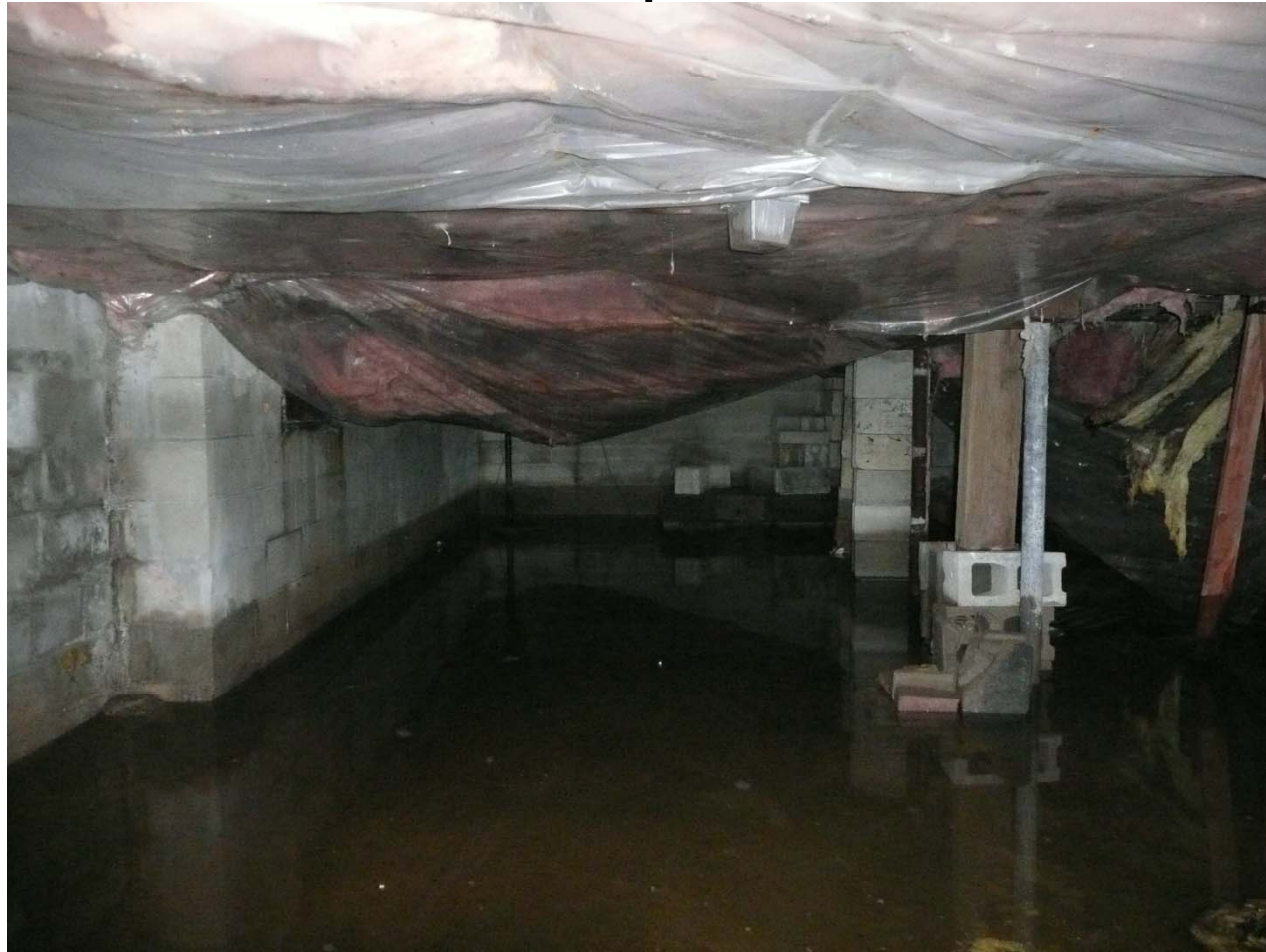
Do you think that this home may have a moisture problem?
