Kohta Ueno

Unvented Roofs Without Spray Foam:
The Latest Building America Research

MARCH 7-9, 2018 • WESTIN BOSTON WATERFRONT • NESEA.ORG/BE18
Conference • Trade Show of the Northeast Sustainable Energy Association (NESEA)

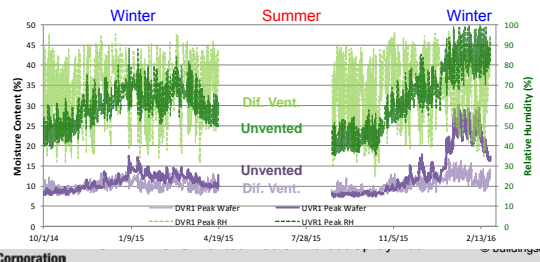
- Diffusion vent avoids wintertime ridge accumulation problems (ridge peak RHs/MCs)
- No failures at low interior RH, bigger difference at higher RH (interior humidification)
- Airtightness disappointing in some cases-no SPF

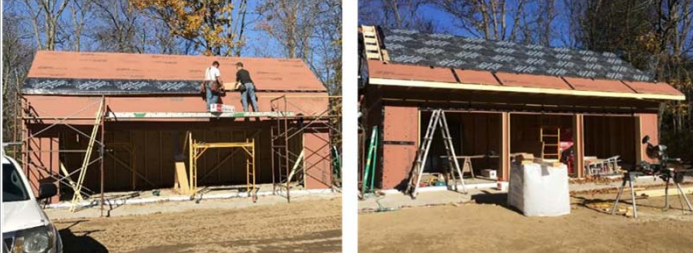
- Adhered membrane connection roof-to-wall
- Overhangs (eave & rake) attached outboard of air barrier layer
- Self-adhered membrane on entire roof

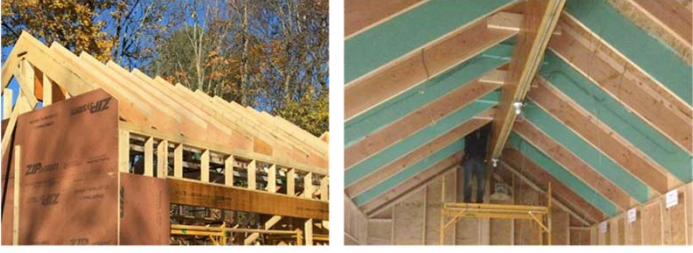
- Roof bays 24" o.c.
- Guard bays between experimental bays ("flash and blow" ccSPF + cellulose)
- Fluid-applied air and vapor barrier at guard bays

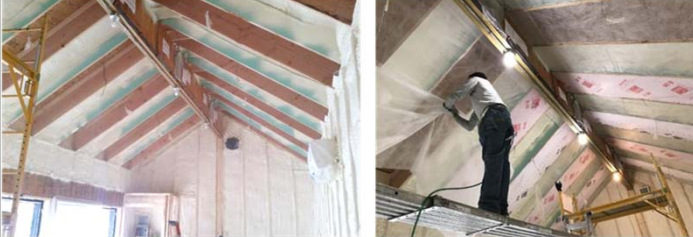
- Flash and blow bays (ccSPF shown)
 - ccSPF completes air barrier between bays, wiring holes
- Insulation netted & blown (fiberglass complete in image; cellulose installation)

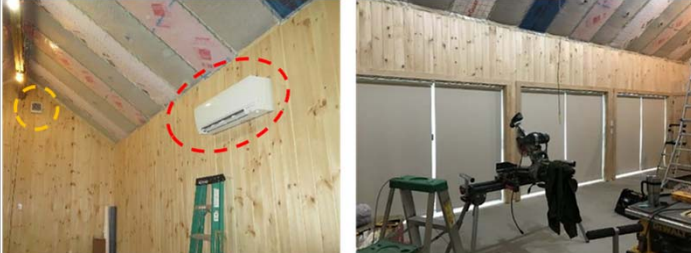
- Space conditioning with MSHP (heating & cooling)
- Ventilation via wall-mounted exhaust fan
- Solar control with roll-down shades (all-south glazing)

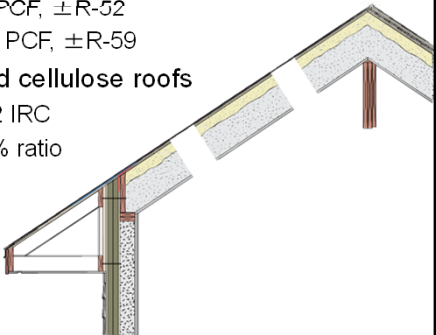
- Rafter bay insulation materials
 - Cellulose @ 3.5 PCF, ±R-52
 - Fiberglass @ 1.4 PCF, ±R-59
- Hybrid ccSPF and cellulose roofs
 - § R806.5 in 2012 IRC
 - ±R-63, 40%-60% ratio

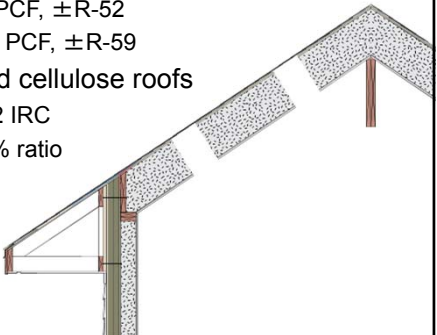
- Rafter bay insulation materials
 - Cellulose @ 3.5 PCF, ±R-52
 - Fiberglass @ 1.4 PCF, ±R-59
- Hybrid ccSPF and cellulose roofs
 - § R806.5 in 2012 IRC
 - ±R-63, 40%-60% ratio

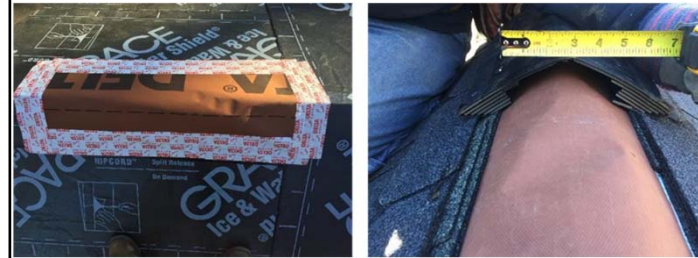
- ± 5 in. opening (fits under typical ridge cap)
- Cosella-Dörken Delta-Foxx
 - 214 perms dry cup
 - 550 perms wet cup

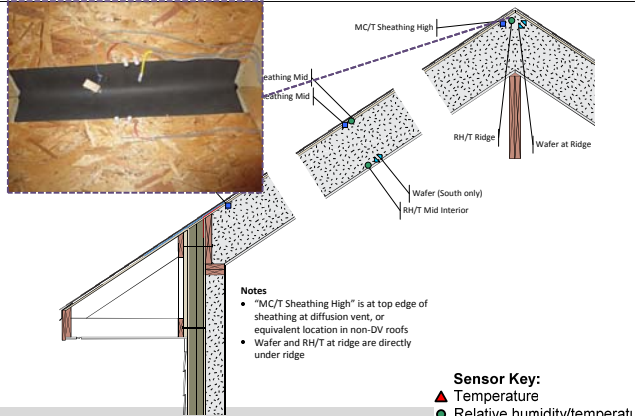
- "MC/T Sheathing High" is at top edge of sheathing at diffusion vent, or equivalent location in non-DV roofs
- Wafer and RH/T at ridge are directly under ridge

- ▲ Temperature
- Relative humidity/temperature
- Moisture content/temperature
- Moisture content block

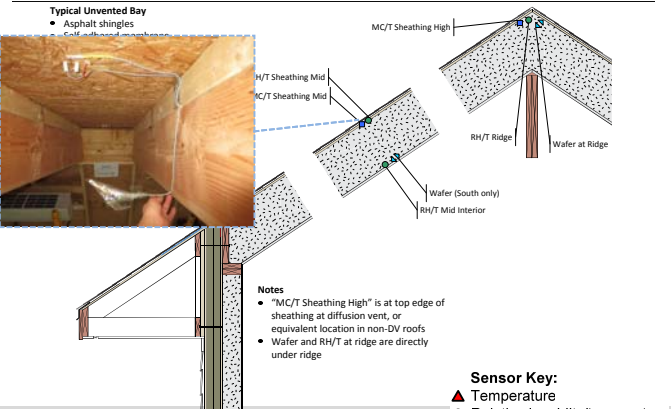
- Asphalt shingles
- Gelfoam insulation

- "MC/T Sheathing High" is at top edge of sheathing at diffusion vent, or equivalent location in non-DV roofs
- Wafer and RH/T at ridge are directly under ridge

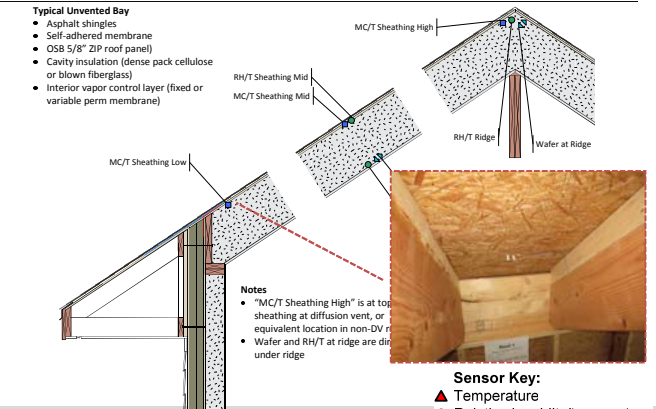
- Asphalt shingles
- Self-adhered membrane
- OSB 5/8" ZIP roof panel
- Cavity insulation (dense pack cellulose or blown fiberglass)
- Interior vapor control layer (fixed or variable perm membrane)

- "MC/T Sheathing High" is at top sheathing at diffusion vent, or equivalent location in non-DV roofs
- Wafer and RH/T at ridge are directly under ridge

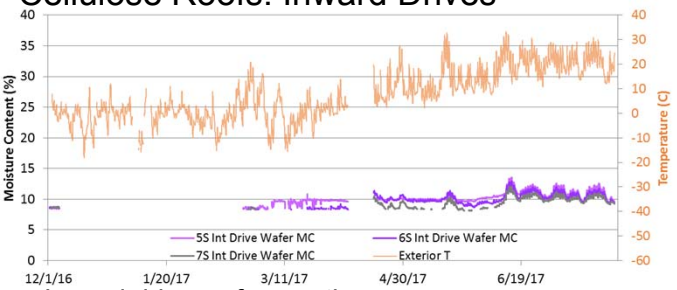
- Inward drive wafer, south
- All well below 15% MC (safe)

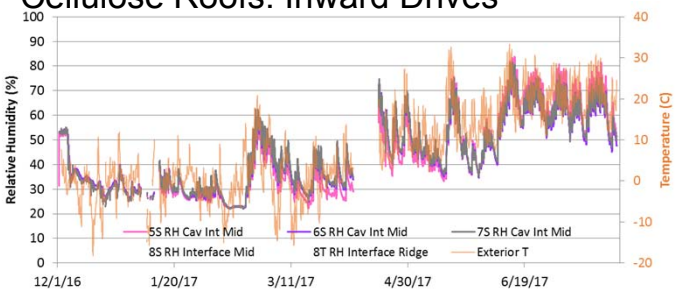
- Inward drive RH, south
- Peaks barely over 80% RH

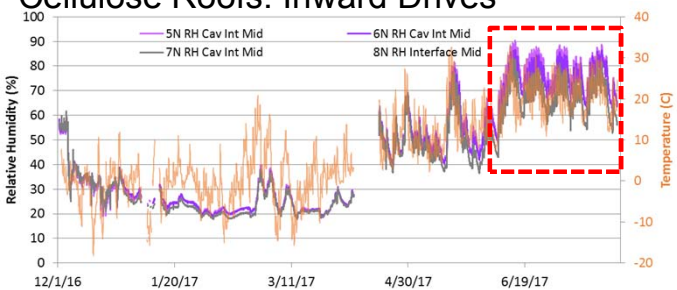
- Inward drive RH, north
- Peaks mostly under 90% RH
- Higher than south-stored moisture?

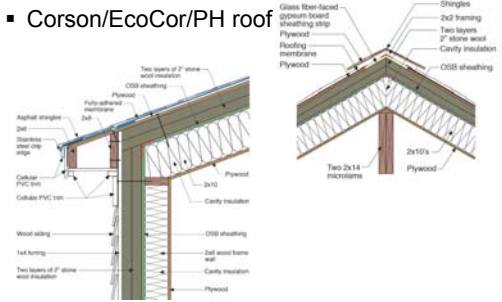
- Code-compliant (IRC § R806.5) still safest (spray foam or exterior rigid insulation)
 - Mineral fiber exterior rigid insulation is an option
 - Corson/EcoCor/PH roof
