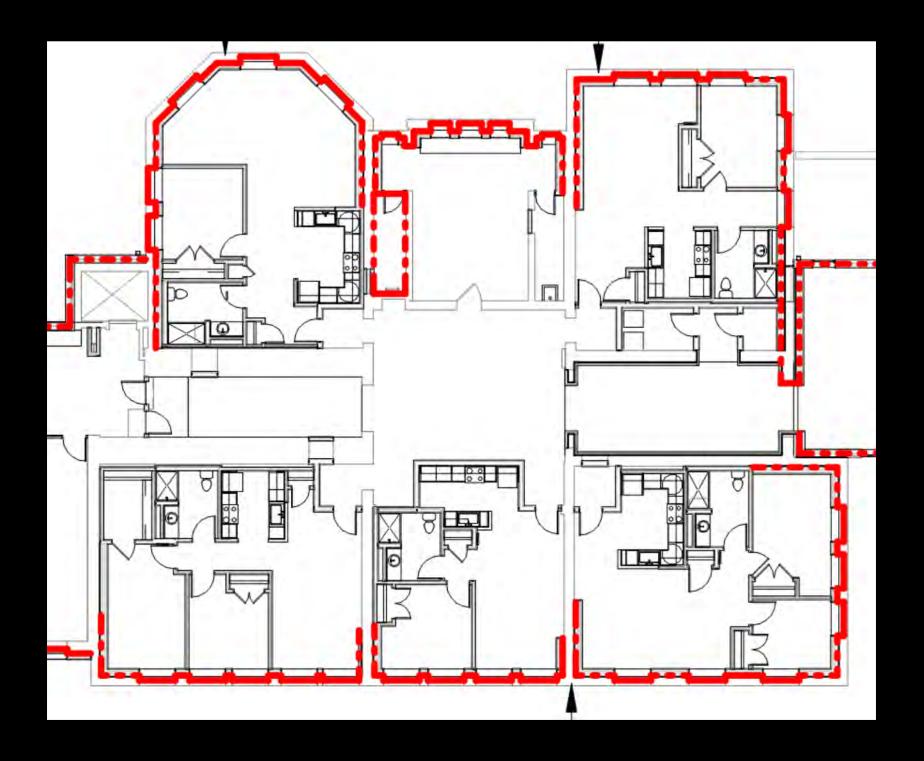
1. 'Sleeve' insulation and air barrier on either side of existing masonry bearing walls.

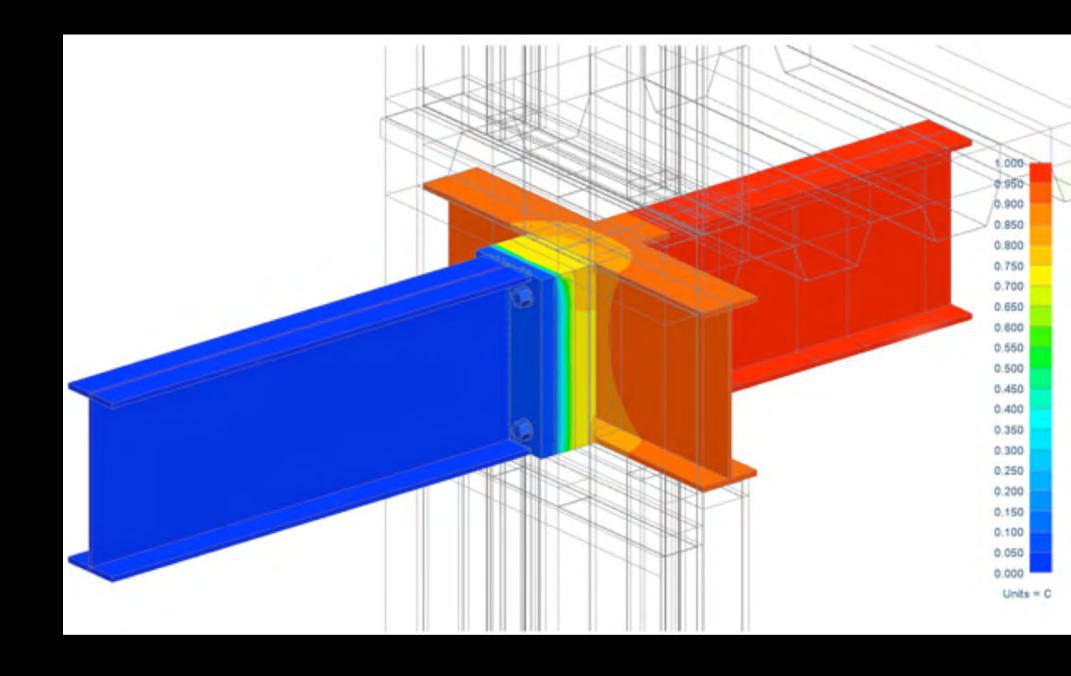
MORNINGSIDE THERMAL BREAK

Steel to Steel

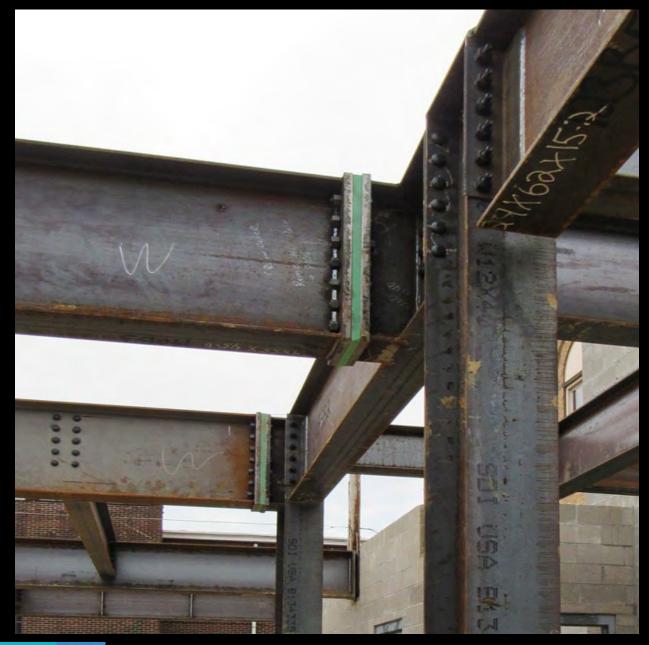
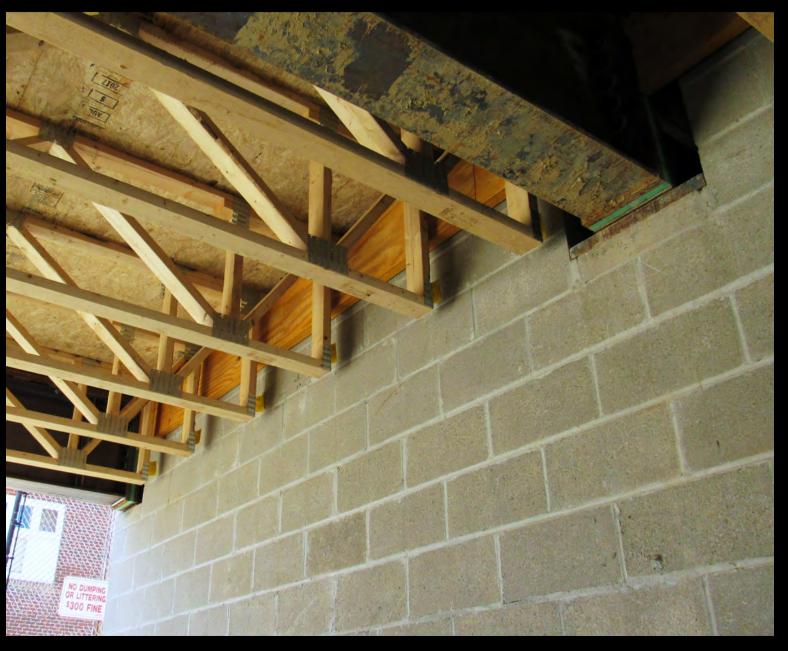
MORNINGSIDE THERMAL BREAK

Steel to Steel
