# **BUILDINGENERGY BOSTON**

## **What's Old is New Again: Renewing Historic Enclosures for Modern Performance**

**Justin Dufresne, Goody Clancy**  
**Tom Haskell, University of Connecticut**

**Northeast Sustainable Energy Association (NESEA) | March 20, 2025**

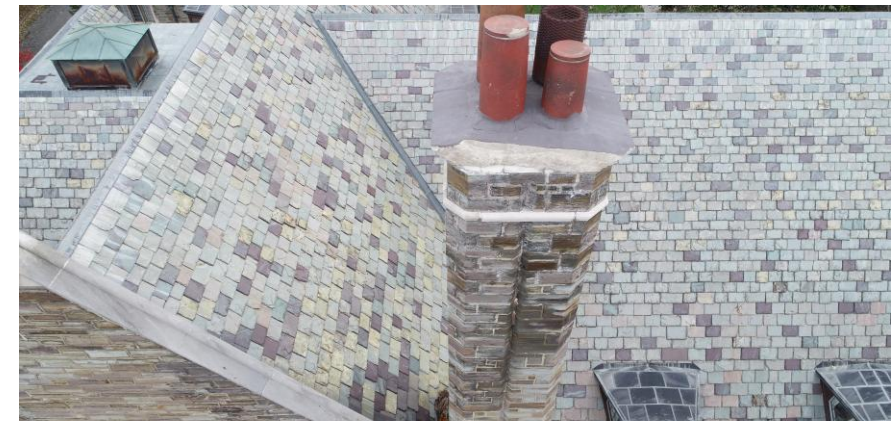
DRONE SURVEY OF ROOF

- Complete visual survey
- THERM
- WUFI hygrothermal analysis
- Existing materials testing
  - Dry Bulk Density Porosity
  - Thermal conductivity
  - Water Absorption
  - Vapor Permeance
  - Water content
  - Free water saturation
  - Freeze-Thaw Saturation
- Exploratory probes
- TALLY Lifecycle Carbon Assessment

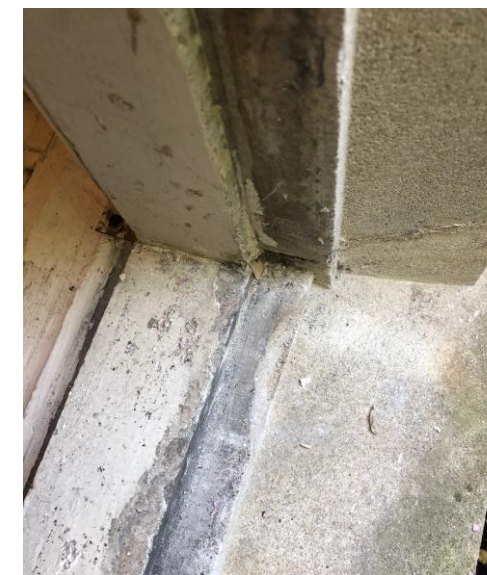
WINDOW SILL CONDITION

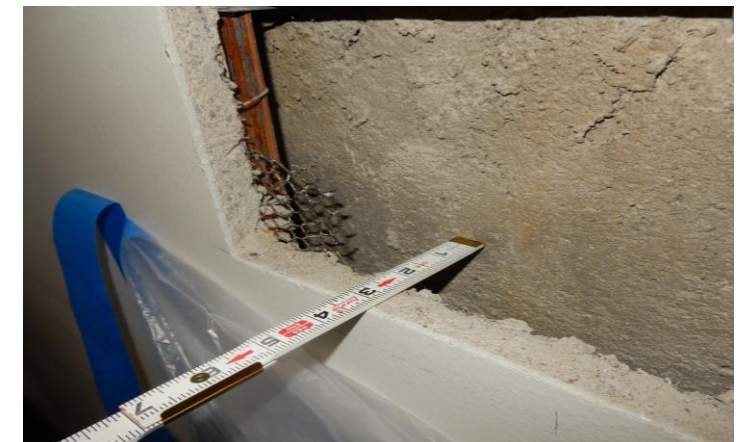
INTERIOR WALL ASSEMBLY PROBE

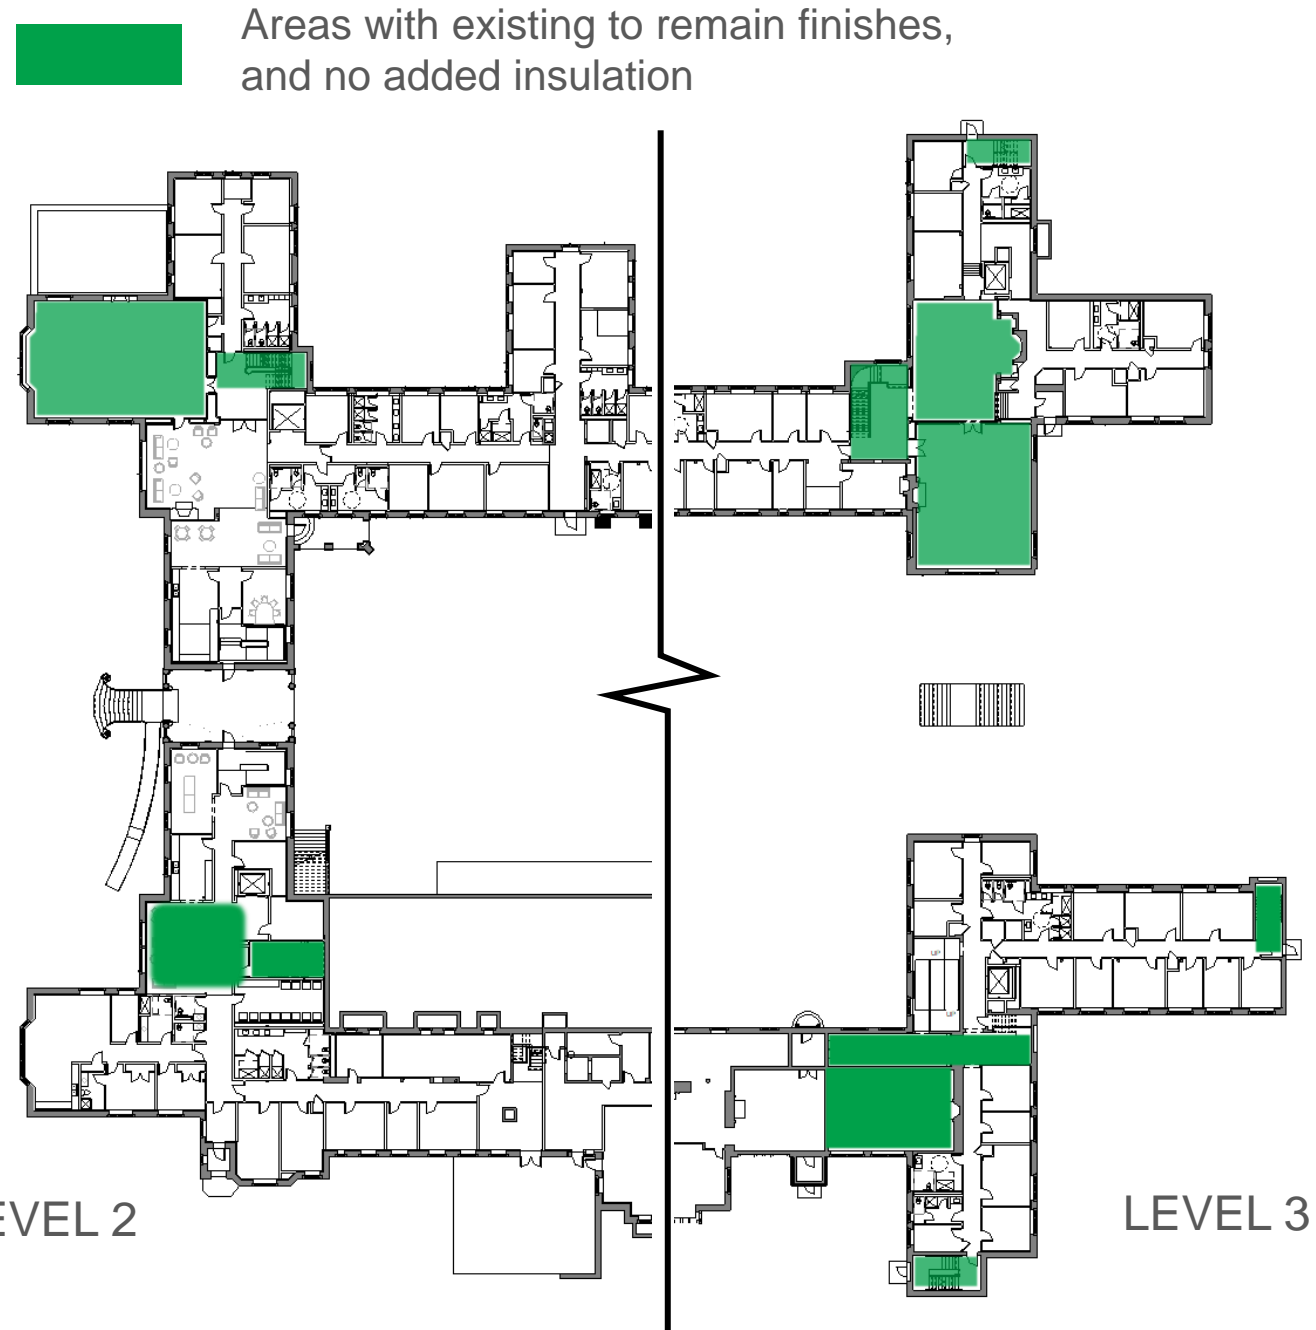
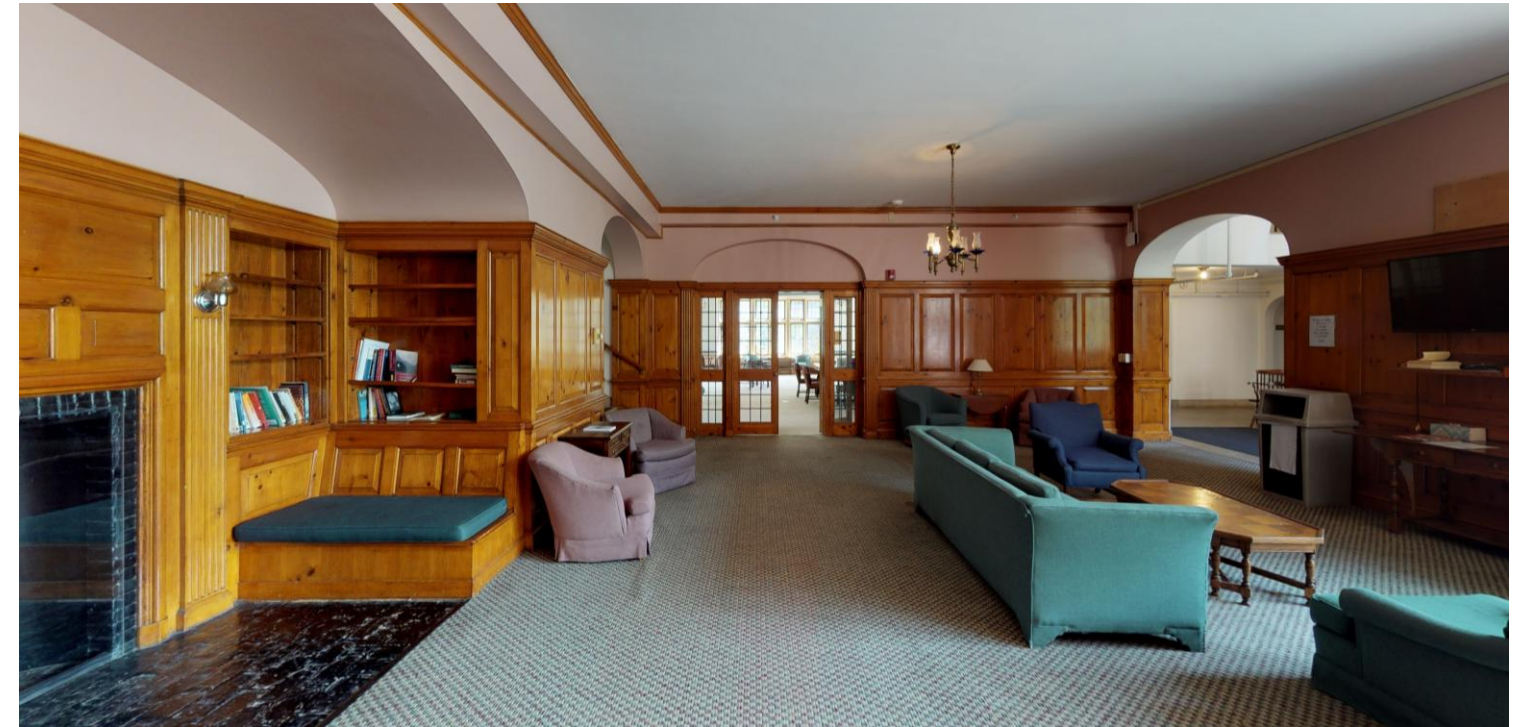
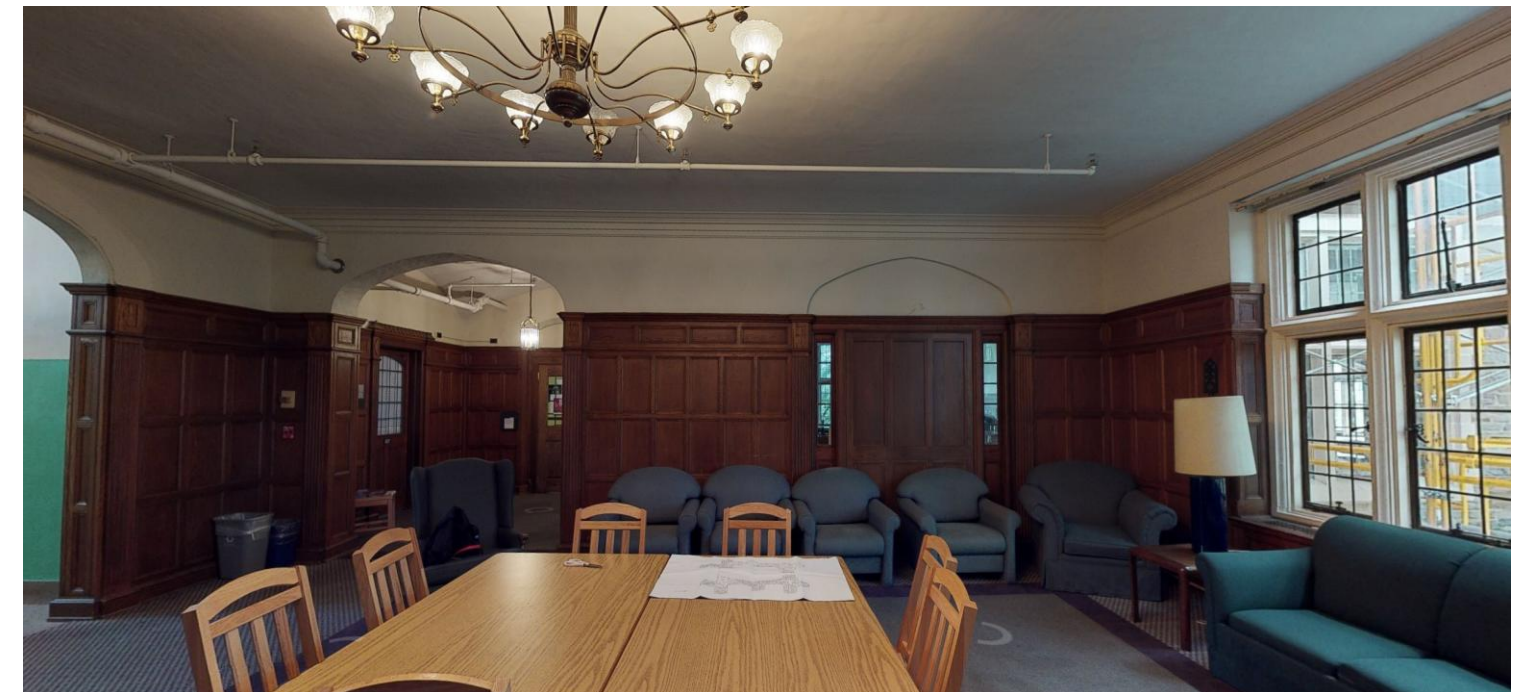
- Continuity of character vs continuity of insulation

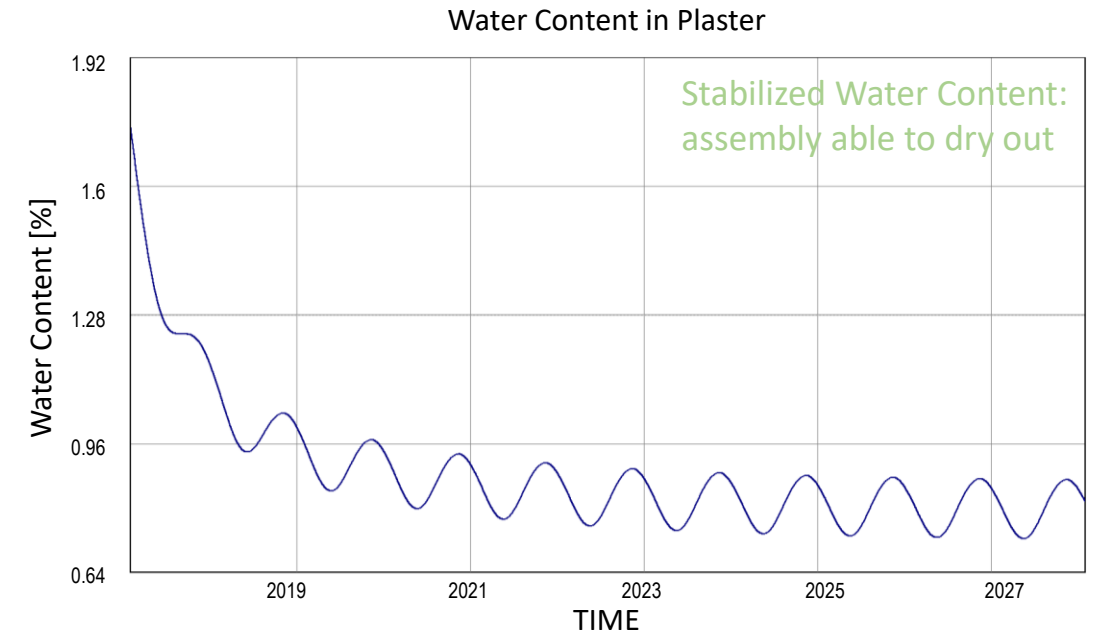
### Existing

## Hygrothermal Analysis

1. Plaster / lath: should it be removed?

The addition of insulation prevents heating from inside from keeping plaster dry

- Material Testing had not been performed
- Question: Should plaster/Lath be removed?
- Result: Yes.

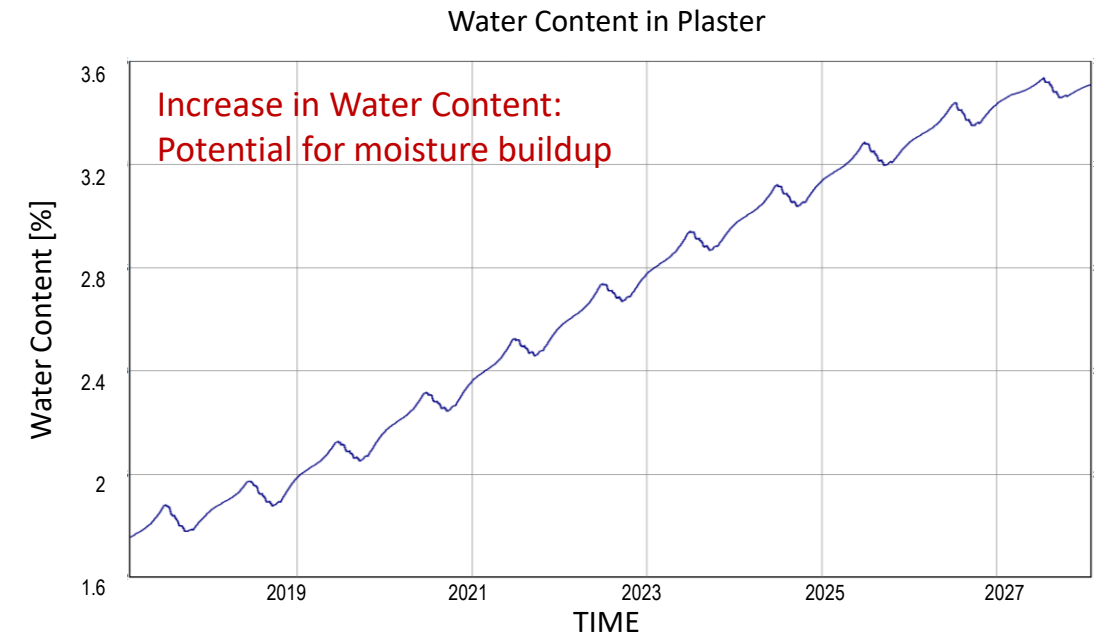
### Proposed: Existing + MW

(Proposed: Existing + ccSPF is similar)

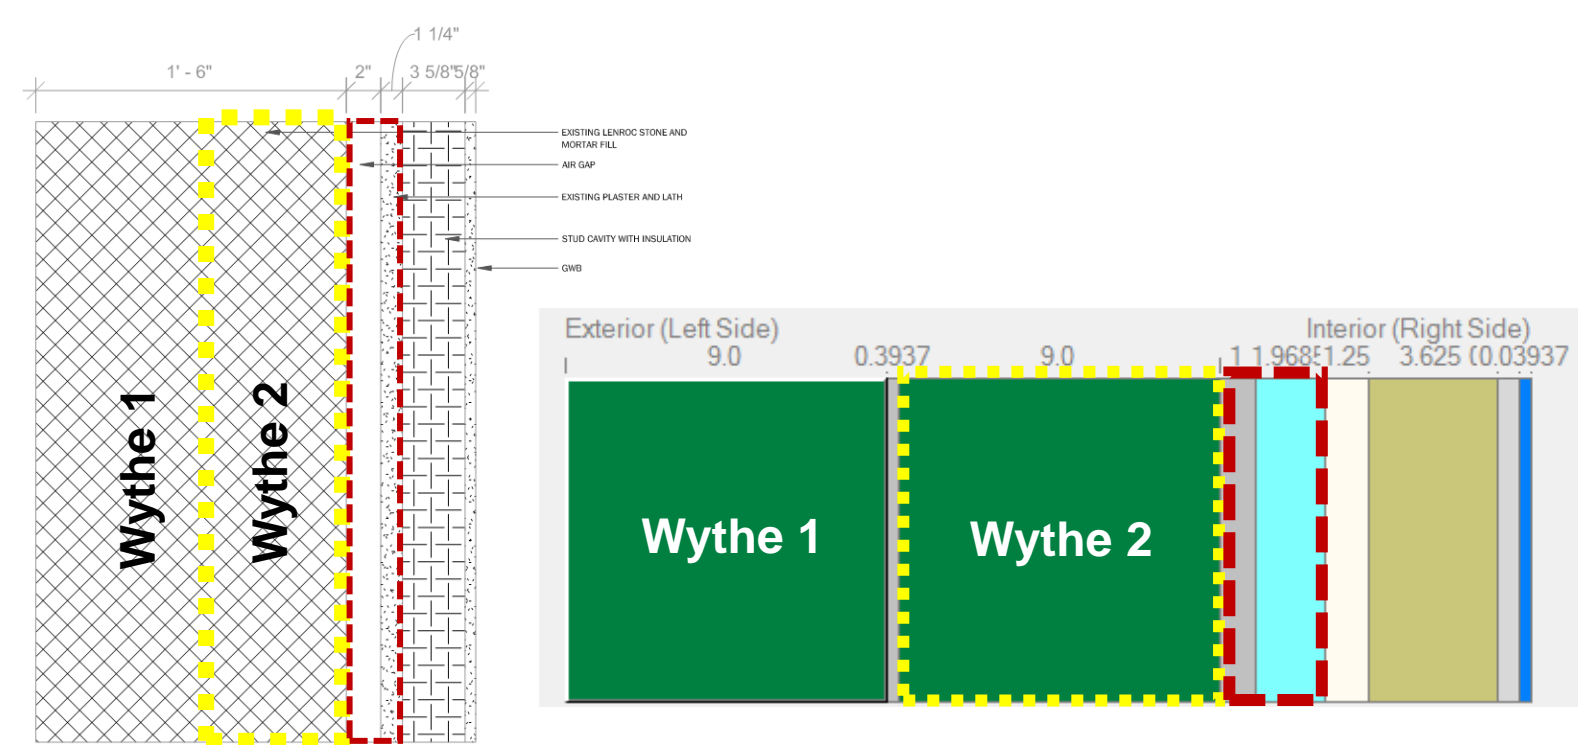
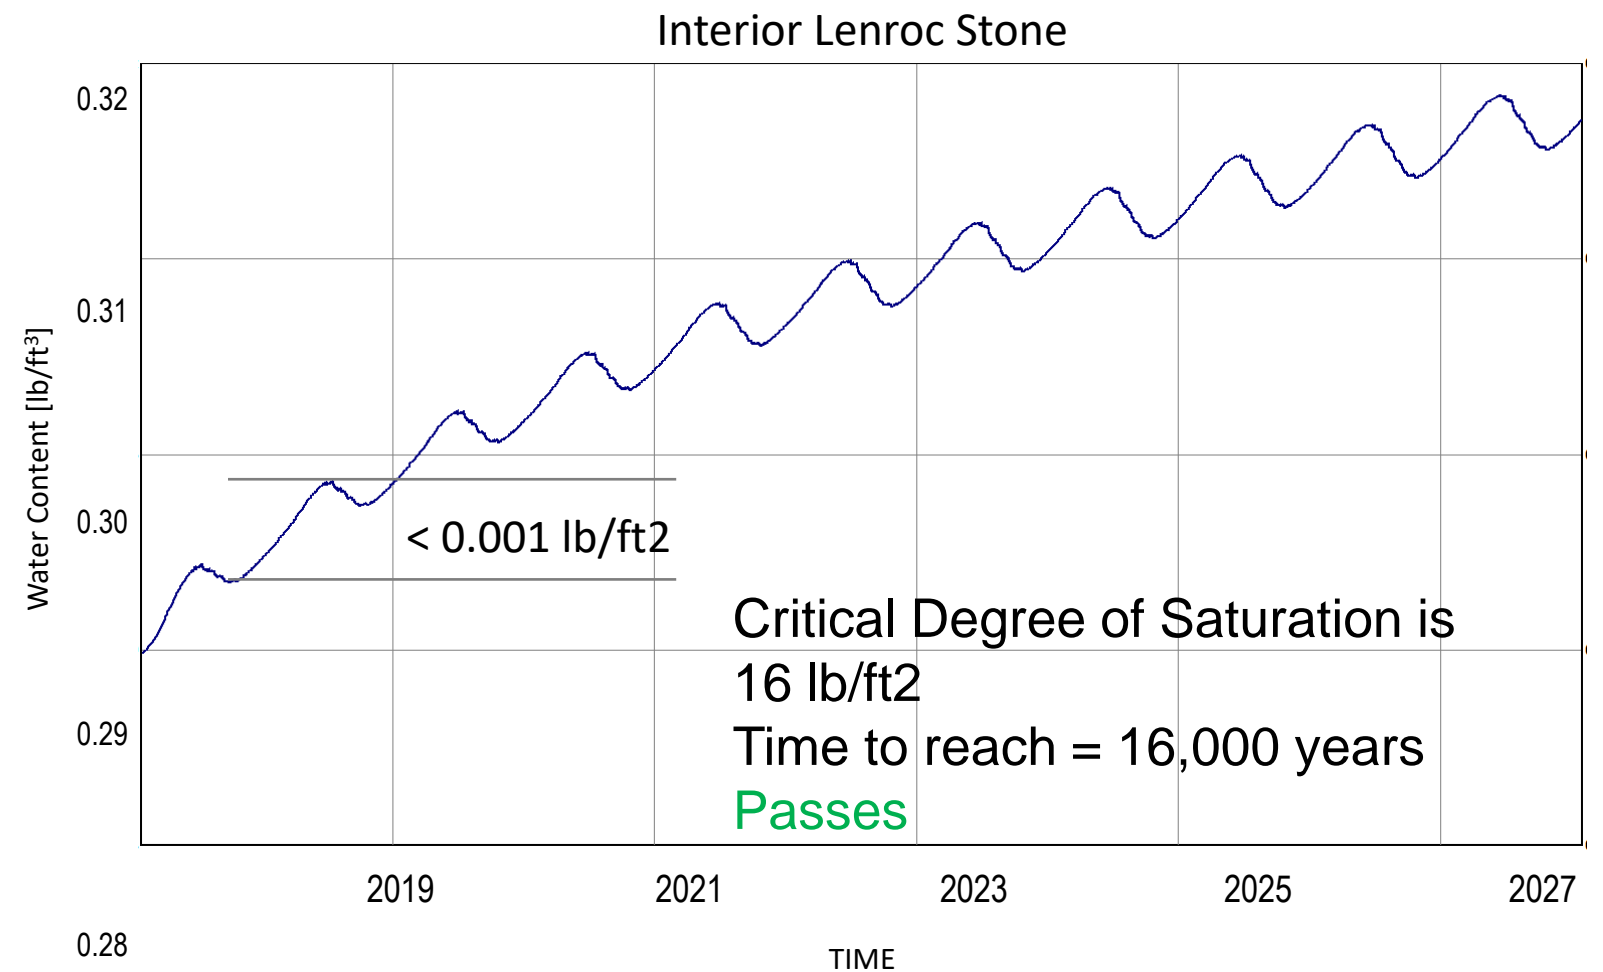
## WUFI Analysis, June 2019

- Material Testing results received
  - Llenroc stone has lower water absorption rate than assumed
- Result: Plaster and Lath can remain  
  - Mineral Wool (MW):
    - Smart vapor retarder / air barrier on interior of MW is critical
    - 3 5/8" insulation thickness or lower is recommended
  - Closed-cell Spray Foam (cSPF):
    - cSPF acts as Class II vapor retarder
    - 3 5/8" insulation thickness or lower is recommended

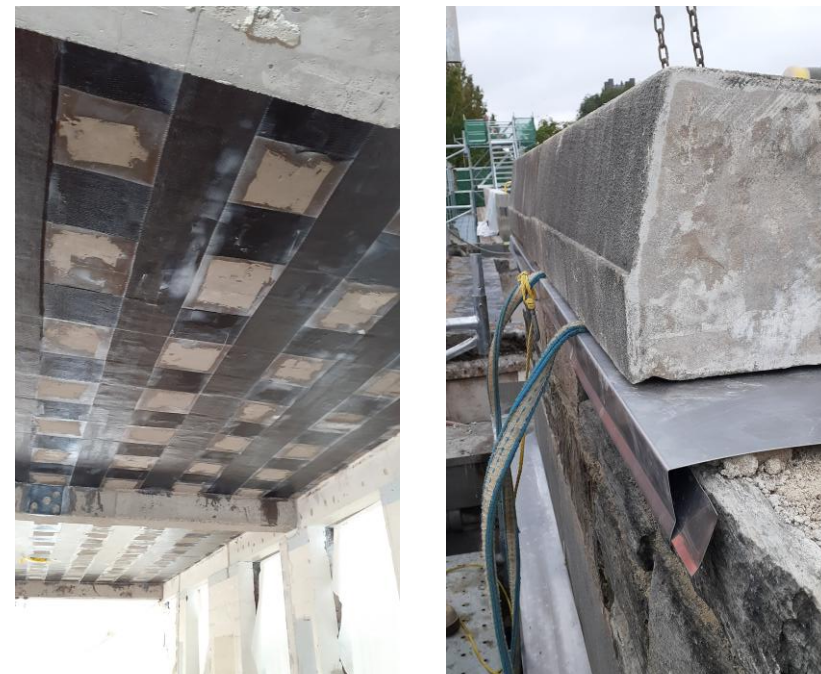
CARBON FIBER REINFORCING, PARAPET REBUILD

- How much of the original building *can* we reuse?
- Priorities for façade repair?
- All interventions must be weighed against life cycle cost & character

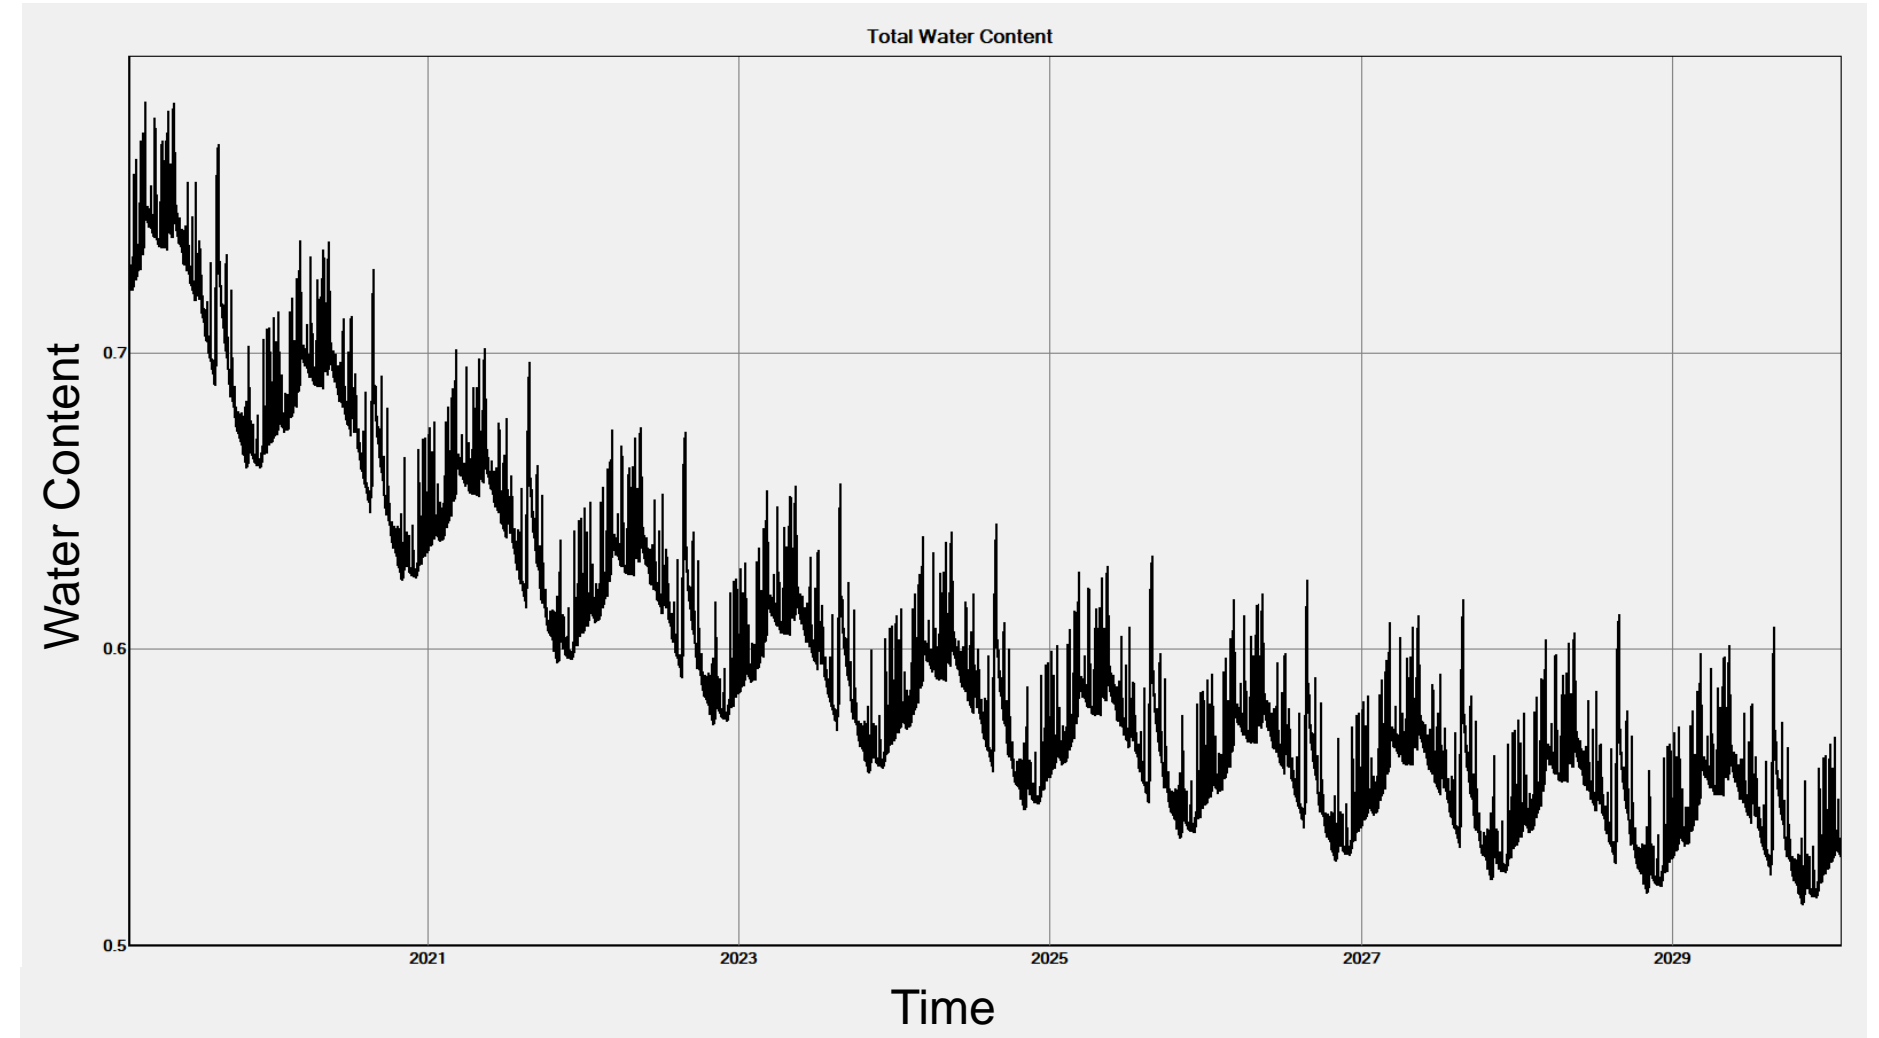
- Total water content and individual water for the proposed options studied trend downward or stabilize – see above for A.0 (all others are similar)
- Because water content is lower than the critical degree of saturation (Scrit) provided by Highbridge’s materials testing, the cases studied pass freeze-thaw criteria
- Mold growth at key interfaces for the cases studied has been found to meet the criteria for the Viitanen Mold Growth Index (MGI)
- Dew point is outlined in the following slides

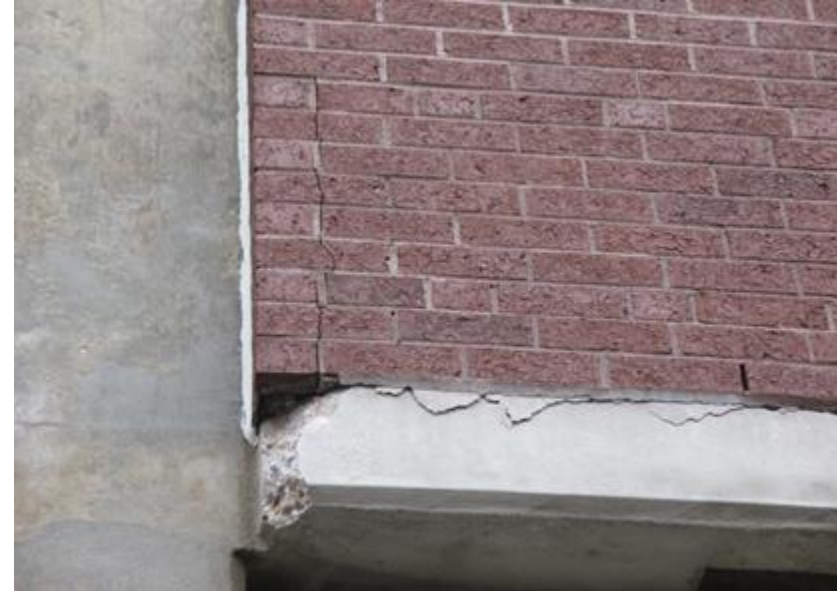
**SPANDRELS & BRICK PANELS**

- R=2.0 (U=0.4) Thermal Resistance
- Air infiltration (severe)
- Deteriorated concrete and masonry

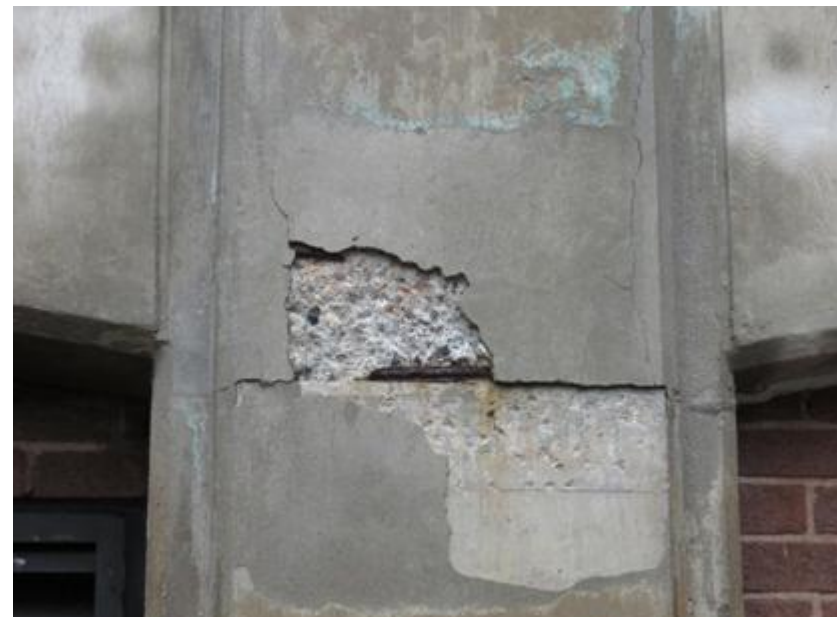
**FAILED CONCRETE PATCHES**

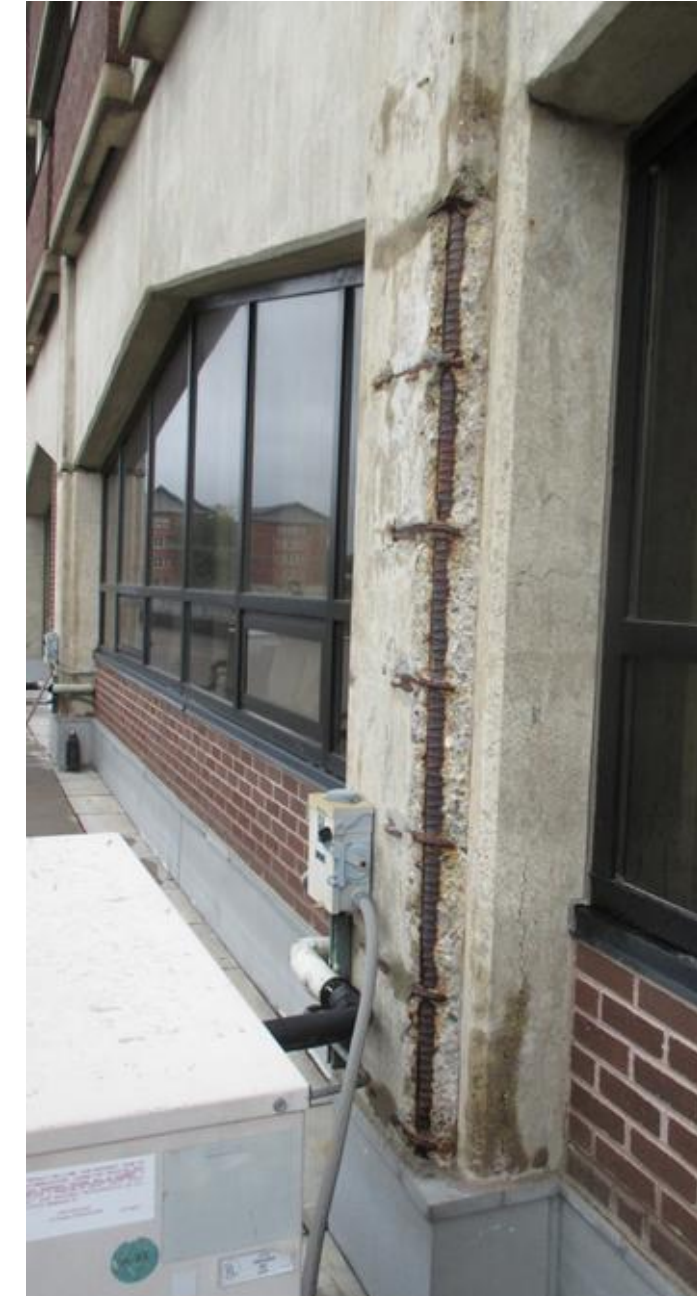
**EXPOSED REBAR**

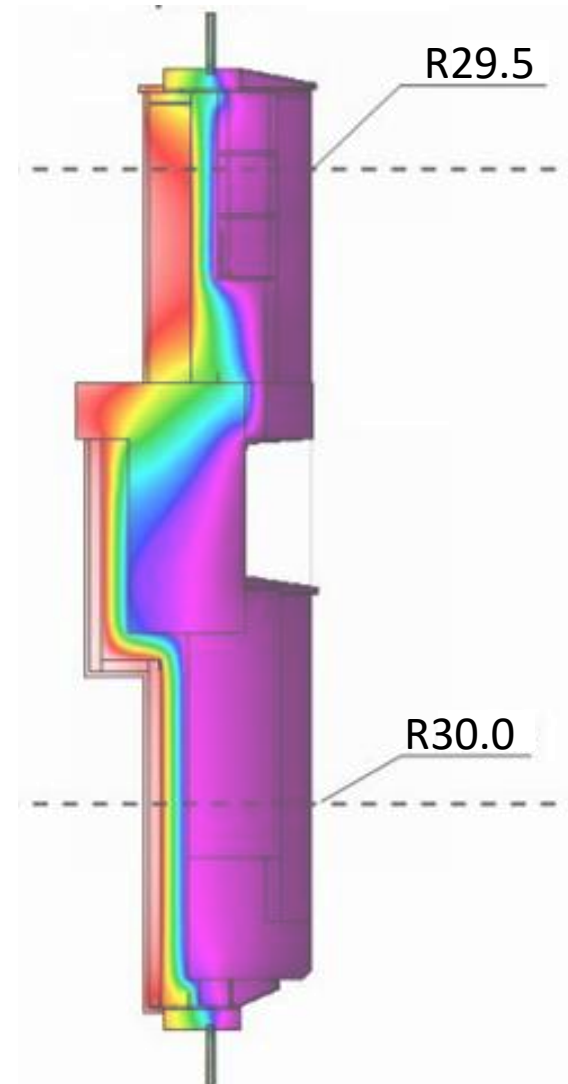
**Interior Insulation**  
**3 1/2" Spay Foam**

- Will added insulation cause damage to the existing façade?
- Answer: No**

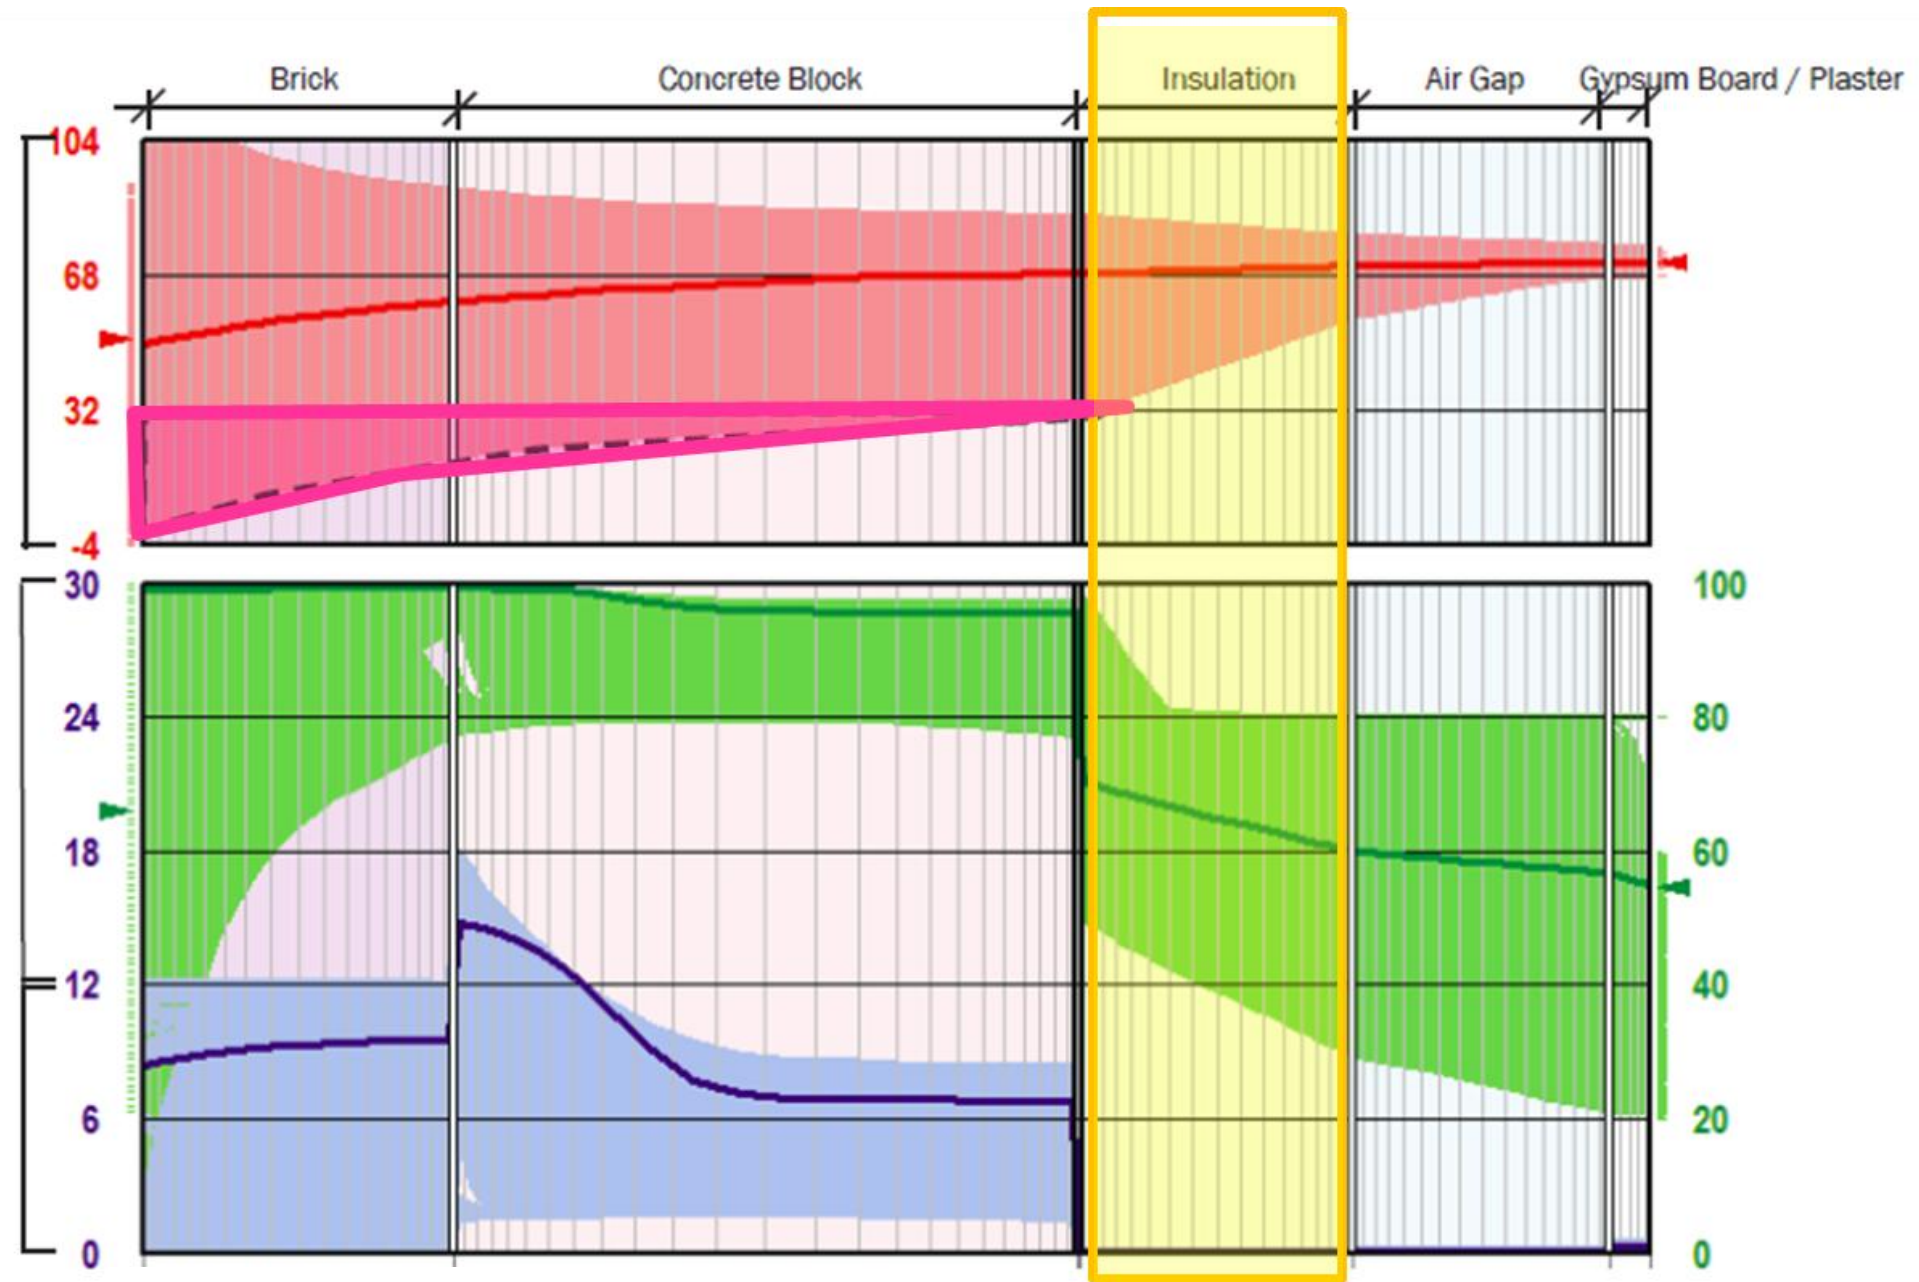
## WUFI ANALYSIS

### PROPOSED FAÇADE SECTIONS

Temperature  
(°F)

Relative Humidity  
(%)

Water Content  
(lbs/ft<sup>3</sup>)

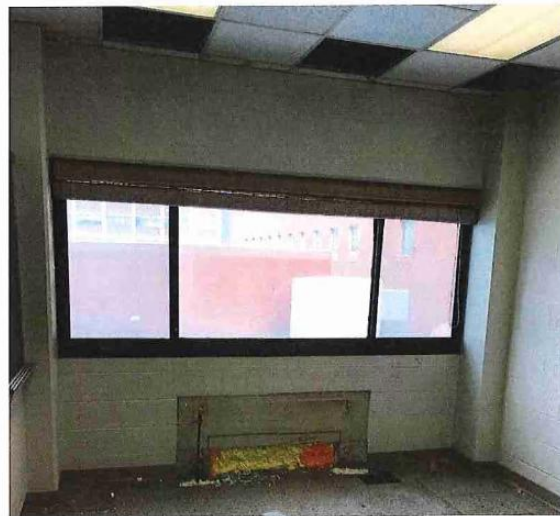
### Pre-Construction Blower Door Test

Ambient Exterior Air Temperature: 7°F  
Ambient Interior Air Temperature: 56°F

<u>Title of Test</u>	<u>Test Results</u>	<u>Allowable</u>
Air Infiltration @ 25 pa	305 cfm	N/A
@ 50 pa	430 cfm	N/A
@ 75 pa	530 cfm	N/A
Air Exfiltration @ 75 pa	318 cfm	N/A

- Enclosure interventions resulted in a **40% reduction** of air infiltration

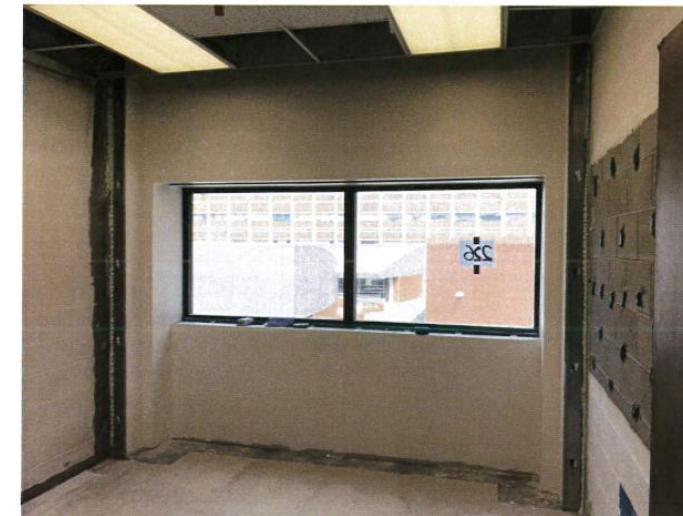
### Post-Construction Blower Door Test

Ambient Exterior Air Temperature: 80°F  
Ambient Interior Air Temperature: 78°F

<u>Title of Test</u>	<u>Test Results</u>	<u>Allowable</u>
Air Infiltration @ 25 Pa	120 cfm	N/A
@ 50 Pa	174 cfm	N/A
@ 75 Pa	219 cfm	N/A
Air Exfiltration @ 75 Pa	109 cfm	N/A

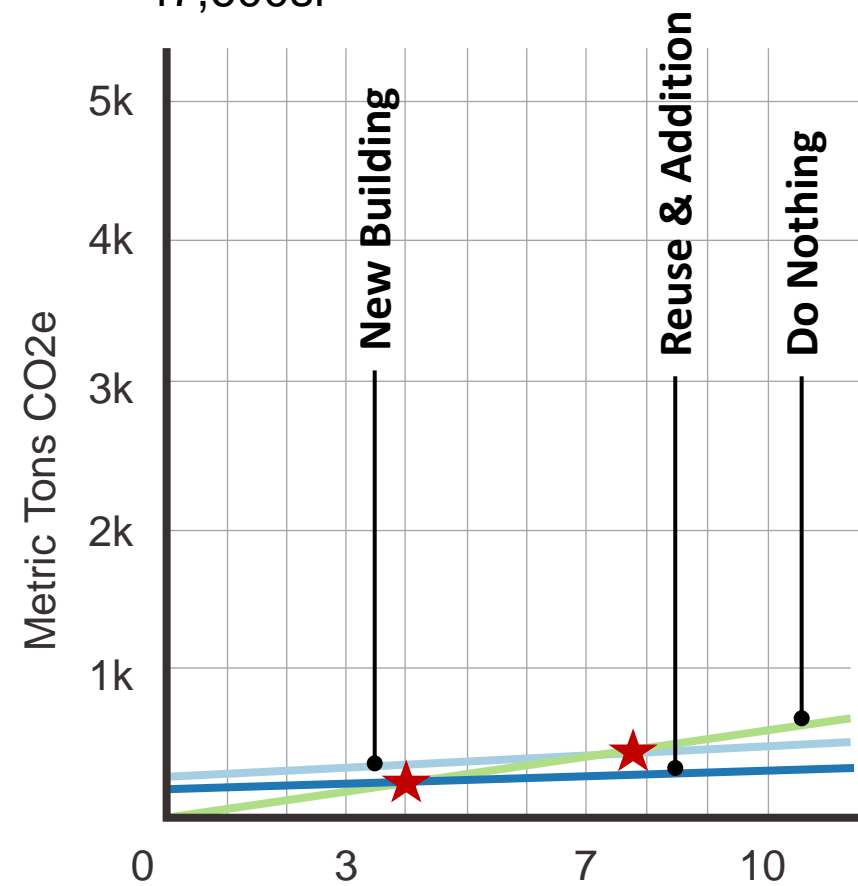
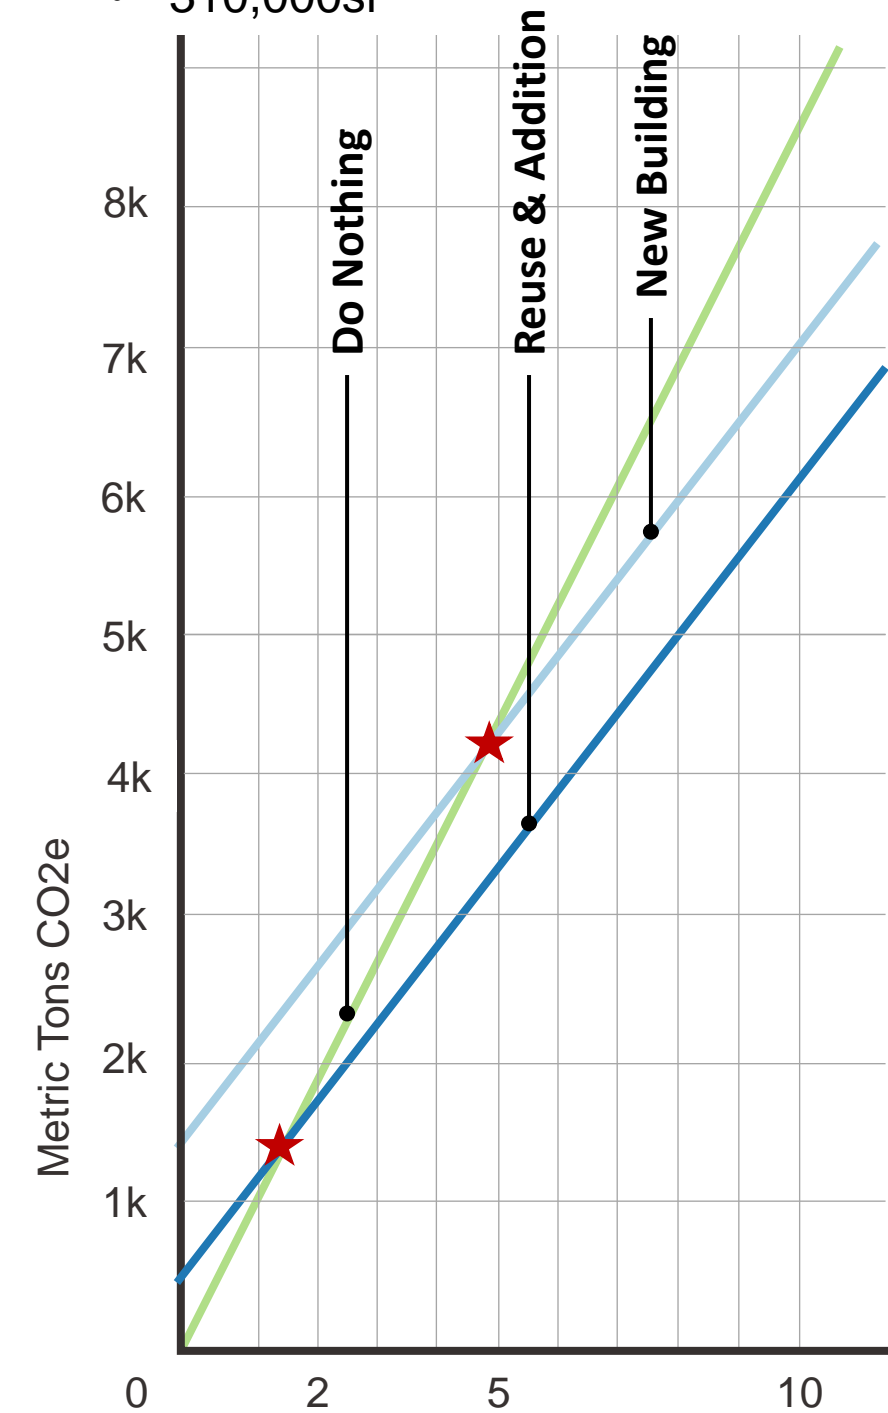
## Cumulative Emissions (Operational & Embodied) Over Time

█ Do Nothing    
 █ Reuse & Addition    
 █ New Building
