Air Tightness Requirements of the Passive House Standard

NESEA BuildingEnergy Boston Conference
March 2018

- Brief Overview of Passive House
- PH Air Tightness Requirements
- Design Phase
- Construction Phase QA/QC
- Case Studies
 - The House at Cornell Tech
 - St. John Neumann
 - Beach Green North

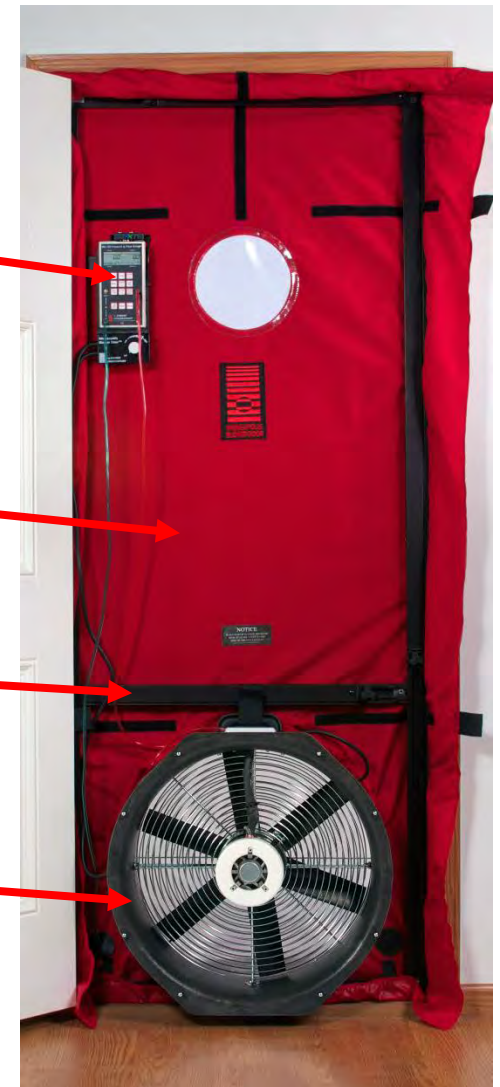
Blower Door Testing

- Basic Components
 - Gauge (manometer)
 - Shroud
 - Frame
 - Fan

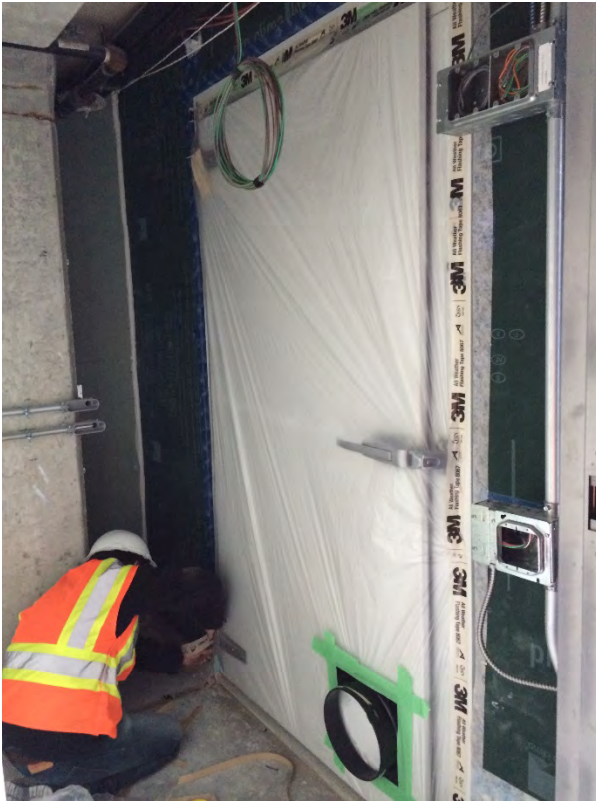
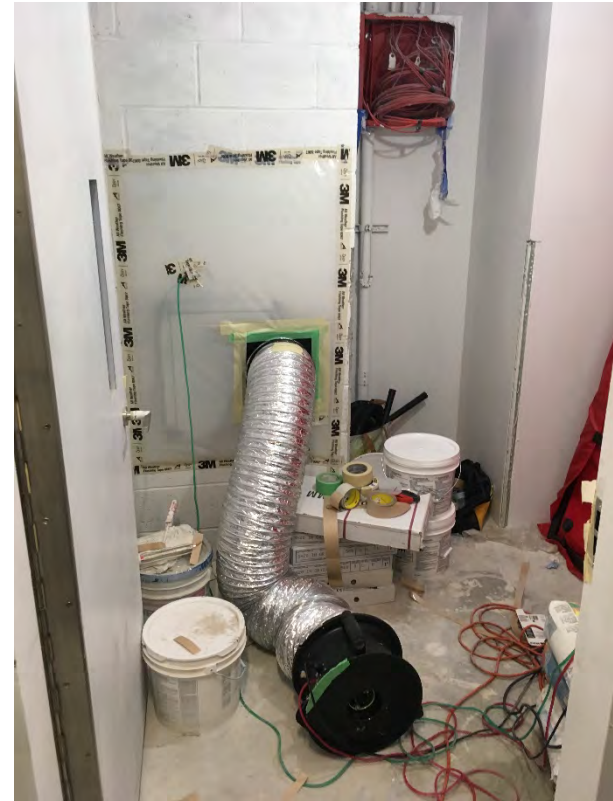
Other Tests

- Condenser porch doors
- Trash chute rooms / doors

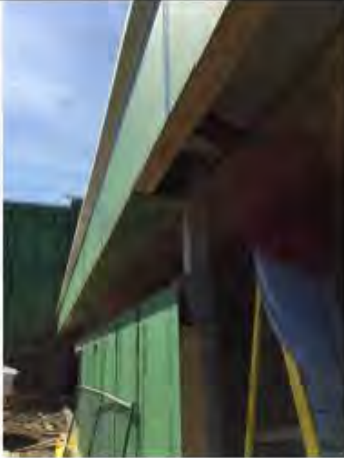
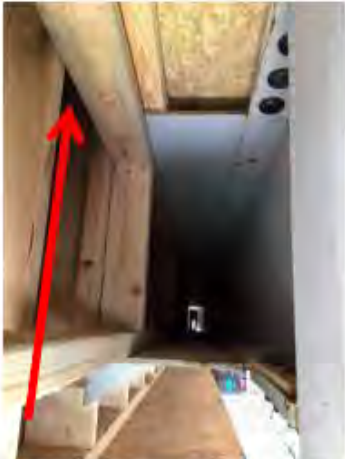
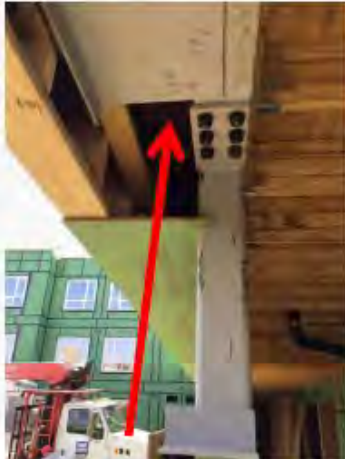
Site Visit Reports

Item #	Description and Action Required	Images
1	<p>9" of OCSP needs to be sprayed on the ceiling of the canopy which is currently un-reachable due to the structural steel of the canopy. This may require temporary removal of the already installed exterior sheathing.</p> <p>After the sheathing is re-attached, OCSF needs to be applied to the interior of it.</p> <p>The condition needs to match Detail 1 on A6.3 shown below.</p>

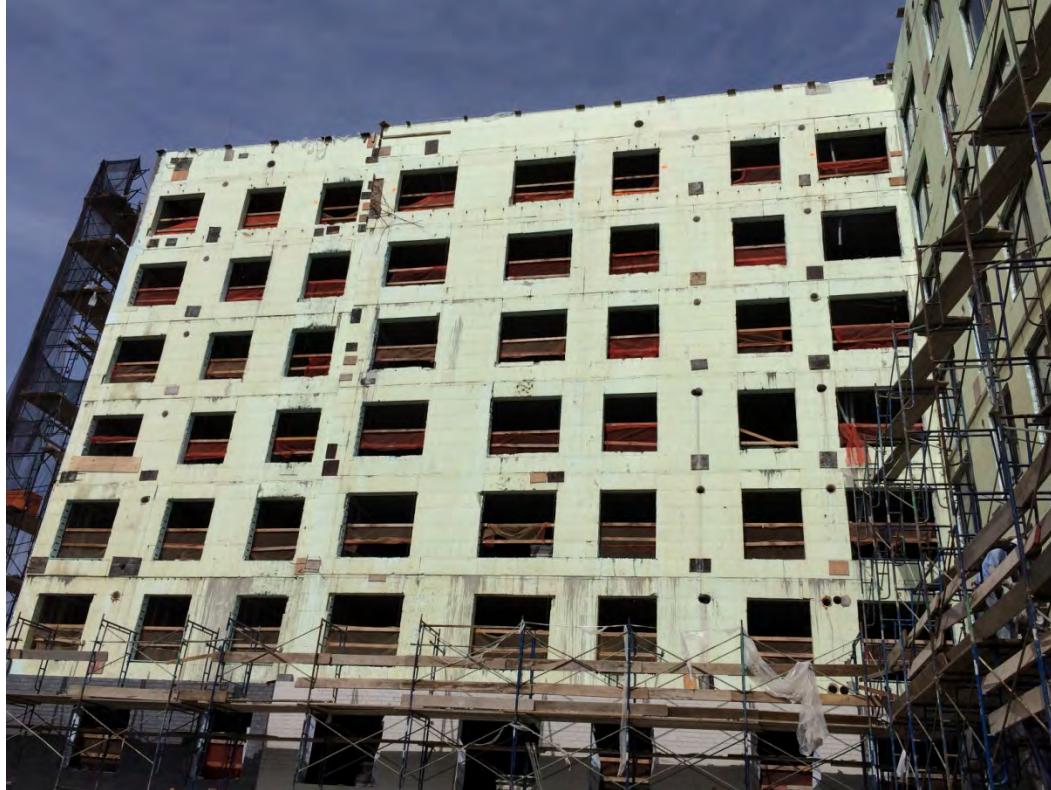
Wall Inspections

- ICF doesn't require as many inspections for insulation and air barrier

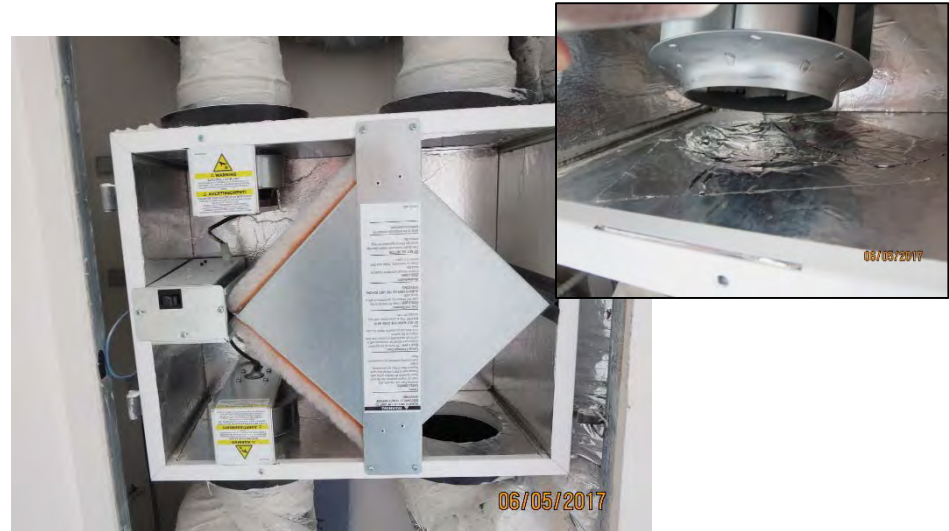
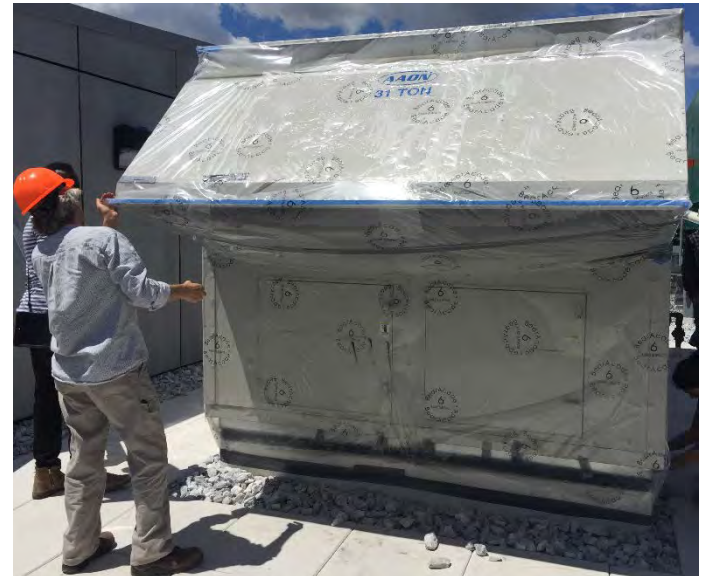
ERVs & Blower Door

- Need to seal off ERVs for final test
- Can't seal off vents from outside for individual ERVs
- Tape off both outdoor connection ports inside every ERV
- Wrap rooftop ERVs
