# BUILDING ENERGY 15

## Super Insulated Walls and Moisture:

## Does Bad Stuff Happen?

## Chris Corson and Kohta Ueno

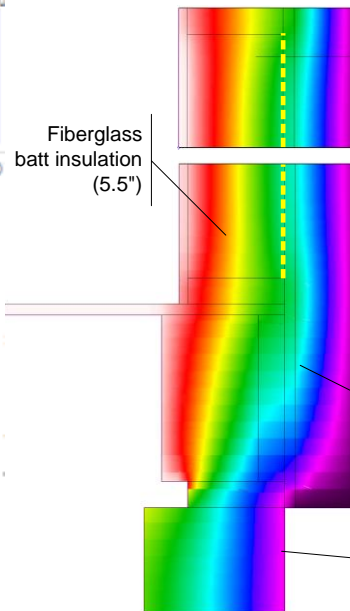
4" insulating sheathing (on 2x6)

4" polyisocyanurate insulation

Structural sheathing

Foundation wall

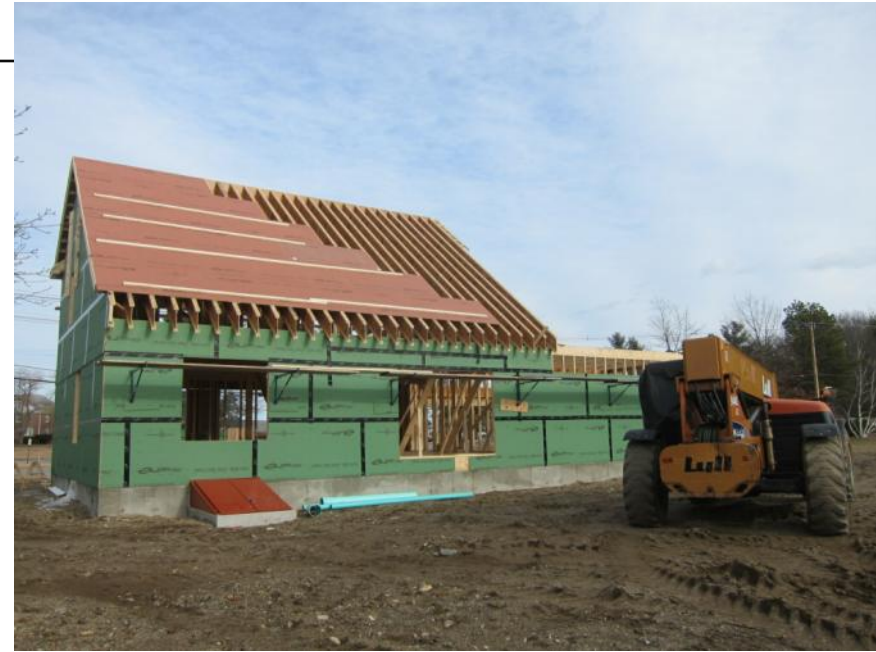
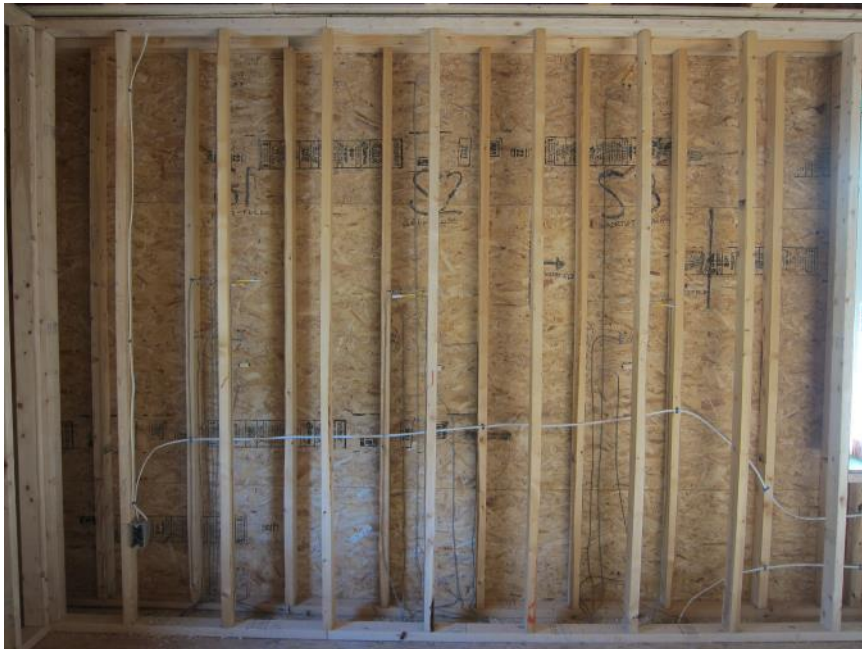
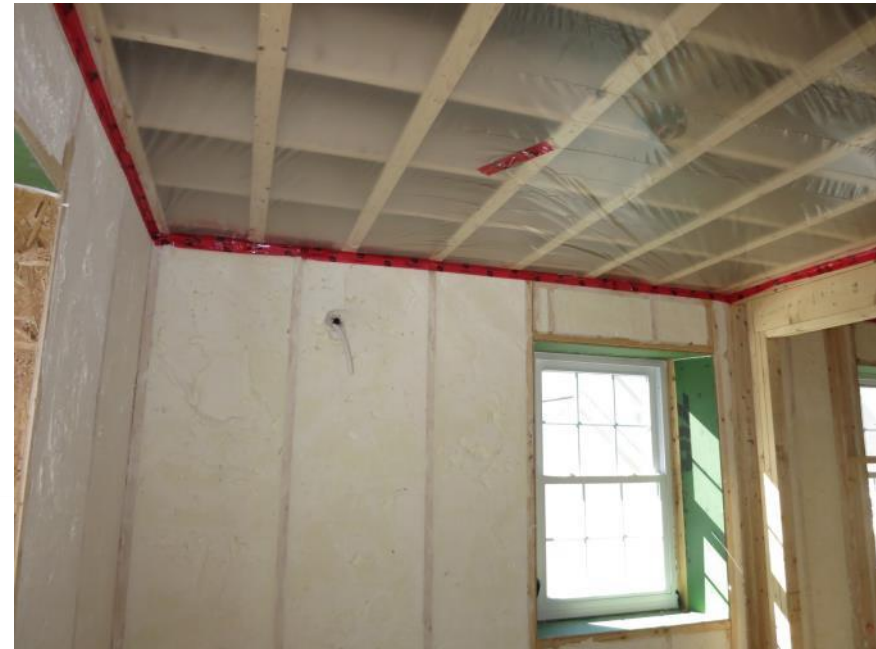
# Wall Construction

- Vinyl siding
- ZIP wall sheathing (OSB)
- Class III vapor control (latex paint)
- IRC R601.3.1—vented cladding over OSB

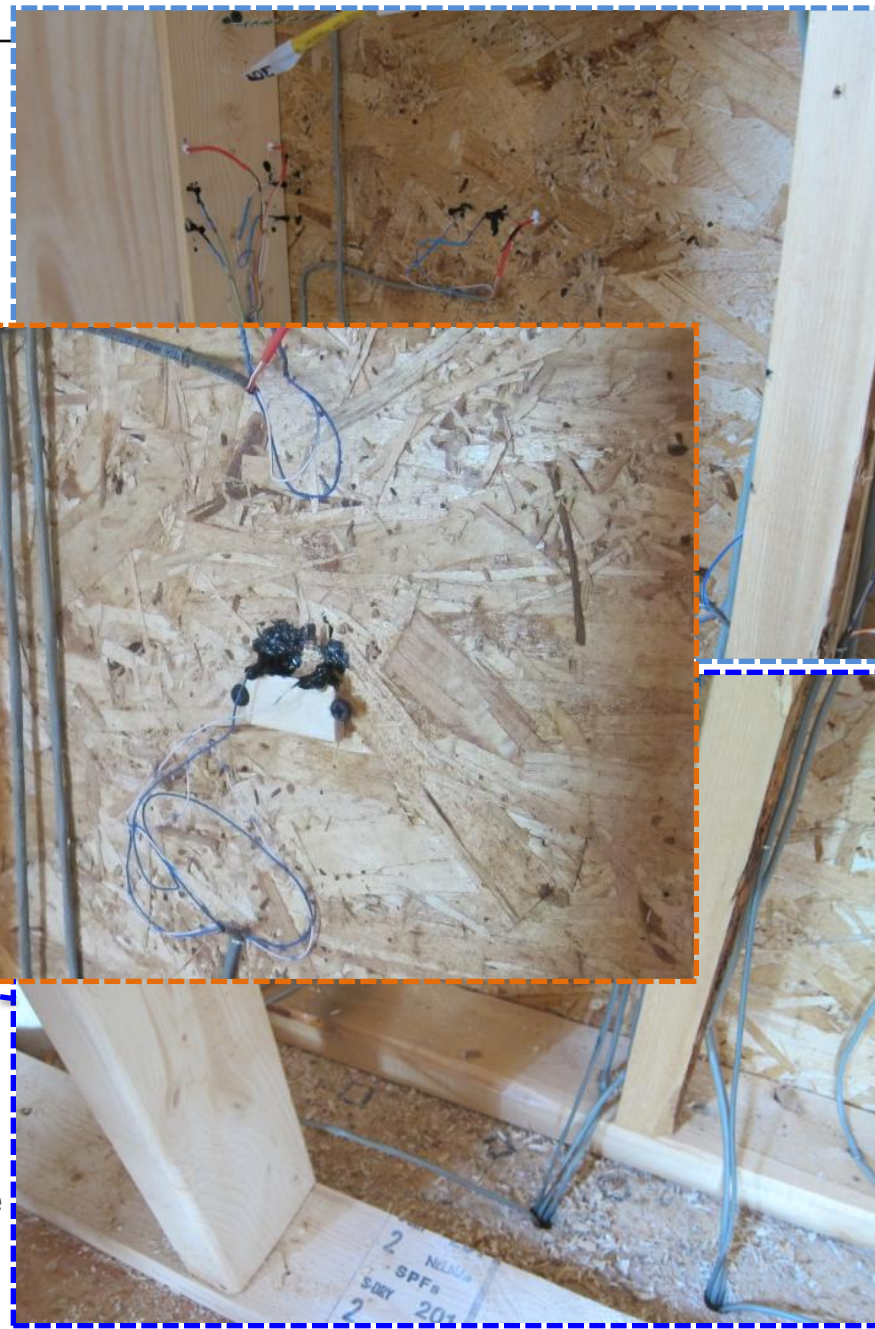
# Test Wall Instrumentation

Upper Wall Sensors

Mid-Height Sensors

Lower Wall Sensors

## Sensor Key:

- ▲ Temperature
- Relative humidity/temperature
- Moisture content/temperature
- Moisture content block

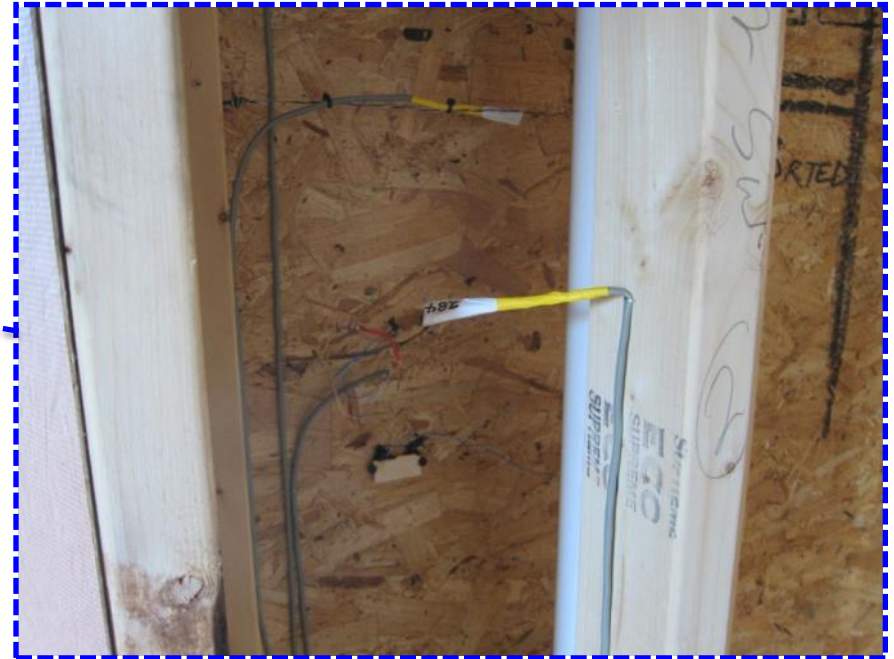
# Test Wall Instrumentation

Upper Wall Sensors

Mid-Height Sensors

Lower Wall Sensors

## Sensor Key:

- ▲ Temperature
- Relative humidity/temperature
- Moisture content/temperature
- Moisture content block

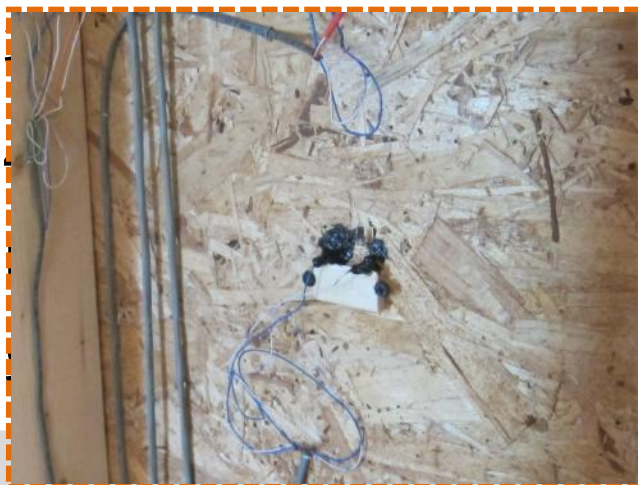
# Sheathing "Wafer" Moisture Contents

- 100% RH
- → liquid water immersion
- in condensation at sheathing
- condensation on south side
